Office of Inspector General | United States Postal Service

Audit Report

Property Condition Review – San Francisco, CA Processing and Distribution Center

Report Number 21-158-R22 | October 27, 2021

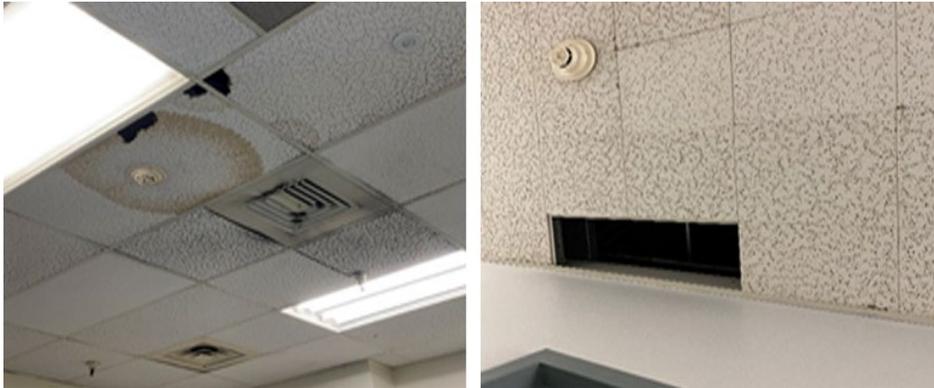
We identified 16 maintenance deficiencies, including stained, broken, and missing ceiling tiles throughout the facility (see [Figure 1](#)); dirty air vents (see [Figure 2](#)); unsanitary restrooms with dirty floors, toilets, and partitions (see [Figure 3](#)); and trash and debris around the building's exterior (see [Figure 4](#)) and roof (see [Figure 5](#)).

Figure 1. Stained, Broken, and Missing Ceiling Tiles

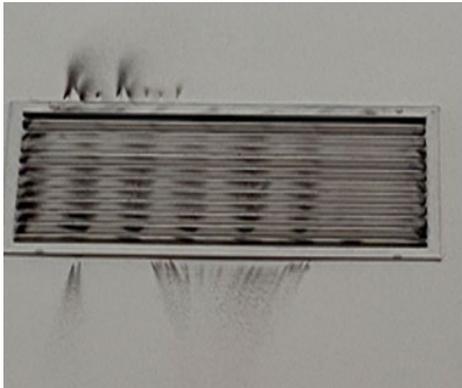
Figure 2. Dirty Air Vent

Maintenance and safety staff abated some issues by cleaning air vents, unblocking electrical panels, securing ladders, performing inspections on fire extinguishers, and removing trash and debris in and around the facility. We appreciate management's prompt attention to these matters.

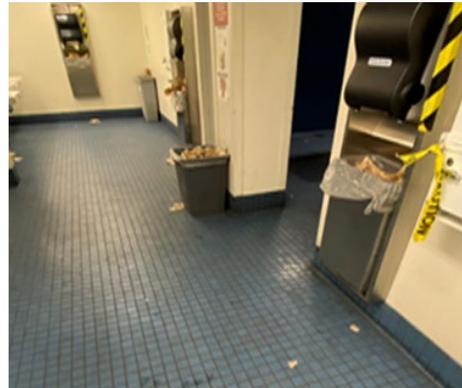
Figure 3. Unsanitary Restroom

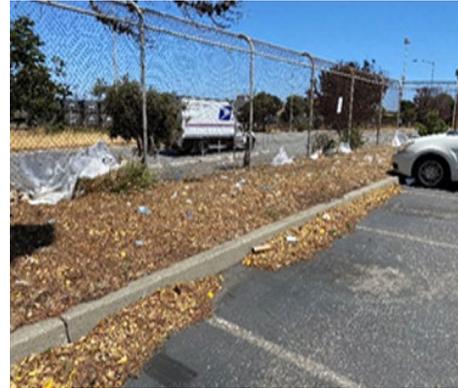
Figure 4. Trash Around Exterior

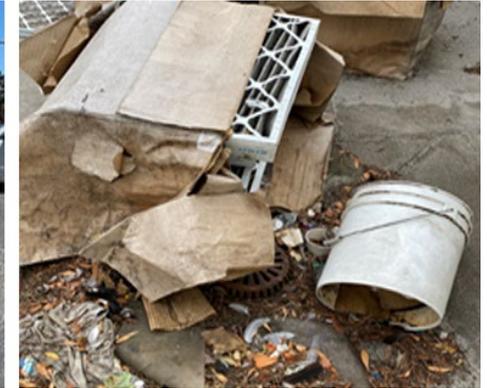
Figure 5. Trash and Debris on Roof

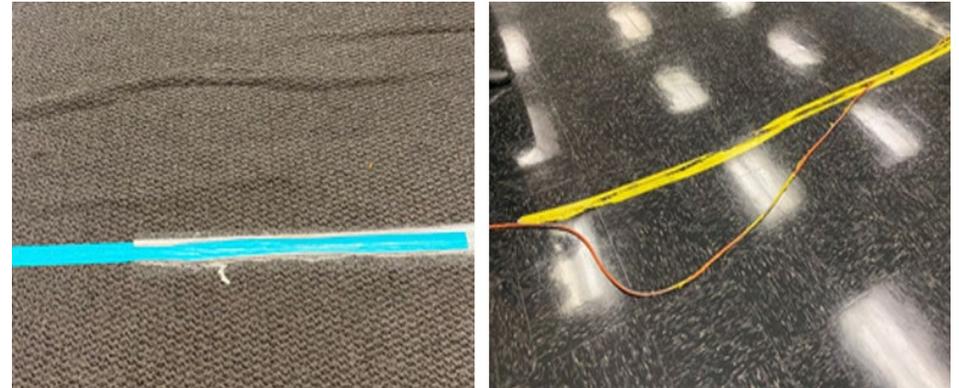
We identified 17 safety deficiencies at the San Francisco P&DC, including potential trip hazards, such as loose carpet and unsecured cords (see Figure 6); blocked electrical panels; microwaves and refrigerators plugged into power strips in an unsafe manner (see Figure 7); and data ports and phone lines that were hanging, uncovered, and detached from the walls (see Figure 8).

Figure 6. Loose Carpet and Unsecured Electrical Cord

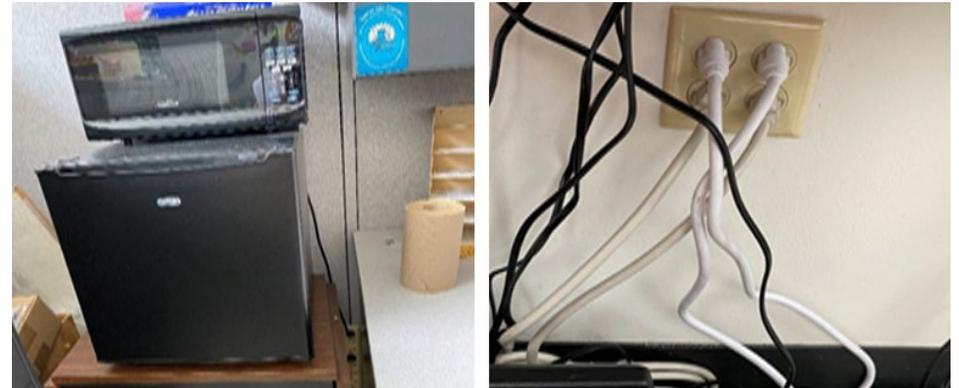
Figure 7. Excessive and Unsafe Power Strip Usage

- Management did not convey to employees how to use power strips properly and safely. The safety specialist stated that because of employees' fears of contracting COVID-19 and not wanting to use appliances in the break rooms, there has been an excessive number of microwaves and refrigerators plugged into power strips.

We recommend the **Senior Director, Processing Operations, Pacific Northwest Division**, direct the Safety Manager to convey to plant employees the proper and safe use of power strips and perform a routine safety inspection to ensure all appliances are plugged into the correct electrical receptacles.

Regarding recommendation 2, management stated that the local safety specialist would conduct semiannual building inspections, provide plant management with the findings, and set abatement timelines. Management also provided stand-up talks on Safety Compendium Electronic Appliances to all plant employees. The talks covered the proper use of power strips and the requirement that appliances be plugged directly into a wall outlet. Management had abated the issues by July 18, 2021 and completed stand-up talks by October 18, 2021.

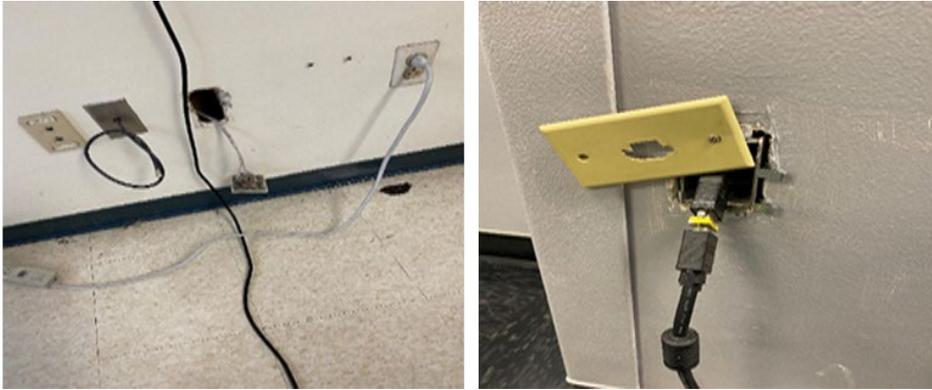
Figure 8. Hanging and Uncovered Phone and Data Lines

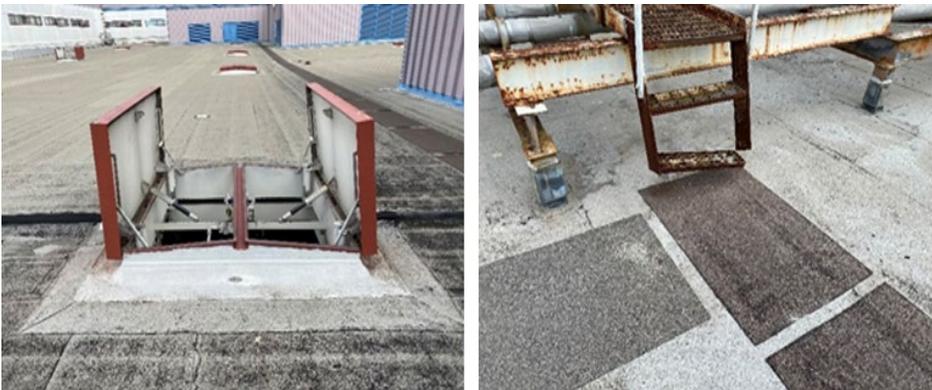
In addition, we identified safety issues on the roof and dock areas. On the roof, we found open fire vents with no fall protection and an unsecured crossover bridge with a broken step (see Figure 9). The open fire vents and unsecured crossover bridge expose employees and contractors to serious work-related injuries. In the dock areas, we found guard rails with protruding bolts and broken concrete near the safety path, creating potential trip hazards for employees and contractors (see Figure 10).

Figure 9. Open Fire Vents and Unsecured Crossover Bridge

- Management stated the fire vents are supposed to remain closed and only open in the event of a fire. Employees manually opened the fire vents for various reasons, such as venting smells from the building or circulating the air.

We recommend the **Senior Director, Processing Operations, Pacific Northwest Division**, evaluate and mitigate safety risks associated with open fire vents.

Regarding recommendation 3, the plant manager provided stand-up talks to plant maintenance management and building staff to eliminate safety risks associated with fire vents. The directive informed staff members that smoke vents are always to remain closed and be used only in emergencies. Management gave all stand-up talks by August 6, 2021.

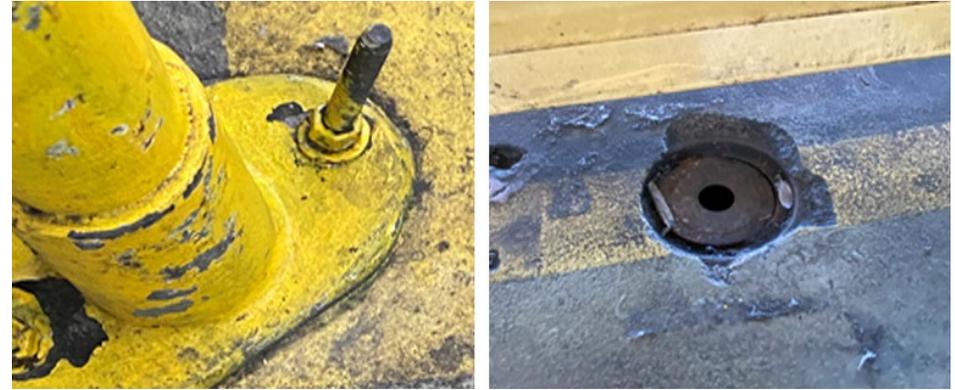
Figure 10. Protruding Bolts and Broken Concrete

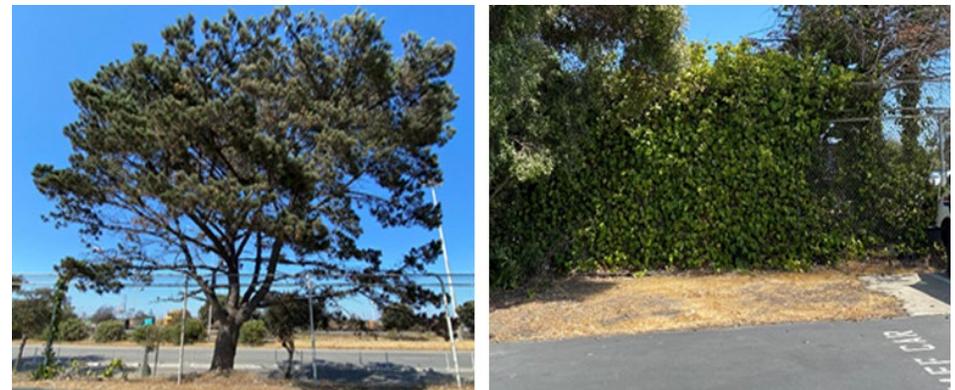
We identified one security issue, which involved overgrown trees along the fence perimeter of the employee parking lot. The trees are close enough to the perimeter fence that someone could potentially climb them and jump over the fence to gain unauthorized entry to secure areas (see Figure 11). Postal Service policy states that trees should not be closer than 10 feet to a fence or building and must not provide points of unauthorized entry to the facility.⁵

Figure 11. Overgrown Trees

We recommend the **Senior Director, Processing Operations, Pacific Northwest Division**, coordinate with the U.S. Postal Inspection Service to evaluate potential security concerns with the proximity of trees to the perimeter fence.

Regarding recommendation 4, management stated that the local facility security specialist completed the Vulnerability Risk Assessment Tool (VRAT) and provided the information to the U.S. Postal Inspection Service specialist. Management awarded a contract for abatement of security concerns related to the trees and
