SUBJECT: Audit Report – Deposit by Mail Controls at Selected Mail

Processing Facilities (Report Number NO-AR-19-007)

This report presents the results of our audit of the Deposit by Mail Controls at Selected Mail Processing Facilities (Project Number 19XG011NO000).

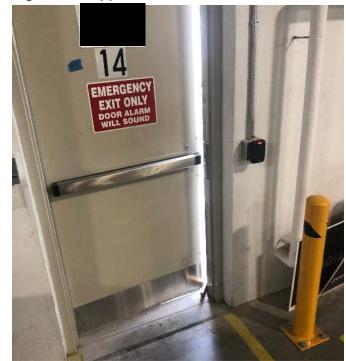
Figure 1. Propped Door

Unsecured exterior door propped open. Source: OIG photograph taken at the

The **Vice President, Network Operations,** establish standard operating procedures for the Deposit by Mail service to include security cameras, secured doors, staged mail, and adequate rewrap procedures.

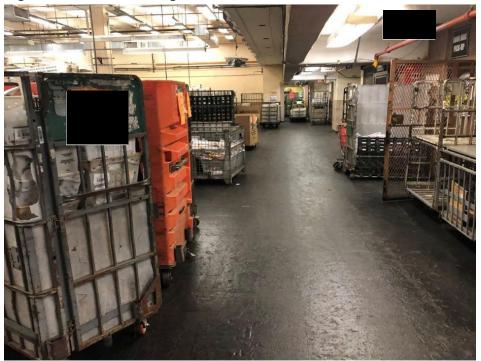
Figure 2. Unsecured Staged DBM Mail

DBM mail from the previous evening is outside the cage. equipment on the left side of the aisle.

including DBM mail, is in the Postal

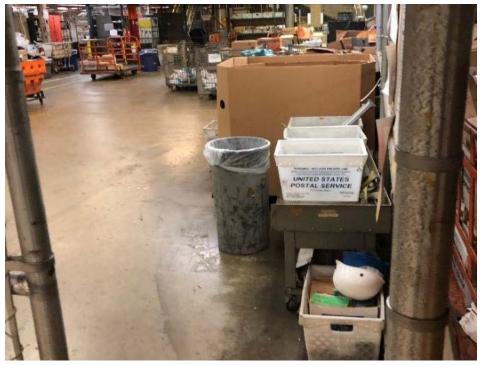
Figure 3. Cluttered Rewrap Area

The box, flat tubs, and hard hat are examples of items that need to be removed from the rewrap area. Source: OIG photograph taken at the
