September 2, 2015

MEMORANDUM FOR: JOHN J. DIPERI
DISTRICT MANAGER, ARIZONA DISTRICT

SUBJECT: Management Alert – Working Conditions at the

Office (Report Number HR-MA-15-004)

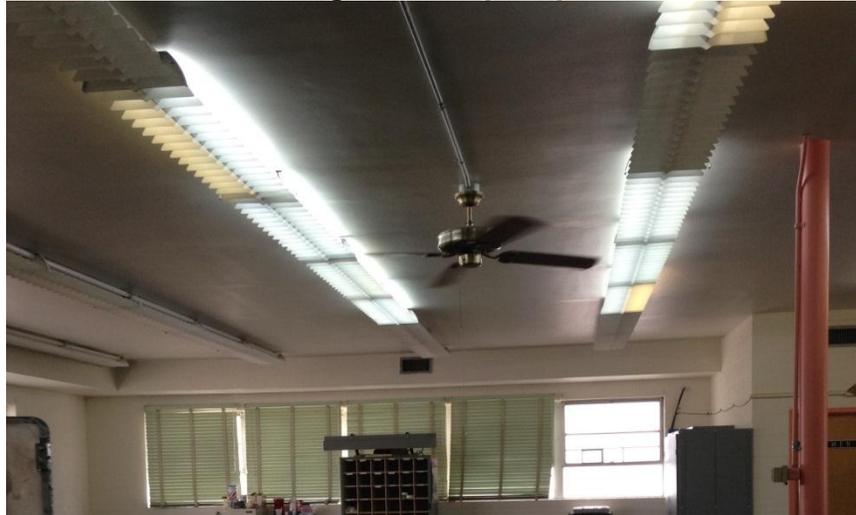
Figure 2 – Lighting

- The major lighting issues are the result of old ballasts¹¹ that cause the lights to burn out when they are switched on and off. According to records in the eFMS a repair request was submitted in September 2014 for replacement of 150 light bulbs. It was not until maintenance personnel visited the Post Office, November 2014, and saw the extent of the outage they took steps to resolve the lighting issues. When the lights were replaced in February 2015 only some of the ballasts were replaced; since most of the old ballasts are still in use, the lights continue to burn out prematurely (see [Figure 2](#) in Appendix A).
- We notified Post Office employees of the unsafe exposed wiring and cracked and exposed outlets after our walkthrough of the facility. One area had exposed wires

Management agrees with the recommendation and pest control services are now being provided to the facility from ECOLAB and there are no further reports of cockroaches, bugs, etc. There is a monthly pest control plan setup with ECOLAB to ensure bug infestations do not reoccur. Figures 2 thru 9 listed in the above referenced report have been either repaired or replaced.

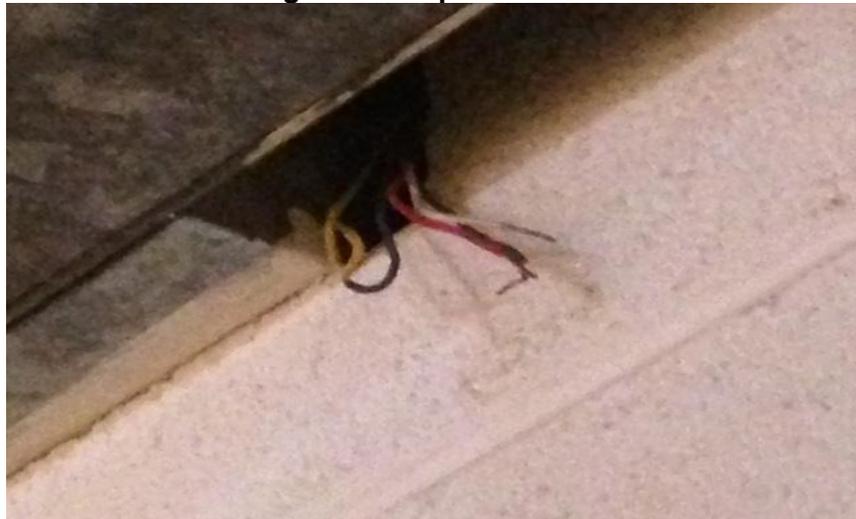
Figure 3 – Exposed Wires

protruding from the ceiling (see [Figure 3](#) in Appendix A) and two cracked power outlets with exposed components (see [Figure 4](#) and [Figure 5](#) in Appendix A).

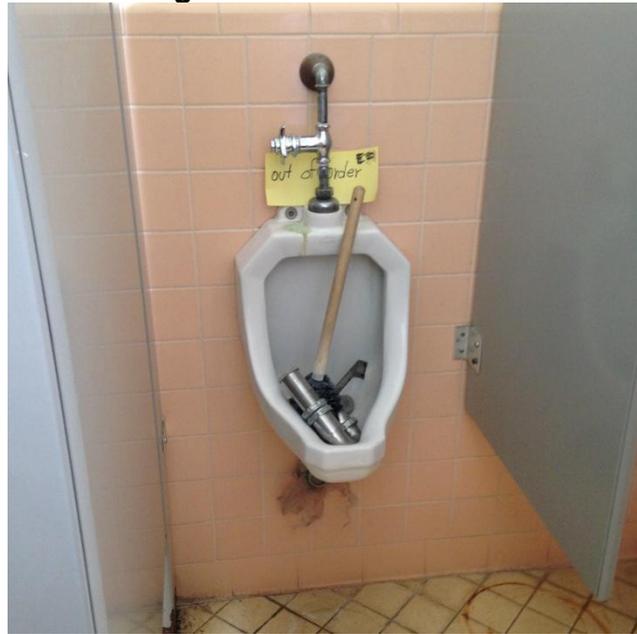
Figure 6 – Broken Urinal

- The significant plumbing problems in the men's bathroom and the water fountain existed prior to the current [REDACTED] arrival in August 2013. The men's bathroom had a broken urinal (see [Figure 6](#) in Appendix A) and a cracked toilet seat (see [Figure 7](#) in Appendix A). The drinking fountain did not dispense water or drain properly (see [Figure 8](#) in Appendix A). The faucet in the women's bathroom recently broke but was still slightly functional (see [Figure 9](#) in Appendix A).

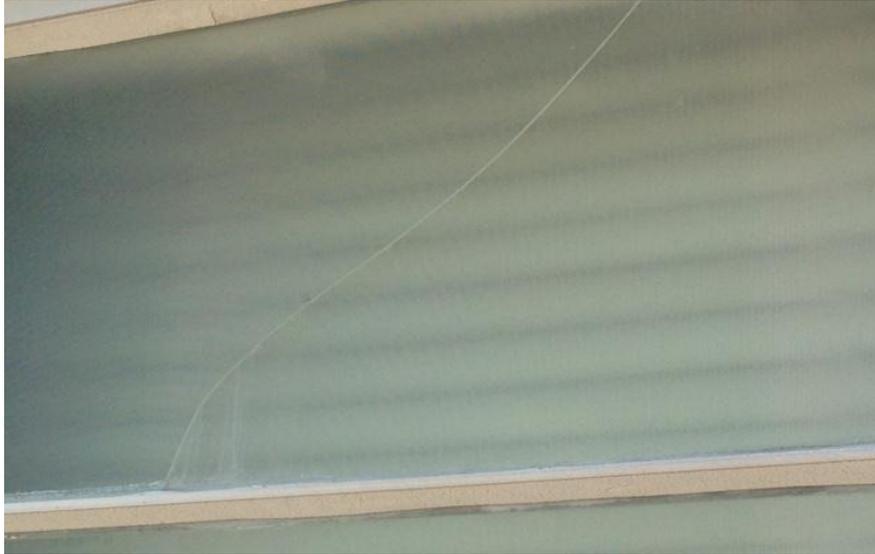
Figure 10 – Cracked Window

- We observed multiple cracked windows with evidence of water seepage (see [Figure 10](#) and [Figure 11](#) in Appendix A) and water-damaged ceiling tiles and walls throughout the facility (see [Figure 12](#) in Appendix A). During heavy downpours, water leaks into the interior of the building and pools on the lobby floor near the Post Office boxes. The landlord previously sent contractors to repair or patch the roof; however, leaks continued during extremely heavy downpours. We also observed cockroaches inside the facility and were told there was an infestation.

The cracked windows, water-damaged wall, and ceiling tiles (figures 10 thru 12) have not been repaired or replaced; however, Wes Redmond, Manager of Post Office Operations, has received a commitment from the [REDACTED] Office landlord's maintenance representative that the items referenced above will be replaced or repaired no later than Friday, September 4, 2015.
