SUBJECT: Management Alert – Property Condition Issues at Spring
Garden Station (Report Number 20-293-R21)

Introduction

Building Maintenance

Building Safety

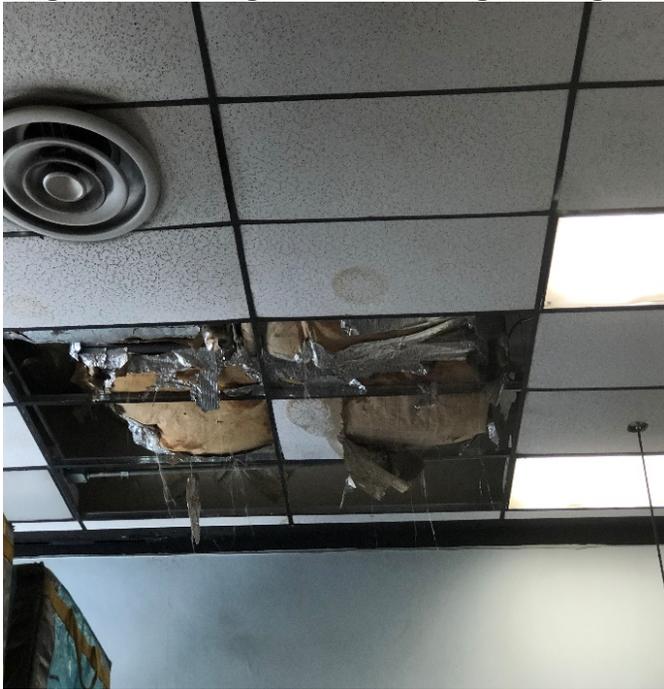
Figure 1. Damaged and Missing Ceiling Tile

At the Spring Garden Station, we observed an active roof leak; damaged, stained, buckling and missing ceiling tiles (see [Figure 1](#)); standing water, broken pipe coverings, rusted equipment, chipped and peeling walls, and cobwebs in the basement (see [Figure 2](#) and [Figure 3](#)); improperly stored supplies and equipment; poor lighting in the men's restroom; and general clutter.

Recommendation #1: We recommend the **District Manager, Philadelphia Metropolitan District**, address all building maintenance and safety issues identified.

- Damaged and missing Ceiling tiles- abated on September 3 (Figure 1).
- Standing water in basement- abated on September 3 (Figure 2).
- Broken Pipe Coverings- abated on September 10 (Figure 3).
- Chipped and Peeling Walls -abated on September 10.
- Stained and peeling ceiling in women's restroom- abated on September 11.
- Metal Pipe sticking out from wall in women's restroom- abated on September 11 (Figure 6).
- Uncovered air conditioner vent hanging from ceiling- abated on September 10 (Figure 4).
- Downed Tree and Trash in Yard- abated tree on September 8 (Figure 5), trash removal by September 30.

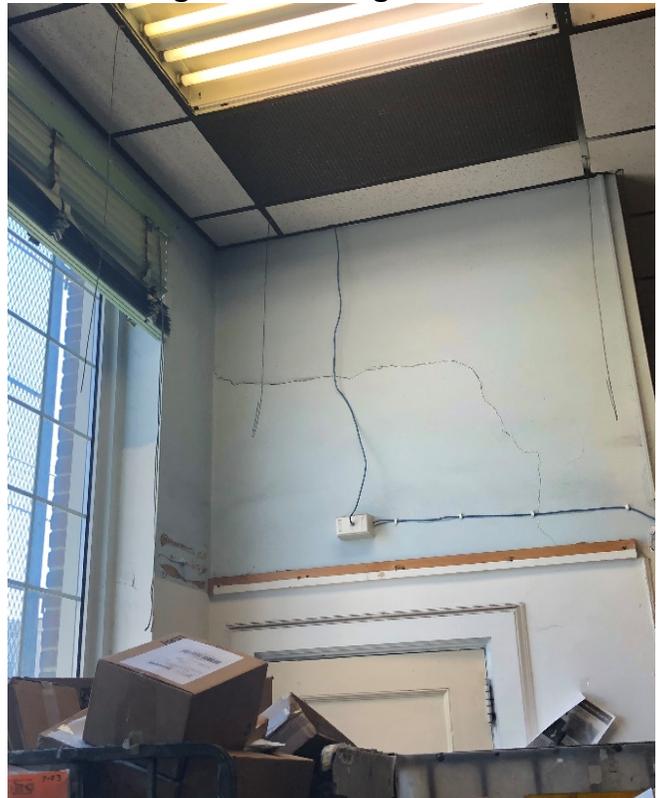
Figure 4. Damaged Walls

In addition, walls throughout the facility had peeling paint, were chipped, and visually dirty (see [Figure 4](#)) and an air conditioner vent was uncovered and hanging from the ceiling (see [Figure 5](#)). Although the air conditioning unit and leaking roof were previously reported in the electronic Facilities Management System (eFMS), others were not.

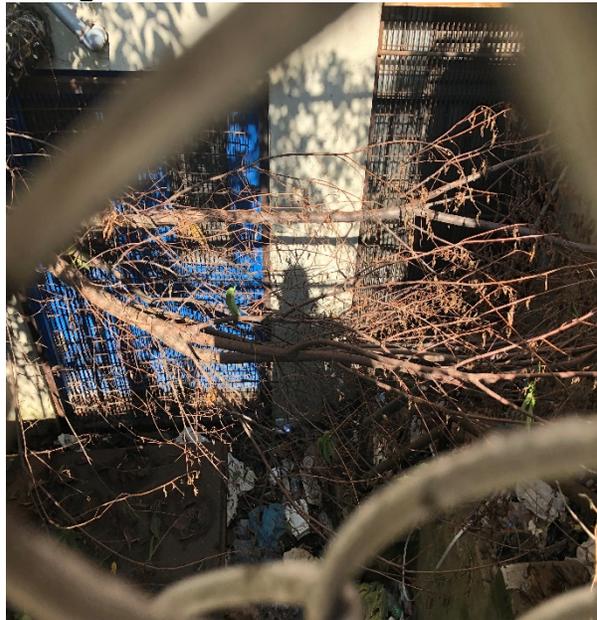
Figure 6. Downed Tree and Trash

1. Trash throughout yard.
2. Downed tree, trash, and a large metal box blocking stairs to the basement (see Figure 6).
3. Excess equipment stored on the dock when there was room for the items in the basement.
4. Leaves and debris on the roof.
5. The air conditioning unit was not working when we arrived but a contractor was onsite repairing it.
6. Lights uncovered or not working throughout the facility.
7. Broken and dirty blinds.
8. Missing tiles on walls in restrooms and lobby.
9. Seat cover holders in women's restroom held up with tape.
10. Rusty partitions in restrooms.
11. Sink in restroom constantly runs.
12. Stained and peeling ceiling in women's restroom.
13. Metal pipe sticking out about two inches from the wall in women's restroom.
14. Insulation hanging from ceiling.

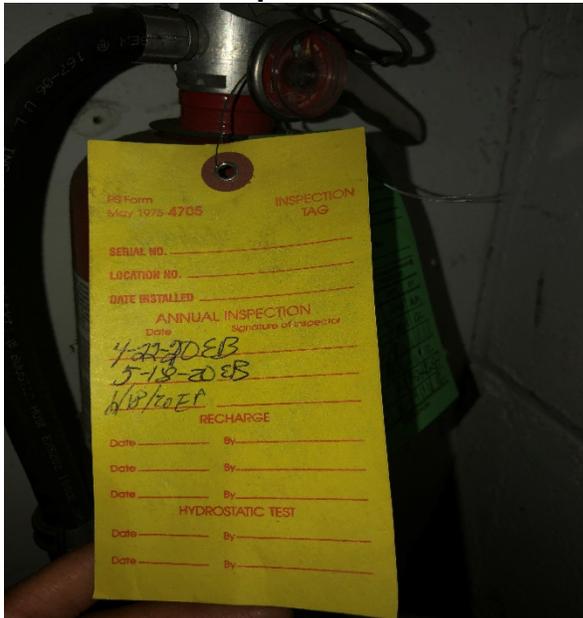
Figure 7. Missing Fire Extinguisher Inspections

At the Spring Garden Station, we identified missing monthly and annual fire extinguisher inspections, trip hazards, and blocked doors, including the emergency exit (see Figures 7 and 8). Electrical panels throughout the facility were uncovered, open, or blocked (see Figure 9). In addition, the floors were damaged and uneven in some places, and one section had a piece of plywood covering a possible hole (see Figure 10).

1. Excessive mail throughout facility causing trip hazards.
2. Emergency exit blocked by equipment inside and outside of the facility (see [Figure 11](#)).
3. Extension cords that were daisy chained (see [Figure 12](#)).
4. Fire extinguisher inspections had not been performed since April 2015 for any of the fire extinguishers, except the basement fire extinguisher which was last inspected in June 2020.
5. Only one vestibule door was accessible; the other was blocked by equipment filled with mail (see [Figure 13](#)).
6. Unsecured ladder and light fixture in basement.
7. Flammable items not properly stored.

Recommendation #2: We recommend the **District Manager, Philadelphia Metropolitan District**, ensure fire extinguisher inspections are performed annually.

Regarding recommendation 2, management ordered new fire extinguishers and scheduled annual and monthly inspections for September 28, 2020.

Management Response/Action Plan: Fire extinguishers on order and estimated delivery September 28. Annual and monthly fire inspections scheduled for September 28.

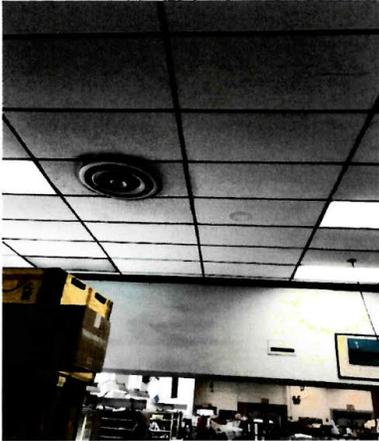
Figure 1. Ceiling Tiles Replaced

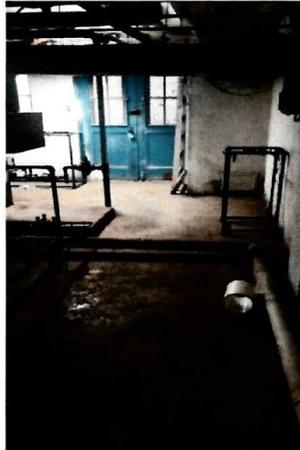
Figure 2. Water in Basement due to clogged drain

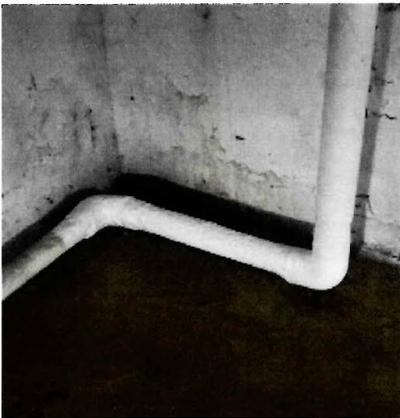
Figure 3. Pipe Insulation replaced.

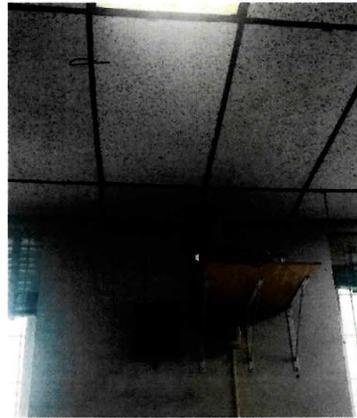
Figure 4. The duct was removed and capped. The ceiling tile was replaced.

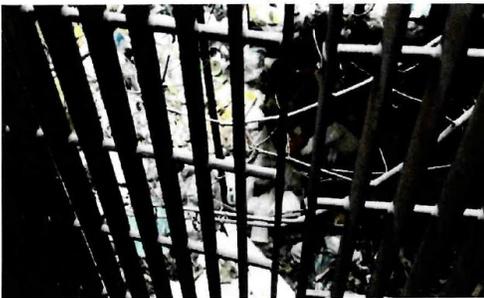
Figure 5. Tree was cut, to be removed by 9/30

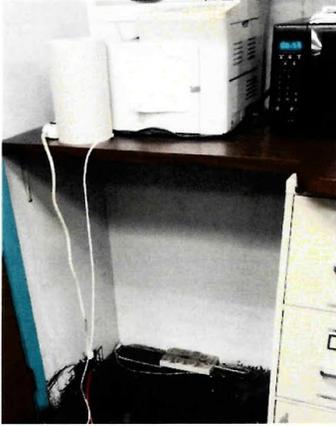
Figure 7. Refrigerator was moved upstairs.

- Excessive mail throughout the facility causing trip hazards
- Emergency exit blocked by equipment inside and outside of the facility
- Blocked egresses
- Unsecured ladder and light fixture in basement- abated on September 3.
- Flammable items not properly stored- Storage cabinet ordered on September 8.
- Extension cords daisy chained- abated on September 11 (Figure 7).

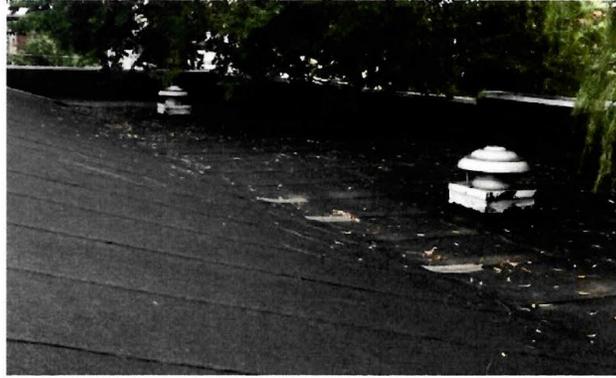
Figure 8. Roof is not leaking, debris was removed.

- Restroom repairs to include: Sink constantly running, missing tiles on walls, seat cover holders procured with tape and sanding and painting of rusty partitions- abated on- September 11.
- Replacement of lights that were not working- abated on September 14.
- Insulation hanging from ceiling- abated on September 11 (Figure 4).
- Replacement of broken and dirty blinds- to be removed by September 30.
- Leaking roof and debris – abated September 3 (Figure 8).
