SUBJECT: Audit Report – Property Condition Reviews – Greenville

Station A, Simpsonville, and Easley Post Offices in South Carolina (Report Number 21-091-R21)

This report presents the results of Property Condition Reviews at the Greenville Station A, Simpsonville, and Easley Post Offices in South Carolina.

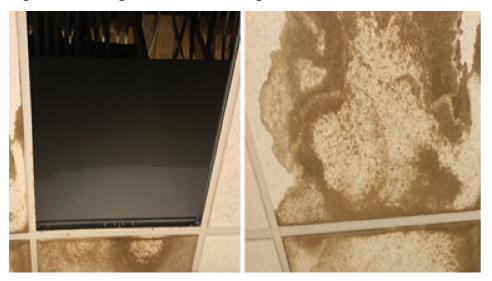
At the Greenville Station A Post Office, we identified missing and stained ceiling tiles in the men's restroom (see Figure 1). We also found stained ceiling tiles in the utility room (see Figure 2), offices, and lobby. In addition, there were dirty vents in the ladies' restroom, a partially detached baseboard strip in the workroom (see Figure 3), and a semi-operable urinal in the men's restroom that retains water after flushing (see Figure 4). We also found burned out light bulbs in the rear customer parking lot.

Figure 1. Missing and Stained Ceiling Tiles in Men's Restroom

We recommend the **Manager, Greater South Carolina District**, address all building maintenance, safety, and security issues identified at the Greenville Station A, Simpsonville, and Easley post offices.

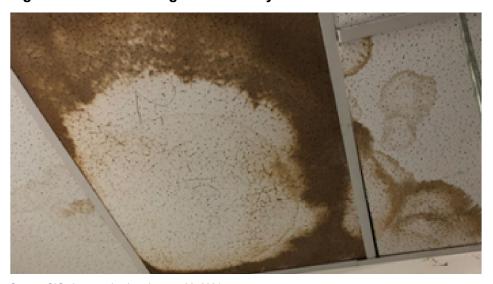
Figure 2. Stained Ceiling Tiles in Utility Room

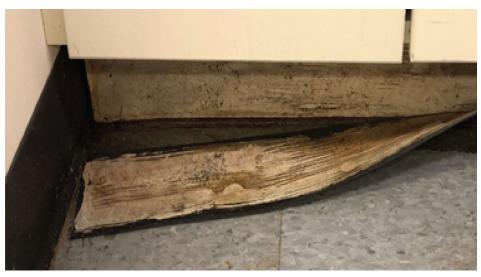
Figure 3. Partially Detached Baseboard Strip in Workroom

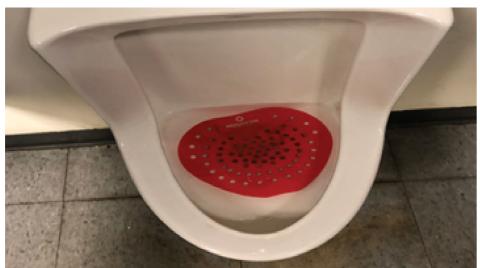
Figure 4. Semi-Operable Urinal in Men's Restroom

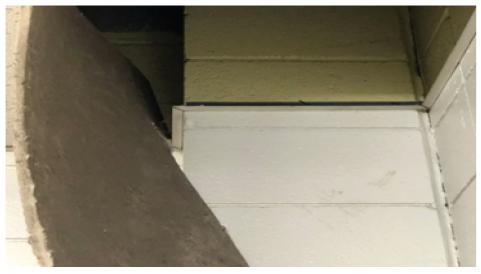
At the Simpsonville Post Office, we identified several issues relating to ceiling tiles throughout the facility (see Table 1 and Figures 5 through 7).

Figure 5. Hanging Ceiling Tile in Loading Dock

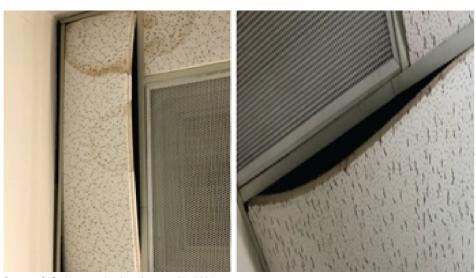
Figure 6. Bulging Ceiling Tiles

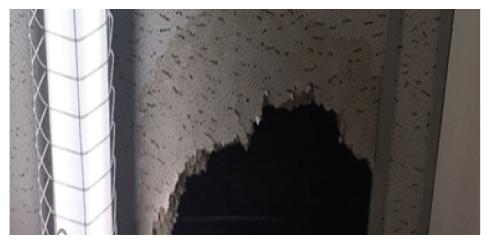
Figure 7. Damaged Ceiling Tile

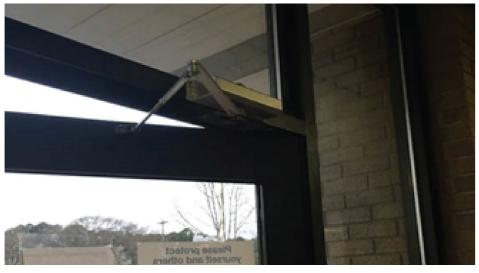
In addition, we found damaged walls in the workroom (see Figure 8) and lobby areas and a damaged door closer at the lobby entrance (see Figure 9).

Figure 9. Damaged Door Closer at Lobby Entrance

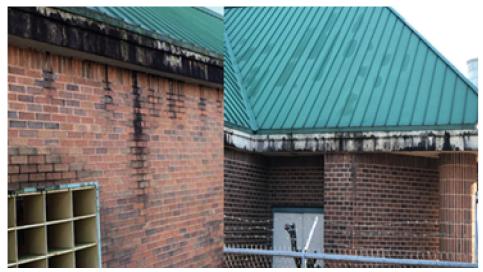
At the Easley Post Office, we found damaged window clerk counters that were reinforced with Priority Mail tape (see Figure 10) and dirty exterior trim at the rear and sides of the building (see Figure 11). In addition, we identified excess equipment such as blue cages, trays, and buckets near the boiler room, electrical room, and dock door, and in the Post Office Box and carrier sections.

Figure 11. Dirty Exterior Trim at Rear and Sides of Building

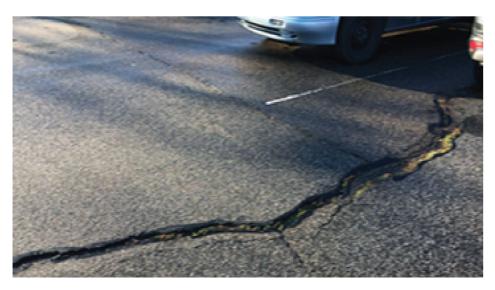
- Misaligned ceiling tile near the mechanical room.
- Stained ceiling tiles in the mail sorting area and carrier section.
- Clogged sink in the ladies' restroom.
- Damaged column behind carrier section.
- Damaged wall near fire extinguisher A in the workroom.
- Dirty vents in the workroom area near the mechanical room and in breakroom.
- Faded parking stripes in the customer parking lot.
- Cracked asphalt in employee parking lot causing a potential trip hazard (see Figure 12).
- Faded handrail paint in the lobby (see Figure 13).

Figure 12. Cracked Asphalt

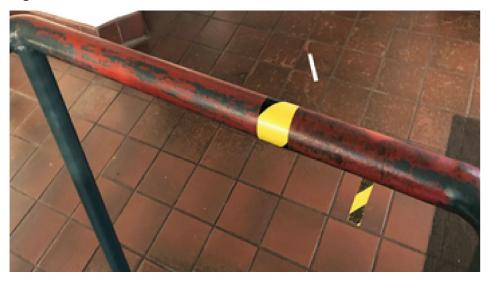
Figure 13. Faded Handrail

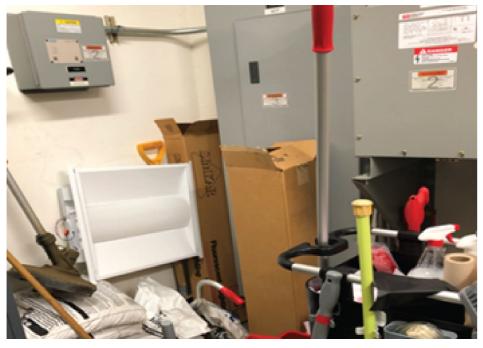
At the Greenville Station A Post Office, we identified a blocked electrical panel in the electrical room (see Figure 14), and none of the three fire extinguishers at the facility had been inspected annually – two were last inspected in November 2019 and one in October 2019. We also found that OSHA poster 3167, *Job Safety and Health* (Spanish version), was not displayed as required.

Figure 14. Blocked Electrical Panel

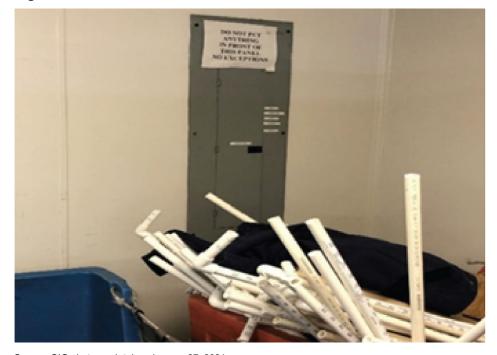
At the Simpsonville Post Office, we found a blocked electrical panel (see Figure 15) and a blocked fire extinguisher in the workroom. None of the seven fire extinguishers at the facility had been inspected monthly since October 2020. We also found that OSHA poster 3165, *Job Safety and Health* (English version), was not displayed as required.

Figure 15. Blocked Electrical Panel

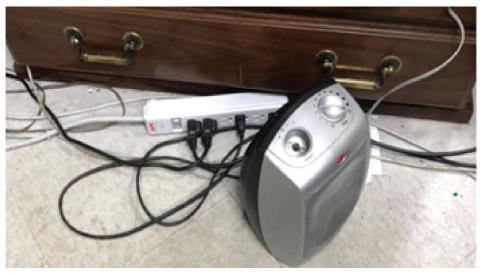
At the Easley Post Office, we identified a portable heater in the postmaster's office (see Figure 16) and a fan in the maintenance office that were plugged into a surge protector instead of the wall outlet, excess equipment that blocked the electrical room door (see Figure 17), and a blocked emergency exit door in the Post Office Box area.

Figure 16. Portable Heater Plugged into Surge Proctector

In addition, management at the Easley Post Office took immediate corrective action by unblocking the electrical room door and unplugging the portable heater and fan from the surge protector. We appreciate management's prompt attention to these matters.

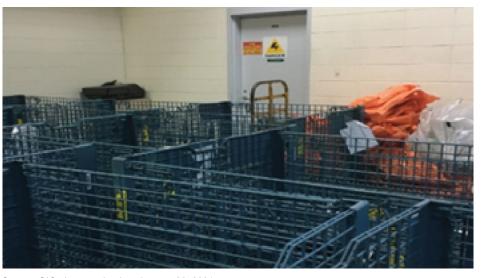
Figure 17. Excess Equipment Blocked Electrical Room Door
