Office of Inspector General | United States Postal Service

Property Condition Reviews - North Royalton, Willoughby, and Jesse C. Owens Post Offices in Ohio

(Report Number 21-138-R21)

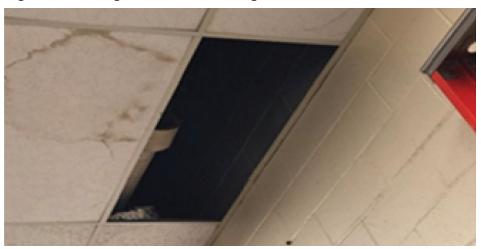
Figure 2. Missing and Stained Ceiling Tiles

At the North Royalton Post Office, we identified damaged walls in the workroom and P.O. Box areas (see Figure 1) and missing and stained ceiling tiles in the workroom and behind the window clerk counter (see Figure 2).

We recommend the **Manager, Ohio 1 District**, address all building maintenance, safety, and security issues identified at the North Royalton, Willoughby, and Jesse C. Owens Post Offices.

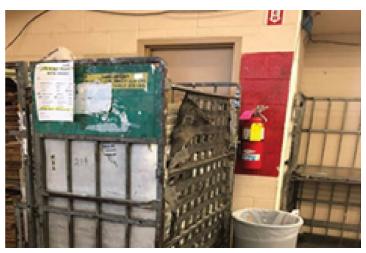
Figure 11. Blocked Inspection Service Door

At the Willoughby Post Office, we identified a burned electrical outlet in the breakroom (see Figure 9), two vending machines in the breakroom plugged into a surge protector instead of directly into the wall (see Figure 10), and a blocked inspection service door (see Figure 11).
