Office of Inspector General | United States Postal Service

Audit Report

Mail Delivery, Customer Service, and Property Conditions Review - Chouteau Station, St. Louis, MO

- Chouteau Station, St. Louis, MO (Report Number 22-115-3-R22)

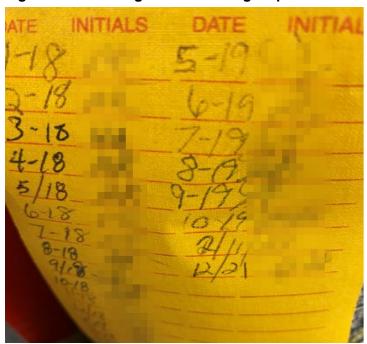
Figure 1. Fire Extinguishers Missing Inspections

We found maintenance, security, and safety issues at the Chouteau Station, including fire extinguishers that had not been inspected.¹⁵ Monthly inspections were last completed in December 2021, and annual inspections were last

completed in March 2021(see Figure 1). We also found walls with possible water damage (see Figure 2), and dusty air vents throughout the facility (see Figure 3). Further, there was no signage posted around the facility stating that vehicles may be subject to search.

¹⁵ Occupational Safety and Health Administration (OSHA), 29 CFR 1910.157(e)(2) and 29 CFR 1910.157(e)(3) requires that fire extinguishers be inspected monthly and annually.

Management should have provided sufficient oversight to personnel responsible for maintaining facilities, reported safety and maintenance issues as they arose, and followed up to ensure the issues were addressed. The Postal Service is required to maintain a safe environment for employees
