**Audit Report**

# Mail Delivery, Customer Service, and Property Conditions Review - Richard J. Pino Station, Albuquerque, NM

Richard J. Pino Station, Albuquerque, NM (Report Number 22-132-2-R22)

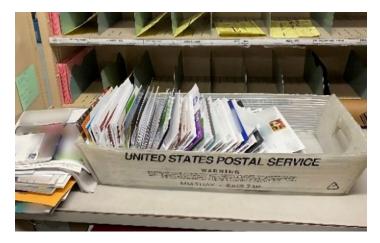
Figure 2. Example of Delayed Mail at Carrier Case

On the morning of June 7, 2022, we identified about 5,996 pieces of delayed mail in the hot case<sup>7</sup> distribution area (see Figure 1) and 13 carrier cases (see Figure 2). Specifically, we identified approximately 4,540 letters in the hot case area and about 678 letters and 778 flats in the carrier cases. This delayed mail was not reported as undelivered in the Delivery Condition Visualization (DCV) <sup>8</sup> system.
