Audit Report

Mail Delivery, Customer Service, and Property Conditions Review – North Milwaukee Station, Milwaukee, WI

Report Number 22-147-1-R22 | August 31, 2022

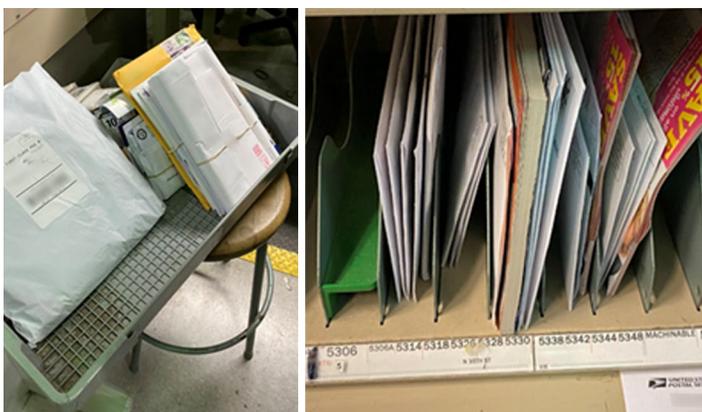
Figure 1. Examples of Delayed First-Class Mail at Carrier Cases

On the morning of June 28, 2022, we identified about 2,451 pieces of delayed letter and flat mail at 34 carrier cases. In addition, management did not report this delayed mail in the Delivery Condition Visualization (DCV)⁷ system. See Figure 1 for examples of delayed mail found at carrier cases.

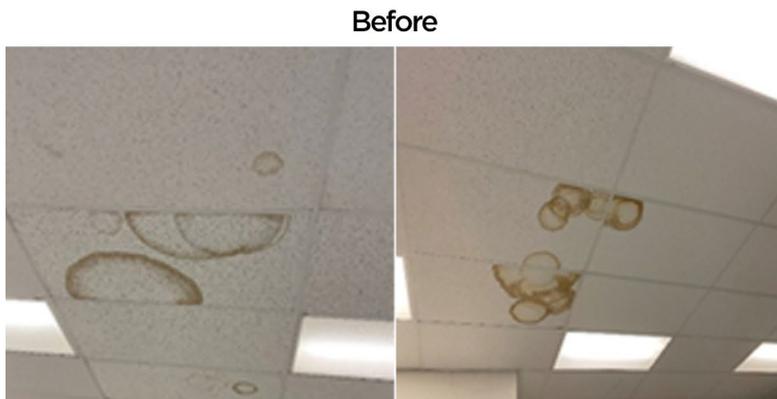
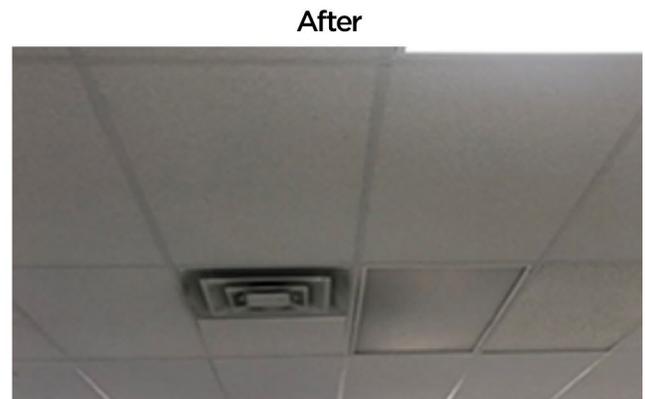
Figure 2. Stained Ceiling Tiles

- Several stained ceiling tiles in the workroom floor and PO Box area (see Figure 2);
- A cracked and damaged sidewalk near the customer parking lot (see Figure 3);
- A damaged gutter downspout in the carrier parking lot (see Figure 4);
- Inoperable front and rear security gates (see Figure 5 and Figure 6);
- Portable fire extinguishers with expired monthly and annual inspections (see Figure 7);

Management did not take the necessary actions to ensure that all facility condition issues were corrected because they were addressing other repairs with higher urgency, such as a roof leak and a garage door that was stuck closed.

During our audit, management took corrective actions by replacing the stained ceiling tiles; repairing the cracked sidewalk, the damaged downspout, the rear security gate; completing the monthly fire extinguisher inspections and removing excess equipment that was blocking a carrier door.

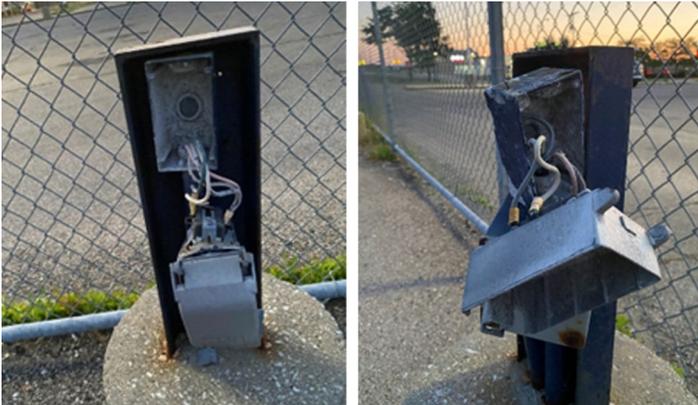
Figure 8. Damaged Exterior Outlets

- Damaged exterior electrical outlets with exposed wires (see Figure 8);
- Multiple electrical devices plugged into one extension cord (see Figure 9);
- Excess equipment blocking a carrier door (see Figure 10); and
- Broken or missing safety mirrors over the carrier garage door (see Figure 11).
