Audit Report

Mail Delivery, Customer Service, and Property Conditions Review – Waukesha Main Post Office, Waukesha, WI

Report Number 22-147-2-R22 | August 31, 2022

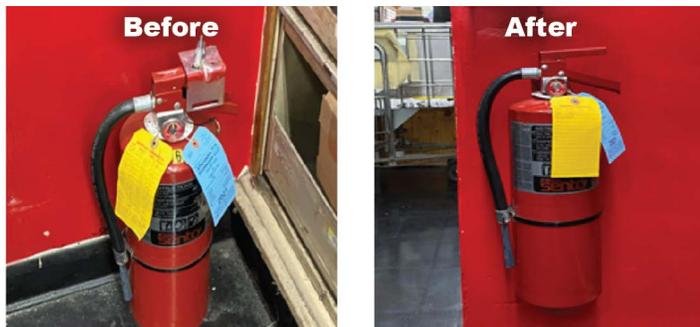
Figure 1. Fire Extinguisher Not Mounted

We found safety, security, and maintenance issues at the Waukesha MPO, including one fire extinguisher that was not mounted (see Figure 1), two blocked inspection service doors (see Figure 2), and a blocked electrical panel in the workroom (see Figure 3). Further, we identified two misaligned ceiling tiles inside the entrance of the customer lobby (see Figure 4), multiple stained ceiling tiles in the women’s restroom and breakroom, and a dirty vent in the breakroom (see Figures 5 and 6). In addition, there was no signage posted in the employee parking lot stating that vehicles may be subject to search.¹⁴

During our audit, management took corrective actions by unblocking the electrical panel and inspections service doors in the workroom, mounting the fire extinguisher, realigning and replacing the ceiling tiles, and cleaning the dirty vent.

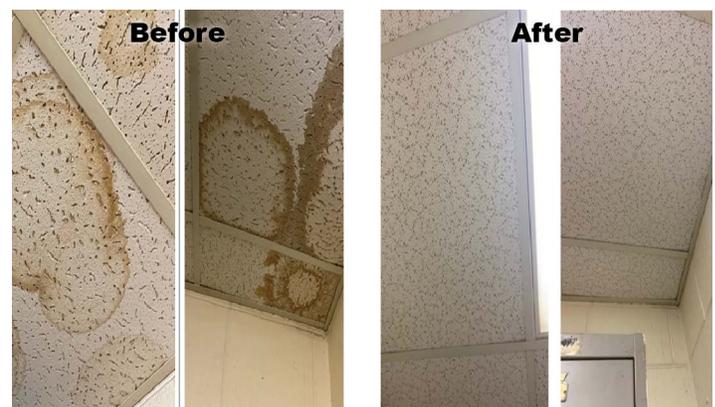
Figure 5. Stained Ceiling Tiles

Management did not provide adequate oversight to ensure that property condition issues were corrected. Specifically, the postmaster said he was not aware of the unmounted fire extinguisher, blocked electrical panel, blocked inspection service doors, and the dirty vent. The postmaster also stated that a roof leak that was repaired about two years ago caused the stained ceiling tiles; however, he did not request replacement tiles.
