## Audit Report

# Mail Delivery, Customer Service, and Property Conditions Review - Dr. Martin Luther King Jr. Station, Milwaukee, WI

Report Number 22-147-3-R22 | August 31, 2022

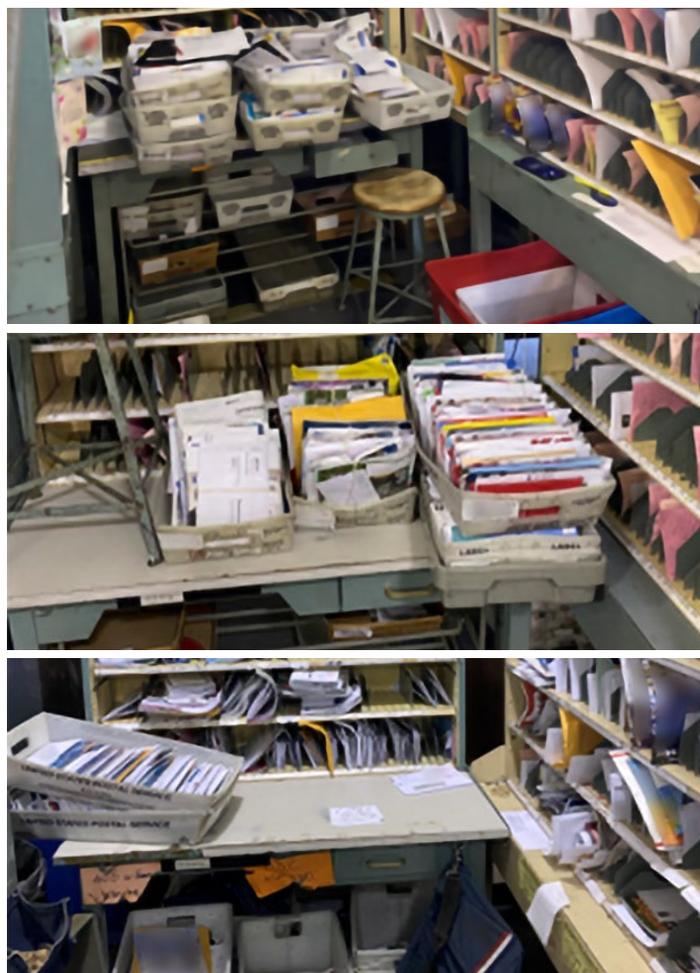
**Figure 1. Examples of Delayed Mail in the Carrier Cases**

On the morning of June 28, 2022, we identified about 11,772 pieces of delayed mail at 10 carrier cases.<sup>7</sup> Specifically, we identified about 10,368 letters, 1,358 flats, and 46 packages. In addition, this mail was not reported as delayed in the Delivery Condition Visualization (DCV)<sup>8</sup> system. See Figure 1 for examples of delayed mail found at carrier cases.

Management should have ensured that the station had enough resources to deliver all the mail each day. Postal Service policy<sup>9</sup> states that managers must review all communications that may affect the day's workload and be sure that replacements are available for unscheduled absences. In addition, policy<sup>10</sup> states that all types of First-Class Mail, Priority Mail, and Priority Express Mail are always committed for delivery on the day of receipt. Managers are required to report all mail in the DCV system that remains in a unit after the carriers have left for their street duties.<sup>11</sup>

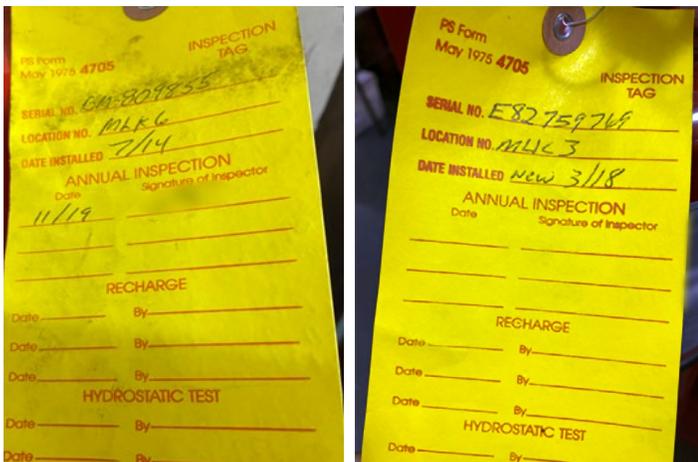
**Figure 2. Examples of Fire Extinguishers Missing Annual Inspections**

- Missing annual fire extinguisher inspections (see Figure 2).
- Several appliances throughout the facility were plugged into power strips rather than directly into wall outlets (see Figure 3).
- An uncovered electrical box with exposed wires located near the postal vehicle parking lot (see Figure 4).

Management should have provided sufficient oversight of facility maintenance; reported safety, maintenance, and security issues as they arose; and followed up to ensure the issues were addressed. The Postal Service is required to maintain a safe environment for employees and customers. In addition, the Occupational Safety and Health Administration (OSHA) requires employers to provide a safe and healthy workplace free of recognized hazards.<sup>19</sup>

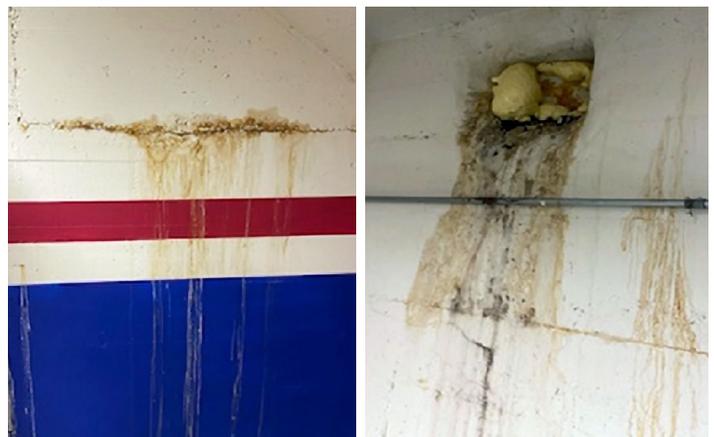
**Figure 5. Water-Stained Walls in the Basement**

- No signage posted around the facility stating that vehicles may be subject to search.
- Water-stained walls in the basement (see Figure 5).
- Cracks in the workroom walls (see Figure 6).
- Chipped flooring in several locations on the workroom floor. During our audit, management took corrective actions by repairing the chipped flooring (see Figure 7).
- A missing heating vent cover in the customer lobby (see Figure 8).

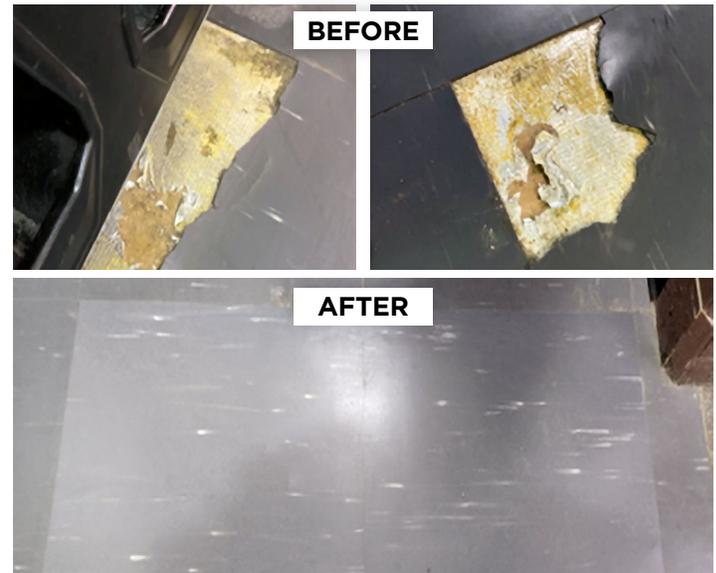
**Figure 7. Examples of Chipped Flooring**

Source: OIG took before photos on June 28, 2022. Unit management provided after photo on August 10, 2022.
