Mail Delivery, Customer Service, and Property Conditions Review – Old National Station, Atlanta, GA

AUDIT REPORT

Report Number 22-181-2-R23 | November 1, 2022

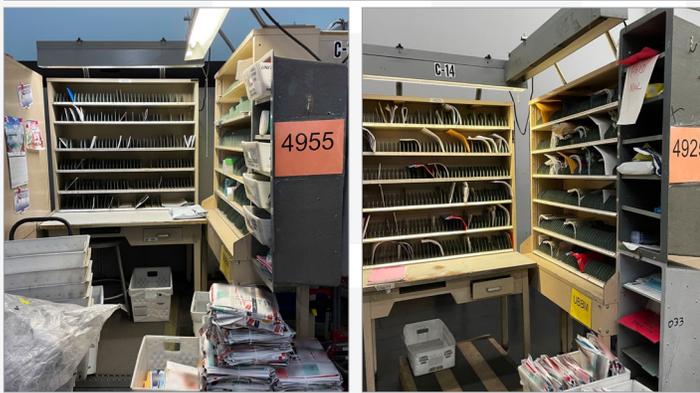
Figure 1. Examples of Delayed Mail in the Carrier Cases

On the morning of August 30, 2022, we identified about 2,770 pieces of delayed mail at 33 carrier cases. Specifically, we identified about 1,741 letters and 1,029 flats. In addition, unit management did not accurately report delayed mail in the Delivery Condition Visualization (DCV)⁹ system. While they reported 1,414 delayed letters and flats the previous day, this represented only 51.05 percent of the delayed mail we identified at the unit. See Figure 1 for examples of delayed mail found at carrier cases.

Source: OIG photos taken August 30, 2022.

We interviewed carriers and management who stated that much of the mail we identified in the cases was due to blocked mail receptacles and broken cluster boxes at apartment buildings. However, the mail was not properly identified as such when we observed it. In addition, management stated that some carriers were not using the 3M case¹⁰ for missequenced mail, but instead were putting it back in their cases upon returning from their routes. Furthermore, the acting PM supervisor was not aware of the mail at the carrier cases to accurately report it in DCV because she did not do a walkthrough of the unit the previous evening. She stated that she was busy with other tasks, including preparing outgoing mail for distribution to the plant

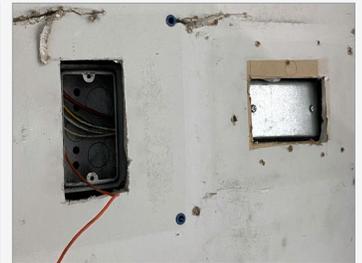
Figure 2. Examples of Exposed Wiring

- Exposed wiring in the customer lobby and work area (see Figure 2).
- Missing monthly inspections for all six fire extinguishers. Four were last inspected on June 21, 2021, and two did not have a monthly tag to identify their last inspection date. In addition, two fire extinguishers were not mounted on a wall.

Exposed Wires Behind the Window Clerk Area

During our audit, management took corrective actions by covering the exposed wiring in the customer lobby, repairing the urinal in the men's restroom, and mowing the grass.

Management did not take the necessary actions to ensure that facility condition issues were corrected. Specifically, the acting station manager had only been at the unit for about one month and was not aware of several of the issues we identified, including the exposed electrical wires in the customer lobby and the issues with the fire extinguishers.

Management should have provided sufficient oversight of facility maintenance; reported safety, security, and maintenance issues as they arose; and followed up to ensure resolution. The Postal Service is required to maintain a safe environment for employees and customers. In addition, the Occupational Safety and Health Administration

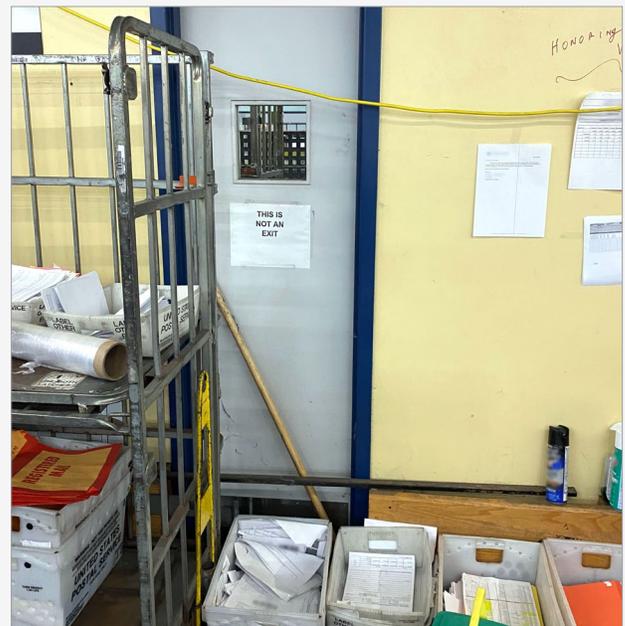
Figure 3. Blocked Inspection Service Door

- A refrigerator in the employee breakroom plugged into a surge protector, rather than into the wall.
- One blocked Inspection Service door (see Figure 3).

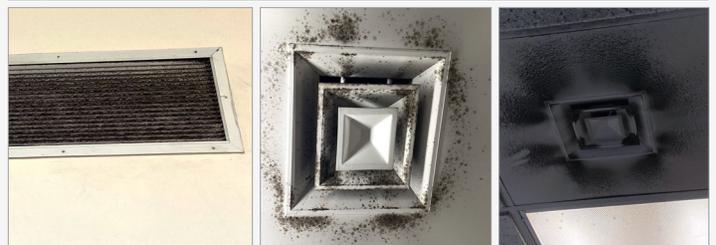
Figure 4. Dirty Air Vents

- Three dirty air vents - one in the customer lobby and two in the workroom area (see Figure 4).
- A damaged ceiling in the workroom area near the P.O. Box section (see Figure 5).

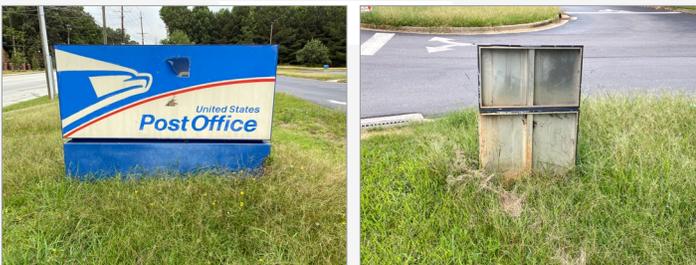
Figure 6. Damaged Signage and Overgrown Vegetation

- Damaged Postal Service signage and overgrown vegetation in front of the building (see Figure 6).
