Our objective was to determine whether the U.S. Postal Service has implemented effective physical security and environmental and wireless access controls according to policy and industry best practices at the Distribution Center (P&DC).

SUBJECT: Audit Report – Western Area Physical Security and

Environmental Controls (Report Number IT-AR-18-002)

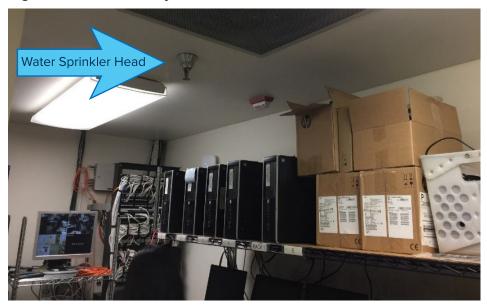
Figure 3. Information System Office

Facility management did not implement water and fire safeguard environmental controls in the information system office and the IT server room according to policy.¹⁴ Specifically:

IT assets in the information system office were not protected against water damage from the sprinkler system. Figure 3 shows a sprinkler head above IT equipment in the information system office.

According to facility management, these occurred because the information system office was not intended to be an IT server room. In addition, budget constraints did not allow facility management to recharge the fire suppression system.

We recommend the **District Manager, Colorado/Wyoming District**, direct the senior plant manager to implement environmental controls for protecting information technology assets against water damage in the information system office.

Regarding recommendation 8, management will cap the sprinklers head in the information system office upon implementation of recommendation 9. The target implementation date is May 30, 2018.

Management will cap the sprinklers heads in the identified room upon completion of recommendation #9
