## Audit Report

# Capital Metro Physical and Environmental Controls Site Security Review

Report Number IT-AR-18-005 | September 28, 2018

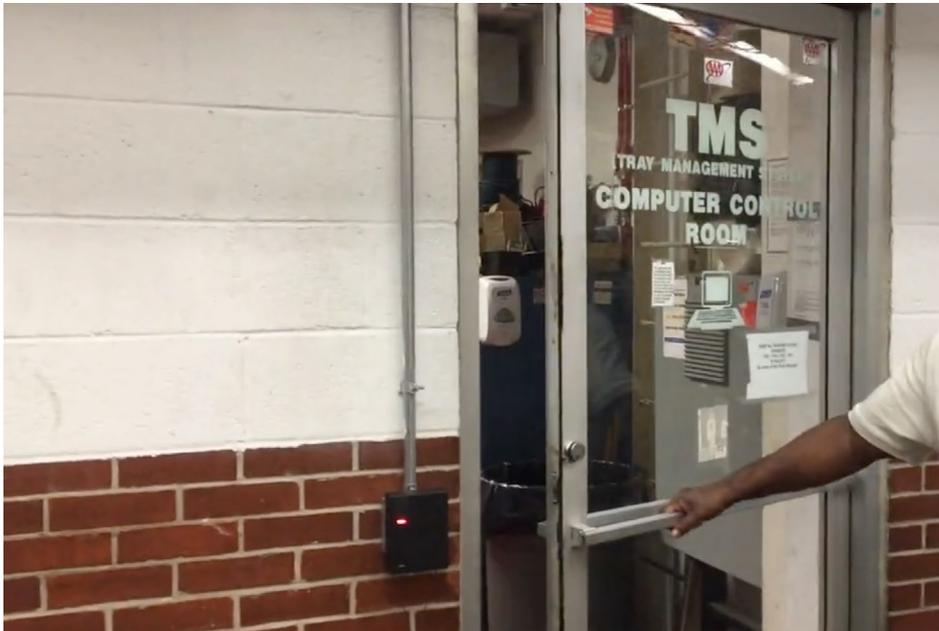
**Figure 1: TMS Server Room Door**

During our site visit, we found that the entrance door to the TMS server room did not lock and 70 Internet Protocol (IP) addresses<sup>8</sup> were posted on equipment and a server room wall. Video 1 shows the TMS server room door not locking. Postal Service policy states physical and administrative security controls must be

These issues occurred because facility management was not aware that the lock on the server room door was broken and there were risks associated with displaying IP addresses in the server room. When the Postal Service does not implement proper physical security controls, there is an increased risk of unauthorized access to TMS servers that control flat sorting, parcel sorting, and mail tray transport throughout the [REDACTED] P&DC.

The [REDACTED] District Manager replace the lock on the Tray Management System (TMS) server room entrance door and make sure that it functions properly, and remove all posted Internet Protocol addresses from the TMS server room.

Management agrees with this recommendation and has implemented by already removing the IP addresses and the lock has been repaired and verified to be operating properly.

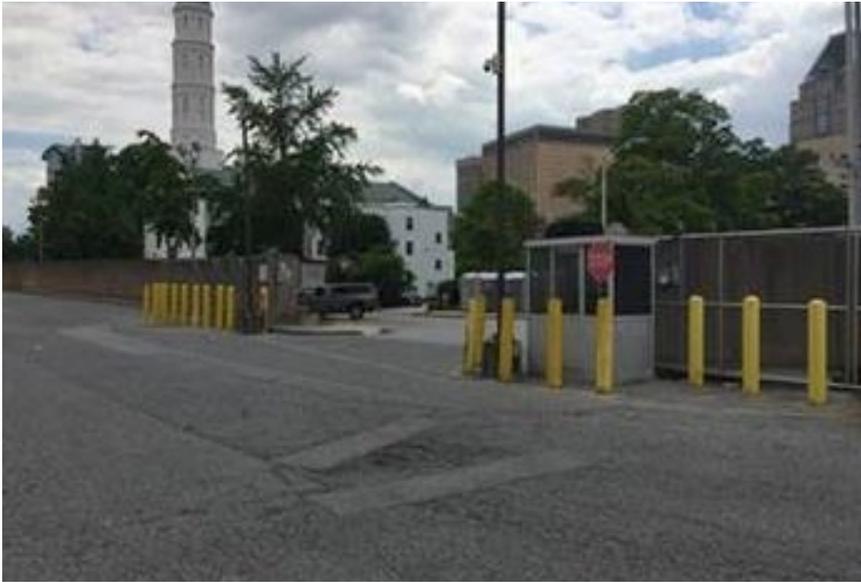
**Figure 2. East Vehicle Entrance Gate**

- **Vehicle Entrance Gates.** The east and west vehicle entrance gates remained open 24/7 without being monitored; and did not have traffic arms, computerized card access systems, intercoms, or functioning closed-circuit television (CCTV)<sup>10</sup> cameras as shown in the east and west vehicle entrance gate photos below. This allows unauthorized individuals to enter the facility through the loading docks gaining access to the facility, workroom floors, and the server rooms.<sup>11</sup> Postal Service policy states that facility entrance gates should have traffic arms, computerized card access systems, intercoms, and CCTV cameras.<sup>12</sup>

This occurred due to a lack of management oversight of the physical security at the facility and an enforcement of policy. Management stated that budget constraints prevented them from installing traffic arms, card access systems, and intercoms at the entrance gates. In addition, the entrance door locks were broken, and a badge access reader was not working; and they did not enforce the policy requiring employees to wear ID badges while at the facility. In the retail area, management did not contract to install the eight CCTV cameras that were purchased over a year ago.

The [REDACTED] **District Manager** ensure entrance gates are monitored and have traffic arms, computerized card access systems, and intercoms are installed at the entrance gates.

Management disagrees with this recommendation. The services of an architectural engineering firm were utilized to review existing site conditions to determine if access controls could be physically accommodated. Review of the existing site has found it physically infeasible to install the necessary equipment required as outlined in this recommendation. The current transportation needs and space constraints prohibit implementation and thus management requests closure of this recommendation.
