SUBJECT: Audit Report – Vehicle Management – Unsecured Trailers – San Francisco Processing and Distribution Center
(Report Number NL-AR-08-004)

This report presents the results of our audit concerning security deficiencies associated with U.S. Postal Service owned and leased trailers routinely stored on an unsecured lot near the San Francisco Processing and Distribution Center (P&DC) (Project Number 08XG019NL000). The Postal Service leased the lot from the San Francisco Port Commission in October 2001. We initially observed these deficiencies in May 2007 during other audit work and immediately reported them to management and the Postal Inspection Service. We initiated this review as a follow-up to our previous notifications and because of continuing deficiencies we observed on January 9, 2008. The audit addresses various strategic, operational, and financial risks. Refer to [Appendix A](#) for additional information about this audit.

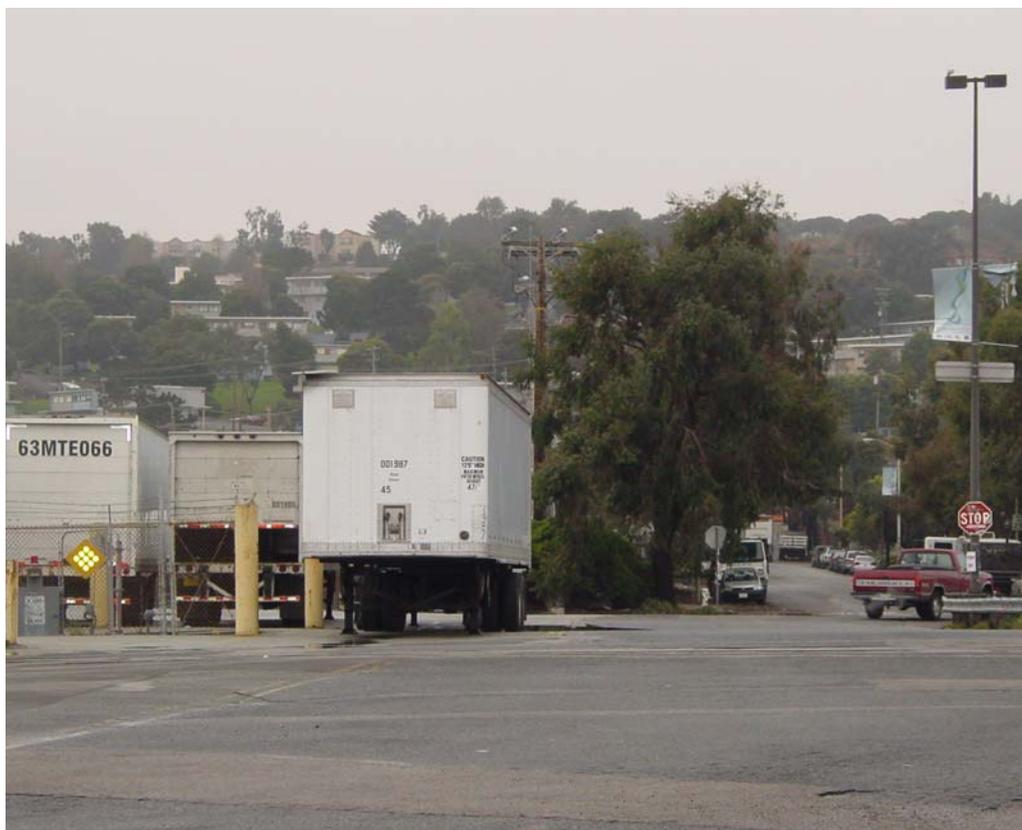
An MTE trailer and other trailers stored at the unsecured lot near the San Francisco P&DC on January 9, 2008.

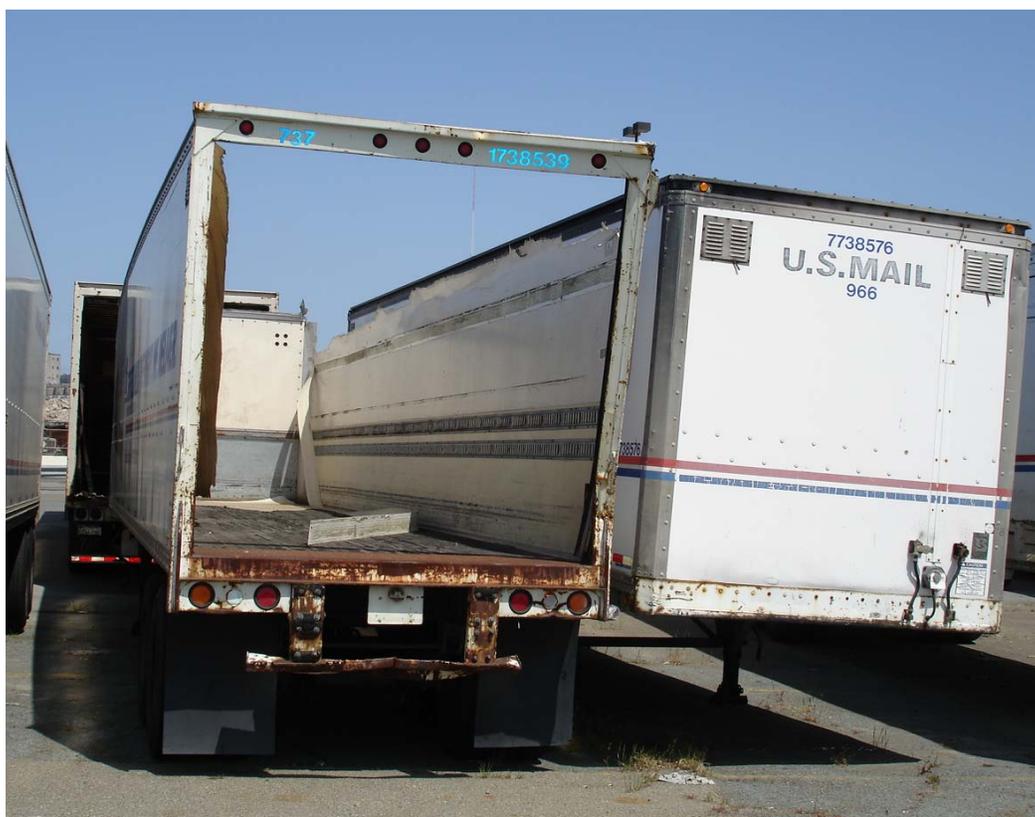
On May 17, 2007, during our audit of the National Trailer Lease, we observed 45 trailers stored at the unsecured facility. Some trailers were defaced with graffiti, some had other damage, and most were unlocked. In many cases, the unlocked trailers were loaded with mailbags, hampers, pallets, over-the-road containers, and other MTE.

A severely damaged Postal Service owned trailer, stored at the unsecured lot on May 17, 2007.

1. Identified and repaired the road worthy trailers. The non-road worthy trailers will be processed to remove from the fleet in accordance with Postal Service procedures. *The San Francisco VMF & Transportation staff is assessing the total cost of repairs for the damaged trailers.*

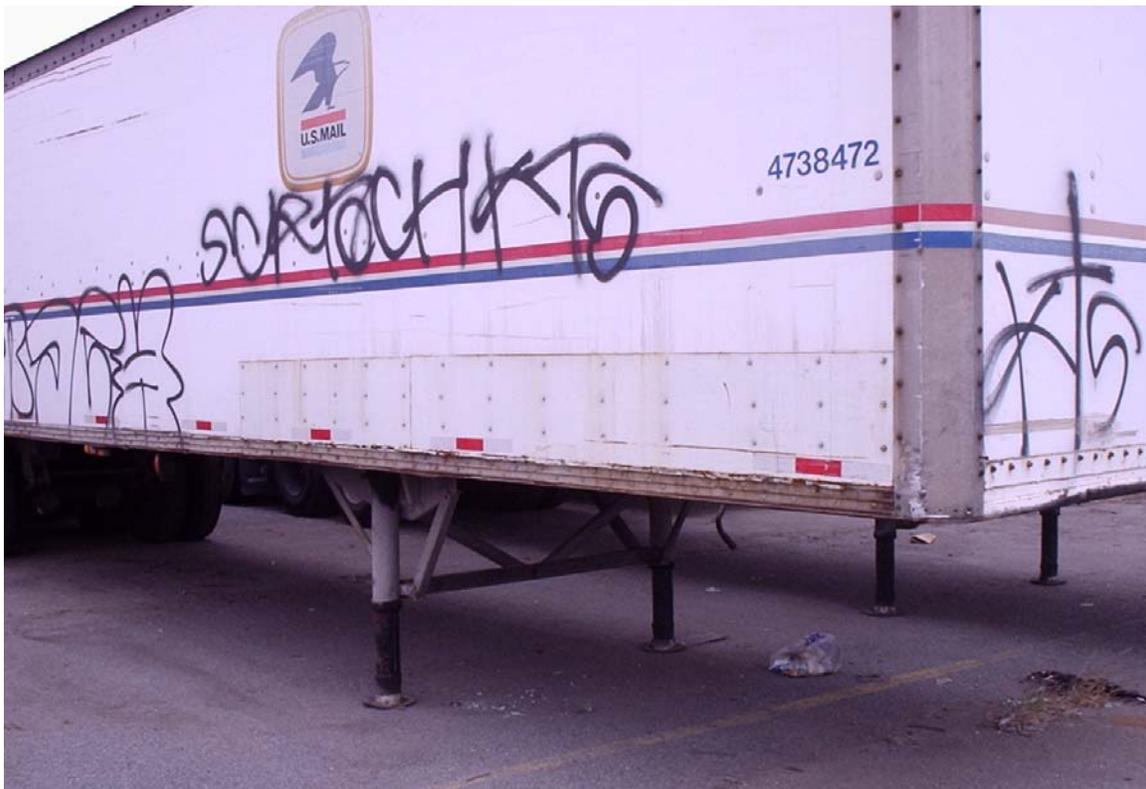
A Postal Service owned trailer, covered with graffiti, on the San Francisco P&DC's unsecured storage lot August 7, 2007.

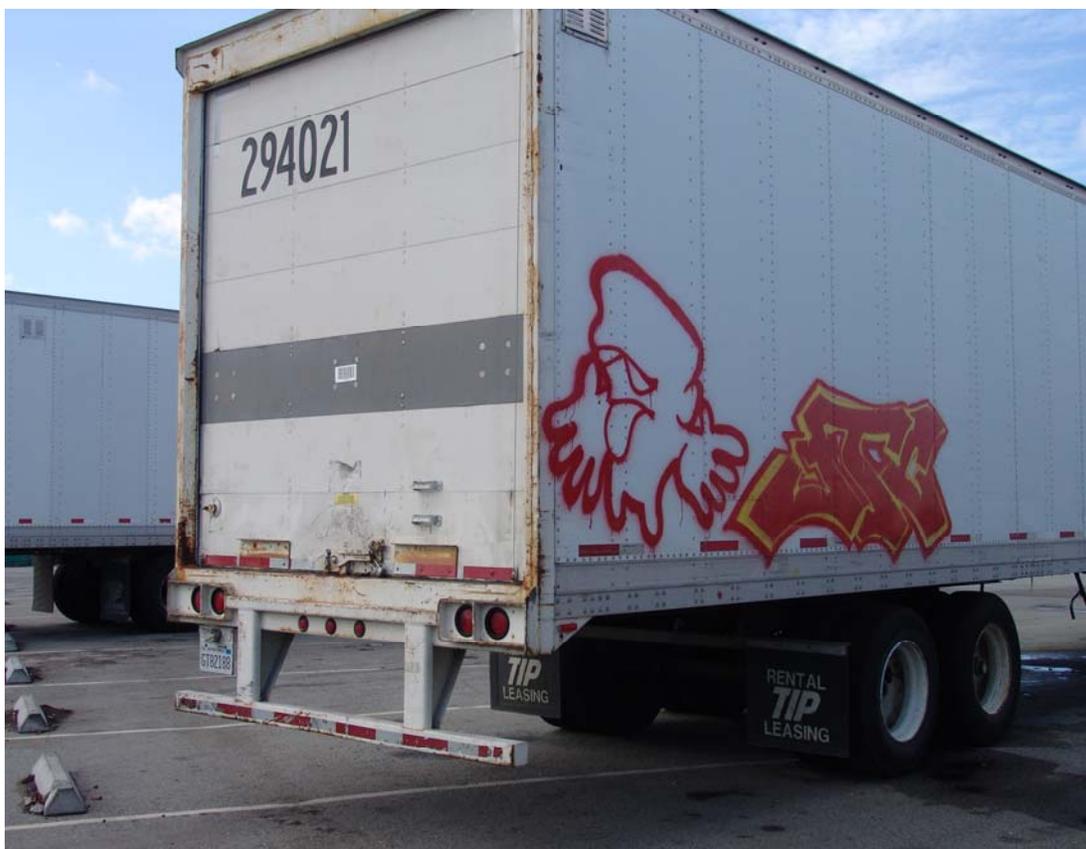
Vandals defaced this leased TIP trailer with graffiti. The Postal Service will incur unanticipated costs to repair the trailer before it can be returned to the leasing contractor. Photograph taken at the unsecured lot October 17, 2007.

During our January 9, 2008, inspection, we also observed both Postal Service owned and leased trailers defaced with graffiti. In addition to reflecting poorly on the Postal Service, the vandalized trailers required repair. Provisions associated with the Postal Service National Trailer Lease require that the Postal Service repair any damage to leased trailers before returning them to TIP. The Postal Service would incur similar unnecessary costs repairing Postal Service owned trailers.

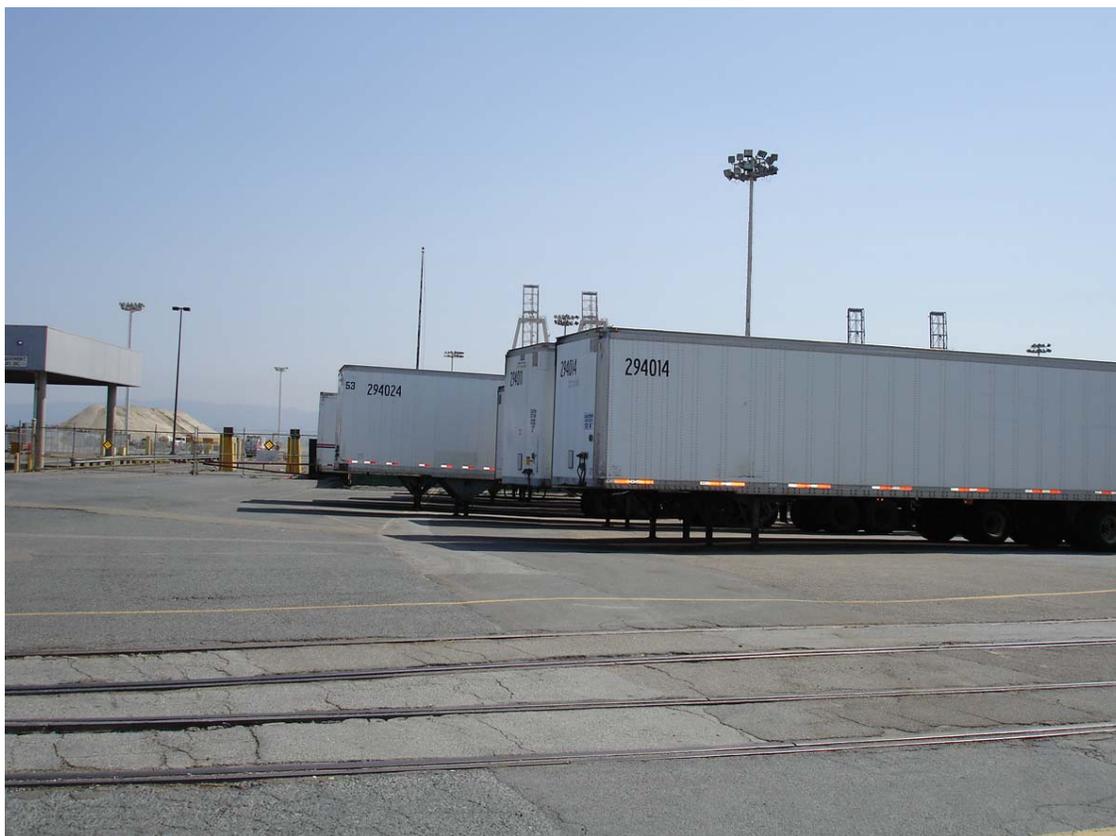
Here is another view of the unsecured lot located adjacent to industrial activities and parklands along the San Francisco Bay. Photograph taken May 17, 2007.

Our January 9, 2008, inspection of the parking lot identified an area open to high-traffic industrial activity along the waterfront, including an active maritime operation, a waste recycling facility, and an electric power plant. The area is also open to public parklands along San Francisco Bay and has free access from San Francisco city streets and

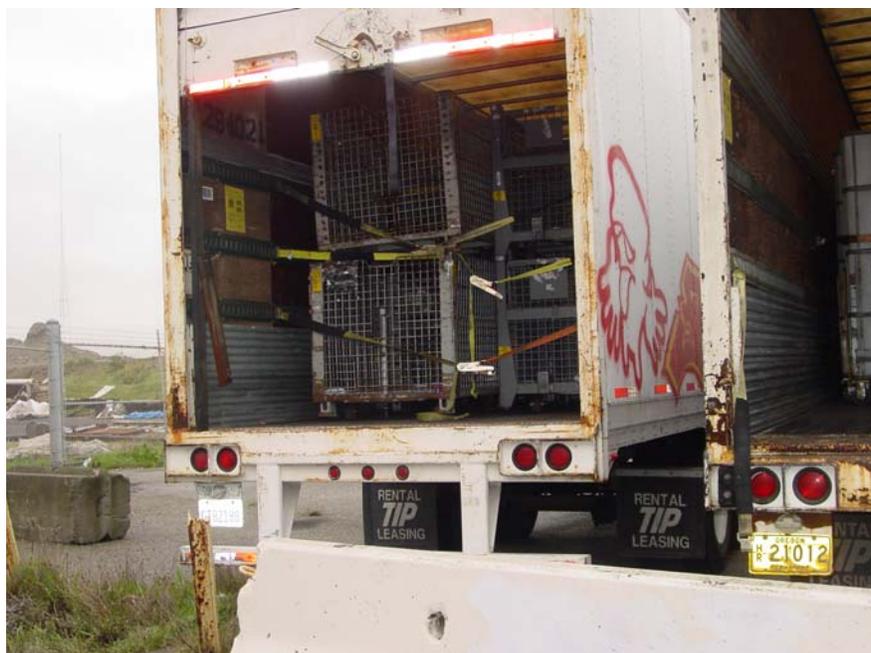
This unlocked trailer was used to store Postal Service equipment. Security is an ongoing concern. This is the same graffiti covered TIP trailer shown on page 6. We took that photograph October 17, 2007, and this one on January 9, 2008.

2. The last week of February implemented a twice daily review and inventory of the leased Pier parking lot to insure that the trailers are locked, there is no vandalism, and there is no camping or squatting in the leased area. The observation of the review is in log maintained by the Transportation and Networks office. *The PPO patrols the Pier 2-3 times a day and maintains a daily log on these patrols.*

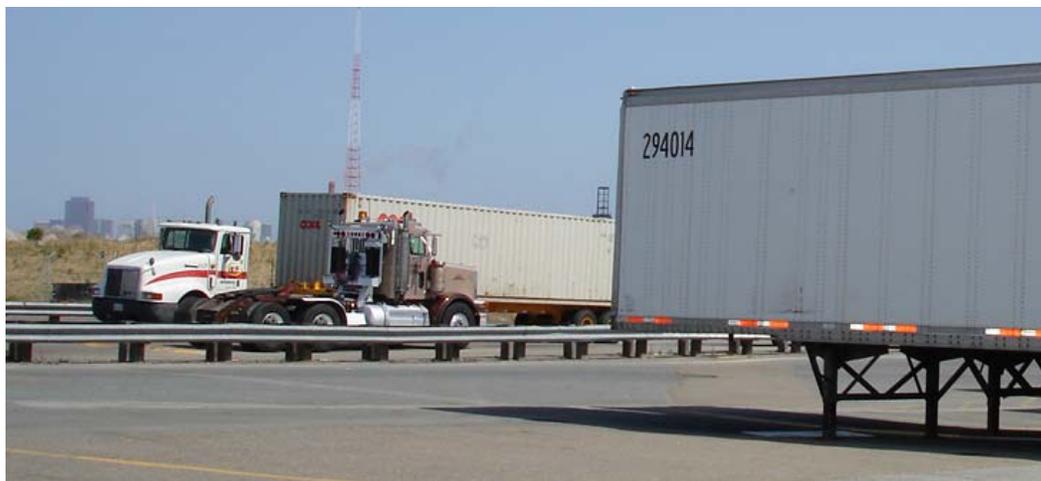
A non-Postal Service tractor-trailer and tractor without a trailer passing through the unsecured lot on May 17, 2007.

public thoroughfares. Because of the industrial activity, traffic patterns routinely included tractor-trailers, tractors without trailers, and other commercial vehicles not engaged in Postal Service operations. As a result of this commercial traffic pattern, we concluded that it would not raise suspicion to see a commercial tractor hooking up to a

Postal Service owned or leased trailer and hauling it away and that criminal elements could easily steal an unsecured trailer and Postal Service equipment.

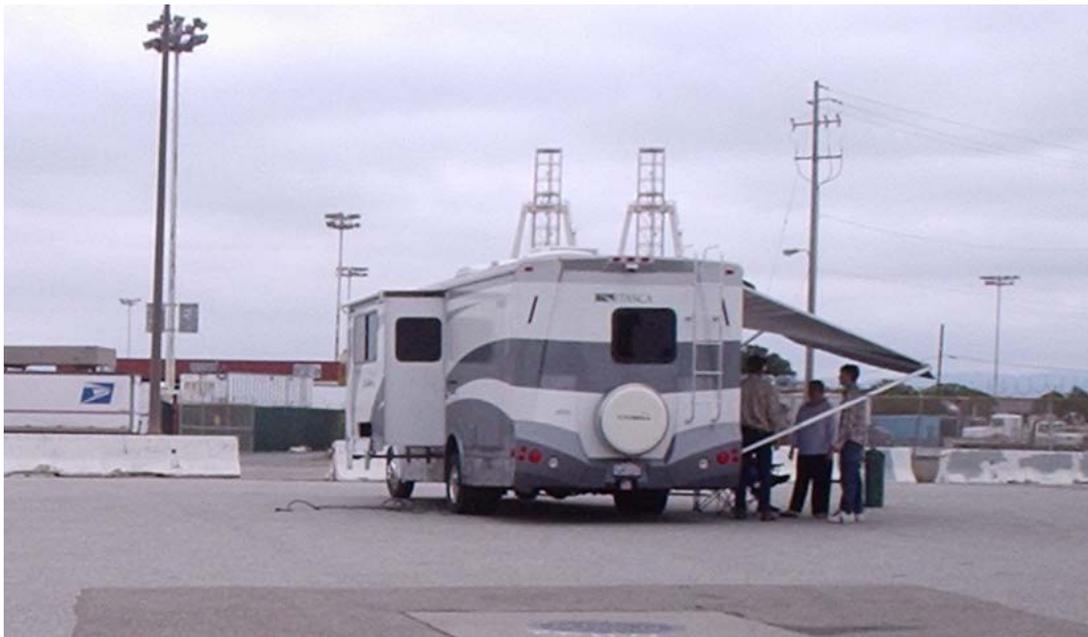
Our discussions with Postal Service employees and managers also identified concerns about unauthorized use of Postal Service property, with transient or homeless people sleeping in the parking lot, seeking protection from the elements inside the open trailers, and using Postal Service pallets, mailbags, hampers, or other equipment to improve their encampments. In addition, on August 7, 2007, we observed what appeared to be a family setting up their camper on the unsecured lot. Postal Service employees expressed concern that if someone were injured on or by Postal Service property there could be legal action and unrecoverable financial loss.

A family setting up camp on the Postal Service leased lot, potentially to take advantage of adjacent parklands along San Francisco Bay. August 7, 2007.

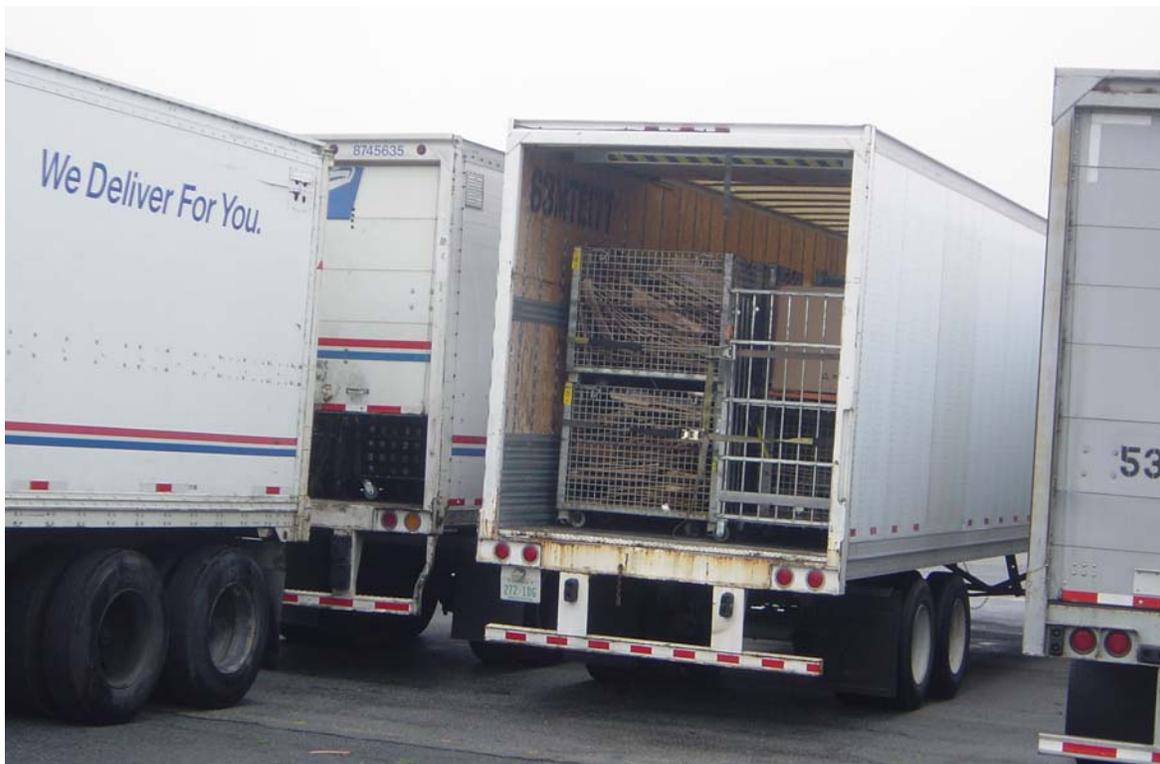
MTE stored in an unlocked trailer places Postal Service equipment at risk of theft, damage, and unauthorized use because it provides material for transient people to improve their encampments. Photograph taken at the unsecured lot on January 9, 2008.
