SUBJECT: Audit Report – Powered Industrial Vehicle Management System at the  
Washington Network Distribution Center  
(Report Number NO-AR-09-010)

This report presents the results of our audit of the Powered Industrial Vehicle Management System (PIVMS)<sup>1</sup> at the Washington Network Distribution Center (NDC),<sup>2</sup> located in the Capitol Metro Area (Project Number 09XG025NO000). The Vice President, Network Operations, requested this audit. Our objectives were to determine whether the PIVMS was functioning as intended and producing efficiency improvements. See [Appendix A](#) for additional information about this audit.

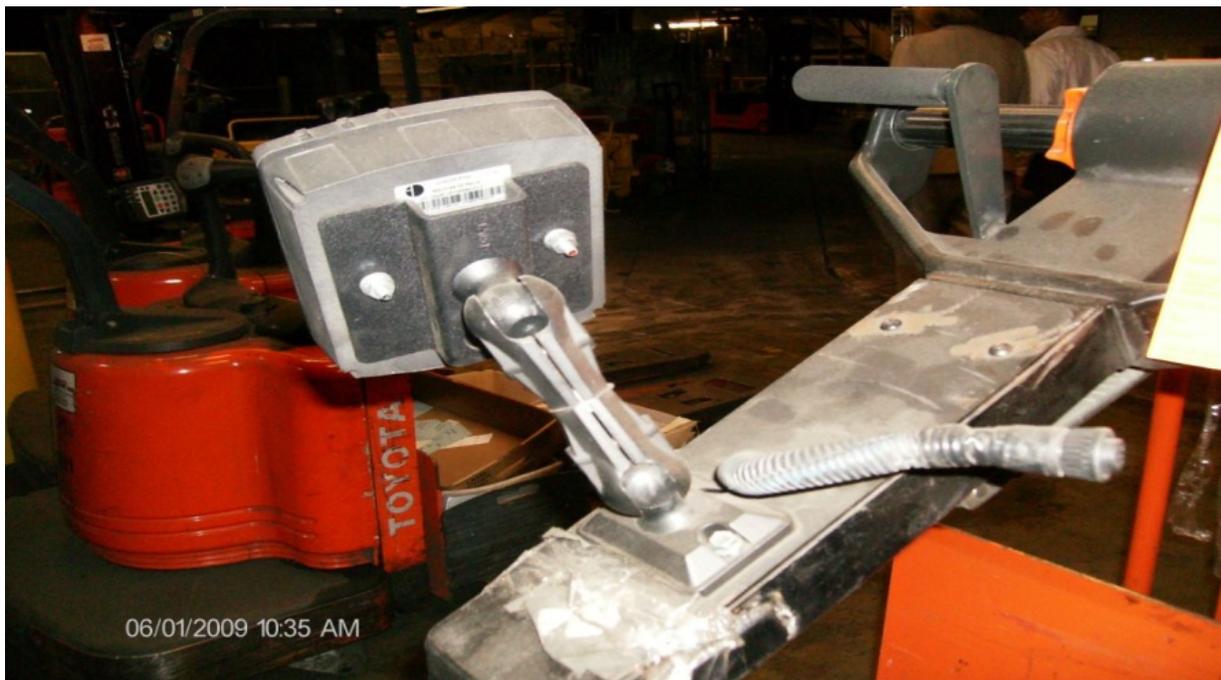
Management stated they believed employees deliberately sabotaged the PIVMS equipment because they did not want to be monitored. Management can use the PIVMS, which tracks vehicle location and utilization, as a tool to monitor employee activity. In addition, management stated that employees were frustrated because, initially, there were problems logging onto the system using PIVMS badges. Eventually, the VACs were disconnected so that employees could bypass the PIVMS and start the vehicle. See Illustrations 1.

**Illustration 1: VAC disconnected**

1. Provide closer supervision over powered vehicle operations to ensure that damage to powered equipment vehicles and the facility does not occur and consider repairing or reinstalling the Powered Industrial Vehicle Management System.

- All PIT equipment is housed at the battery shop.
- Equipment operators are required to sign-out equipment prior to use.
- Supervisors conduct daily driver observations.
- Safety talks are being given to all employees stressing the importance of PIT safety.
- We will request the reinstallation of the PIVMS at the Washington NDC.

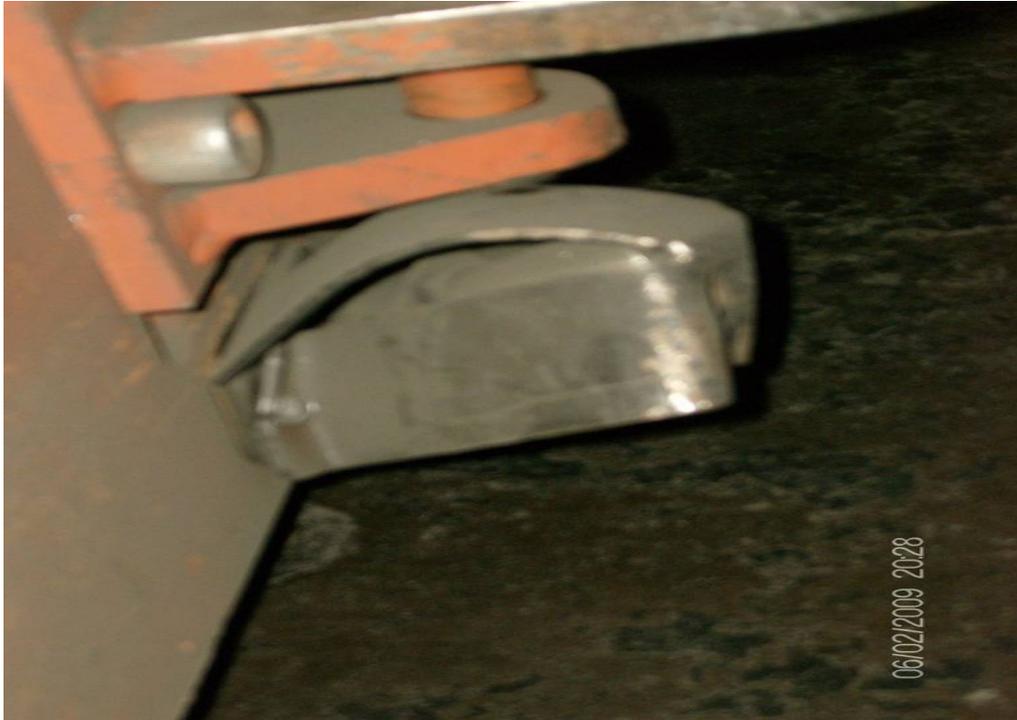
In addition, there was damage to the PIVMS sensors used to detect motion and measure travel time while pulling or carrying a load. See Illustration 2.

Illustration 2: Damaged travel with load sensor<sup>4</sup>

<sup>4</sup> The PIVMS uses sensors to detect motion and measure travel time while pulling or carrying a load.

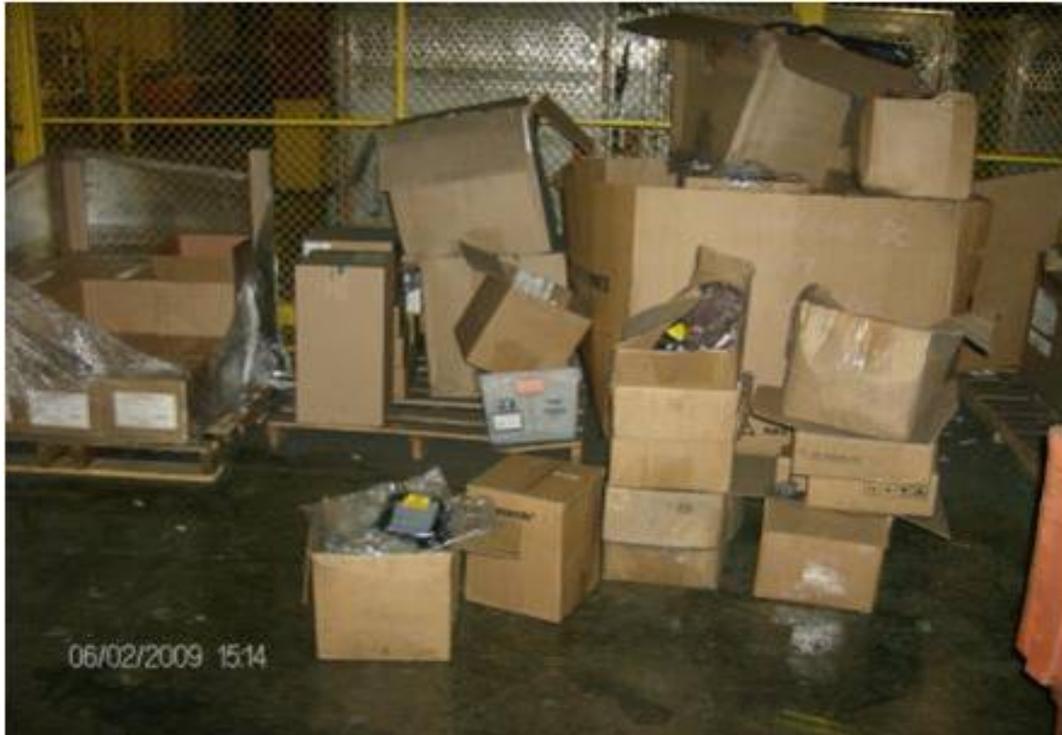
When management installed the PIVMS in July of 2006, the replacement parts were never secured and put into inventory. Instead, the replacement parts were left on the workroom floor. See Illustrations 3 and 4. During our audit, management secured these replacement parts.

Illustration 3: PIVMS replacement parts left over from the July 2006 installation were stored in a cage on the workroom floor and not organized or inventoried.

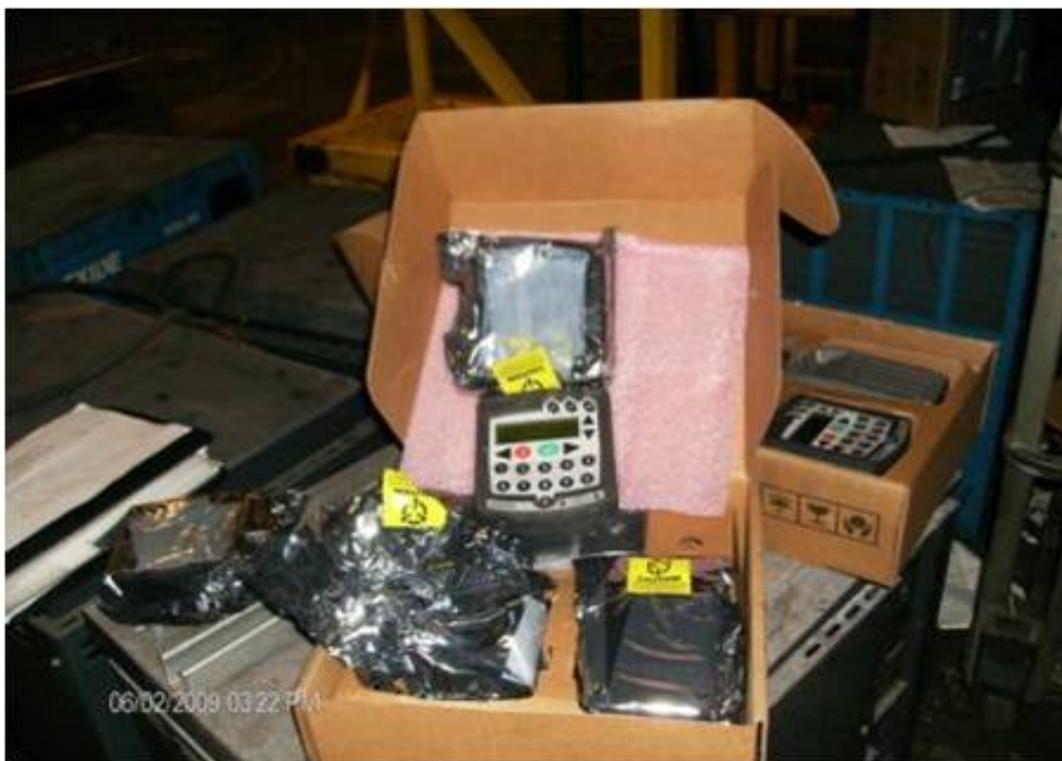
Illustration 4: PIVMS replacement parts remained unsecured on the workroom floor, June 2, 2009.

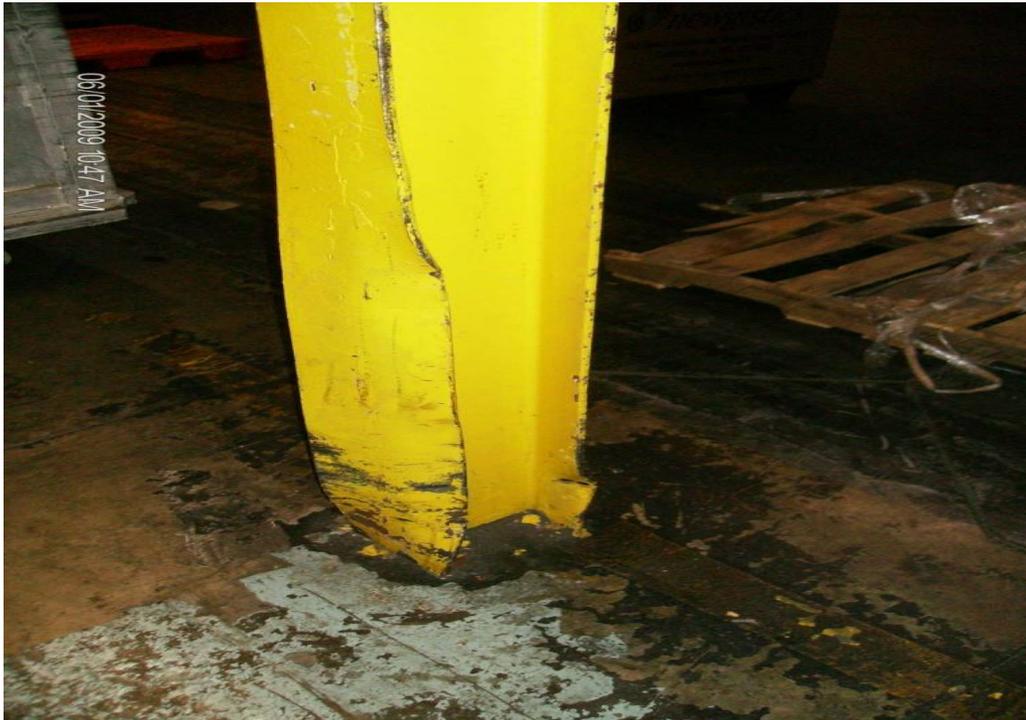
We also found extensive damage to the building from powered vehicle accidents. See Illustrations 5 through 8.

**Illustration 5: Severe damage to a supporting column caused by a vehicle impact.**

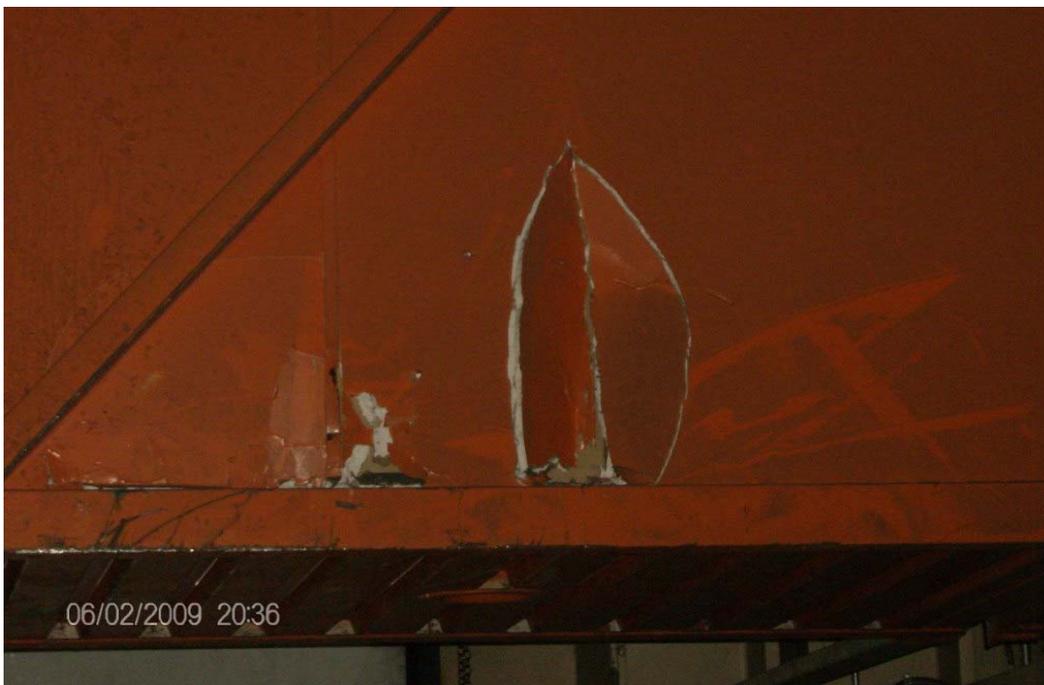
**Illustration 6: Damage to an overhead look out gallery caused by a forklift with the mast raised.**

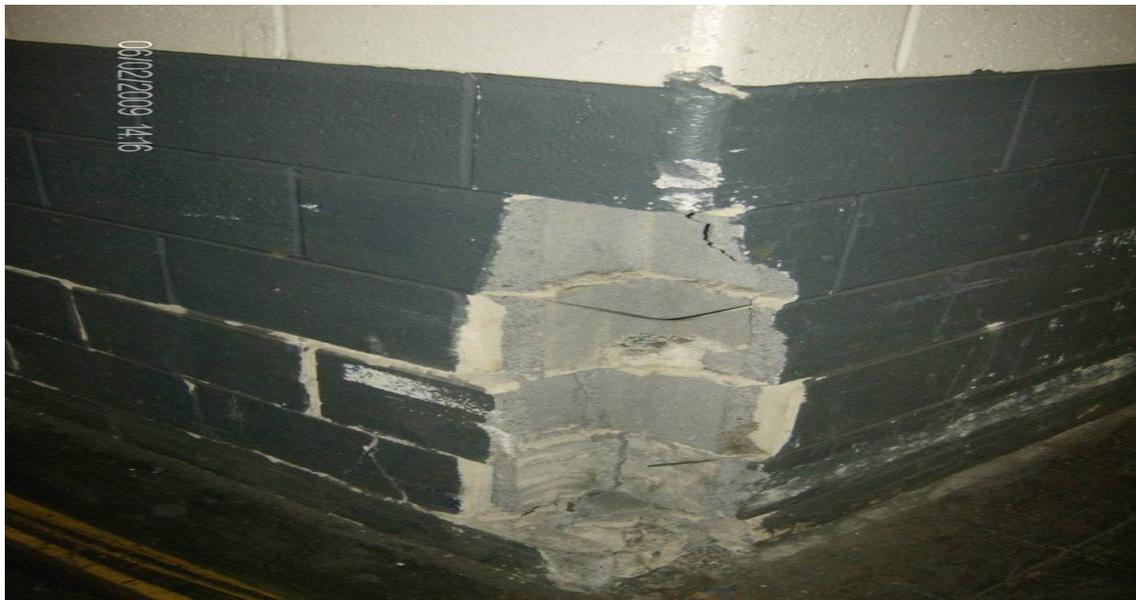
**Illustration 7: Damage to a building from a vehicle impact.**

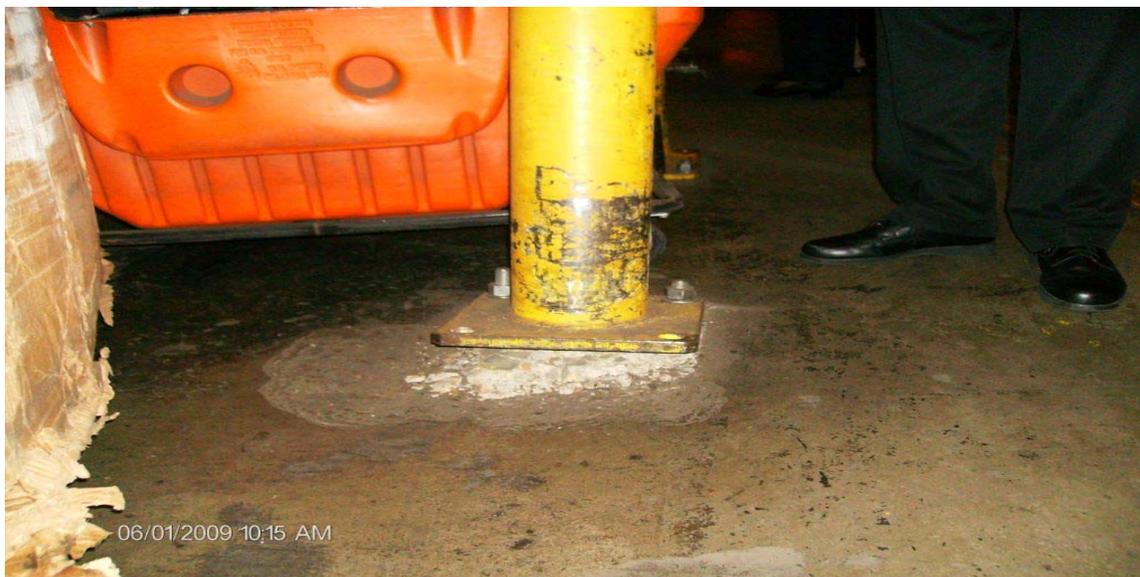
**Illustration 8: A safety post with bolts sheared off from impact from a PIV.**

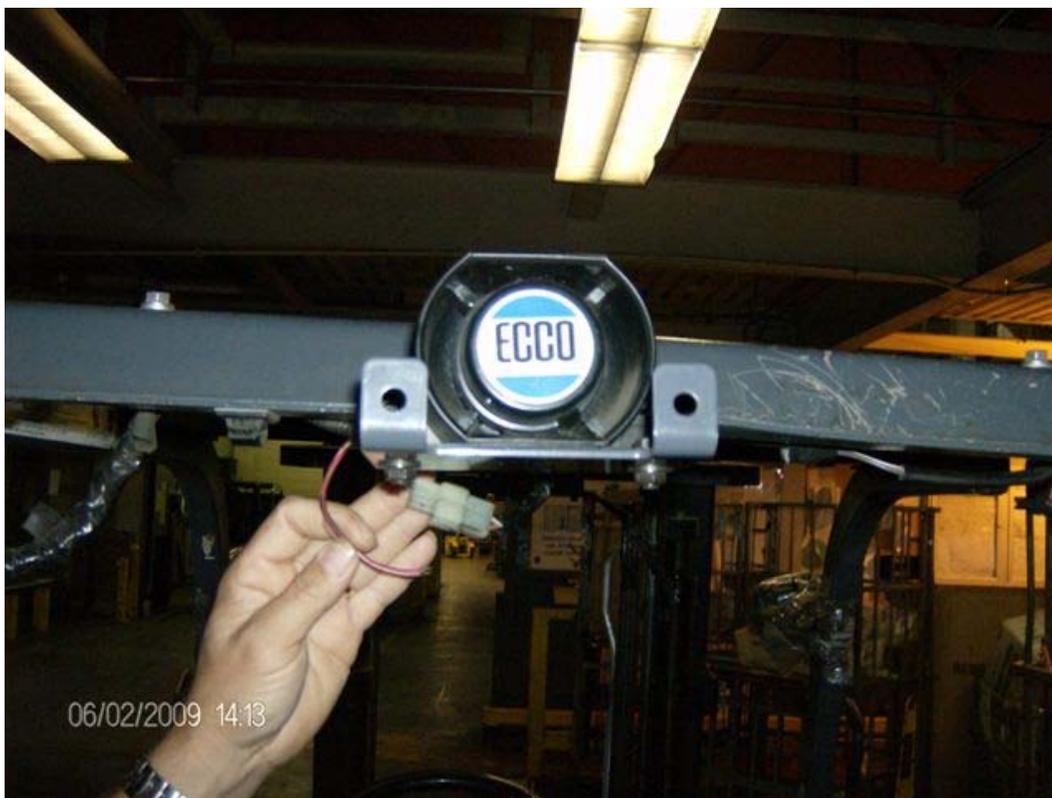
- Equipment operators did not complete the OSHA checklist before starting a vehicle. The OSHA standard for powered industrial truck training [29 CFR 1910.178(l)] requires that an employer provide training to truck operators on a variety of topics and states that “Daily, pre-shift inspection of powered industrial trucks is required by OSHA standards.” Supervisors stated that they believed in many cases that the vehicles would not pass a safety inspection. For example, since warning horns did not work on some vehicles, management issued equipment operators whistles instead. See Illustration 9.

**Illustration 9: The warning horn on vehicle did not work because the wire had been cut.**

During our audit, management implemented a vehicle safety checklist for employees to use before starting a vehicle.

- We have assigned each piece of equipment to a specific pay location.
- We have required completion of a daily PIT OSHA checklist by each operator prior to equipment use.
- Manager's Distribution Operations are required to ensure all operators have current license and proper training.
- PIT maintenance mechanics will receive formal training on PIT repair.

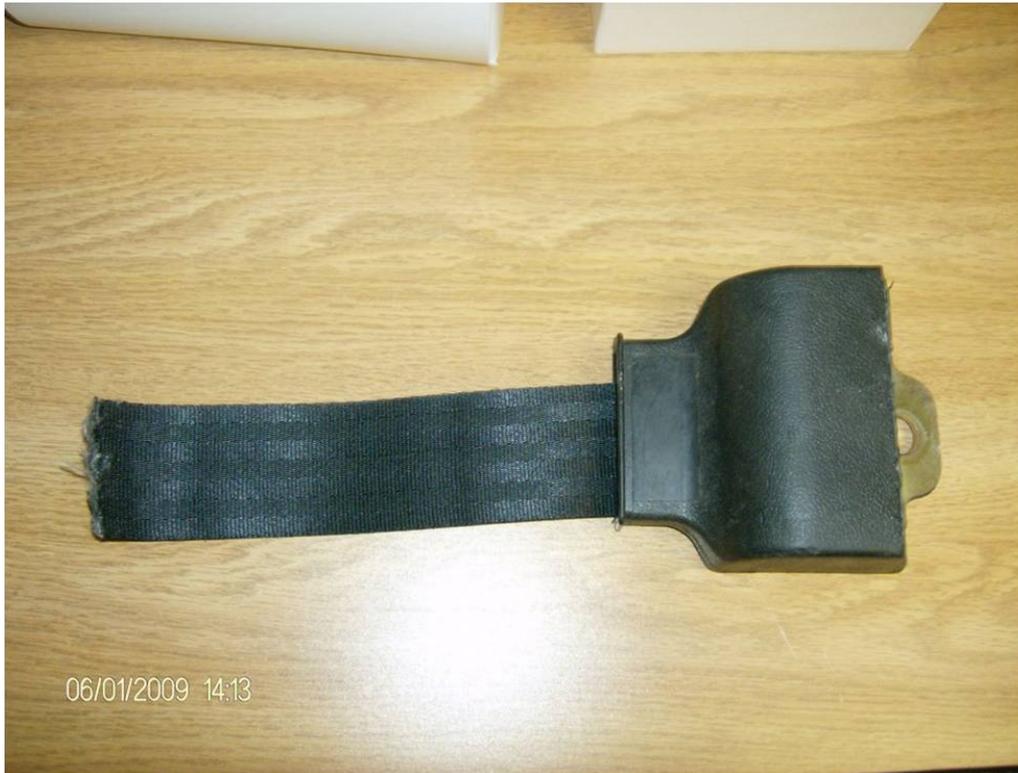
In addition, safety belts had been cut and removed from some vehicles. See Illustration 10.

**Illustration 10: Removed powered equipment seat belt**

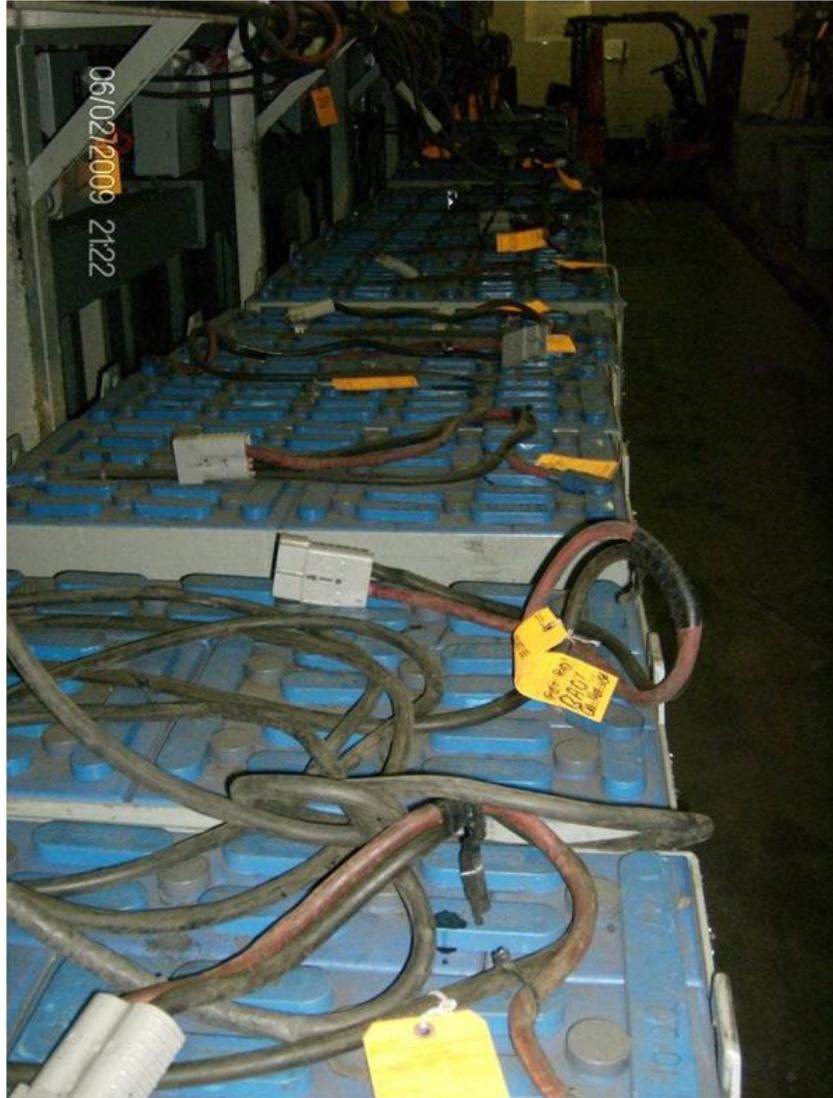
- Management did not have a system in place to monitor battery usage. Industrial batteries provide a maximum return on investment when they are discharged to appropriate levels during operation and allowed to recharge and cool down for enough time during their charge cycles. At the Washington NDC, there were not always sufficiently charged batteries for the vehicle inventory and they were routinely put into vehicles before being completely charged. Using a battery that is not completely charged reduces battery life. See Illustrations 11 and 12.

**Illustration 11. Batteries labeled with tags were not functioning properly.**

- Maintenance personnel have been instructed not to short-charge batteries.
- The battery room is locked and secured.
- We will request the purchase of additional batteries to maximize the availability per piece of equipment.

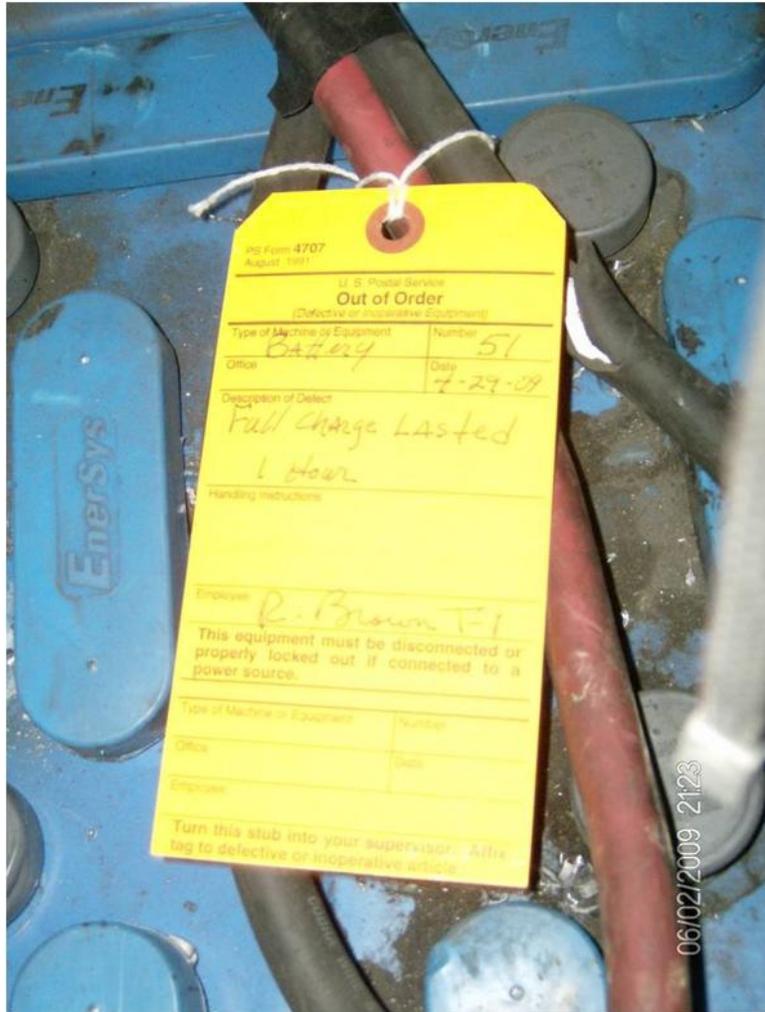
Illustration 12. Example of tag on a battery. It says “Full charge lasted 1 hour.”

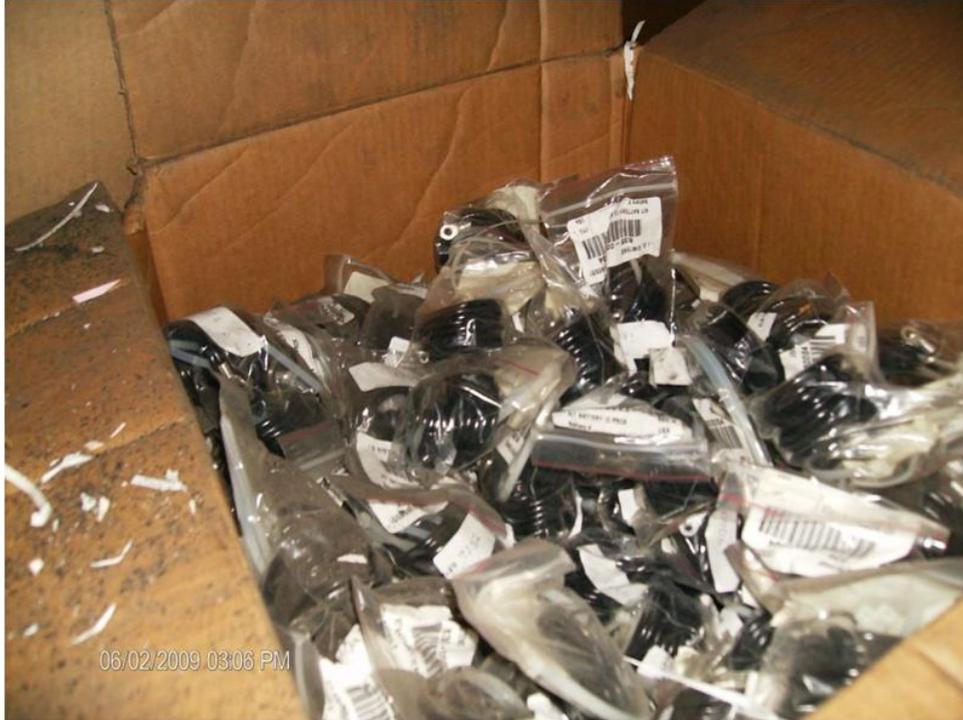
- Since the PIVMS was not functioning, vehicle batteries did not include battery fobs. The PIVMS battery fob assists management in keeping track of the batteries. The VAC reads the battery fob identification code and sends information on the battery to the central computer server. See illustration 13.

Illustration 13: Box of battery fobs never installed on batteries.

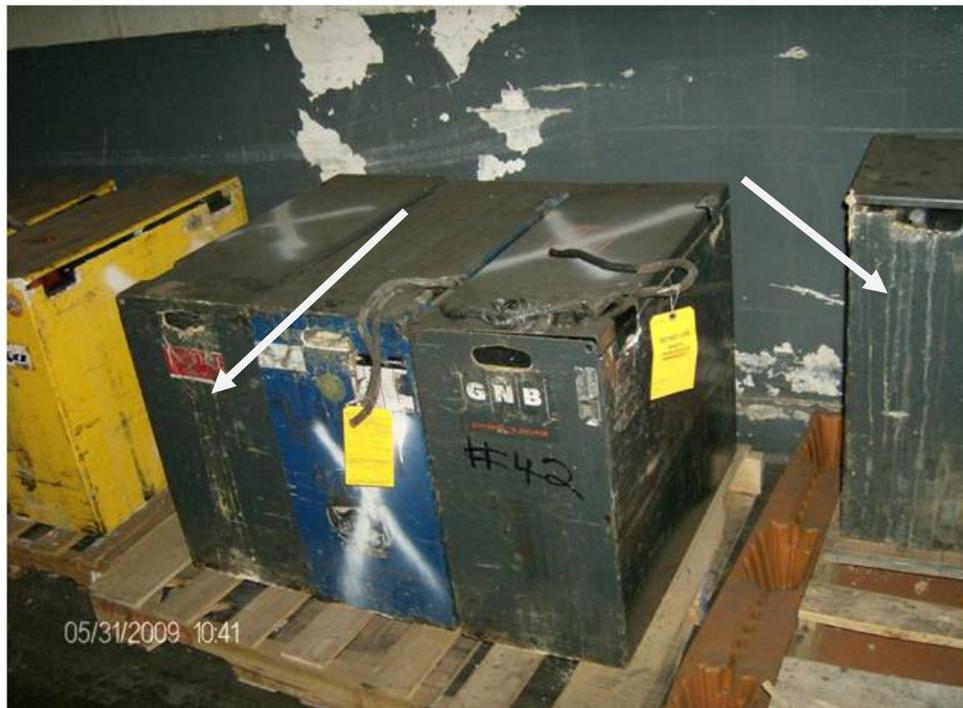
- We also found potentially unsafe non-functioning batteries on the workroom floor. See Illustration 14. During our audit management disposed of these batteries.

Illustration 14: Potentially unsafe non-functioning batteries

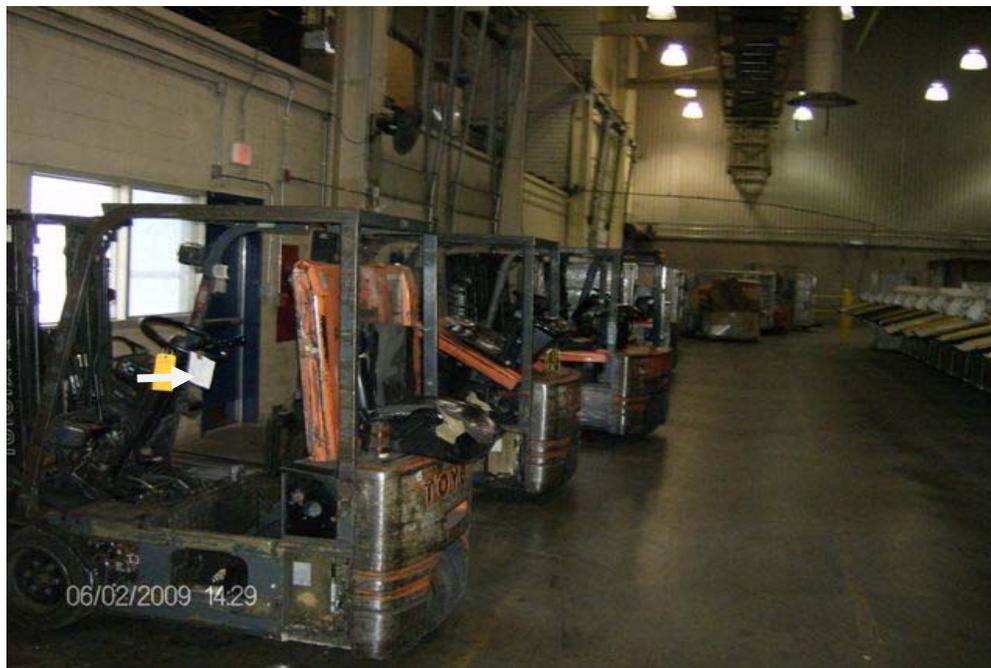
- Vehicles at the Washington NDC were not adequately maintained. For example, 15 of the 55 vehicles were out of service. See Illustration 15.

**Illustration 15: Tags on vehicles indicates they were awaiting maintenance on June 2, 2009.**
