### Facility Condition Reviews - Capital Metro Area

### Audit Report

Report Number  
SM-AR-16-009

July 18, 2016

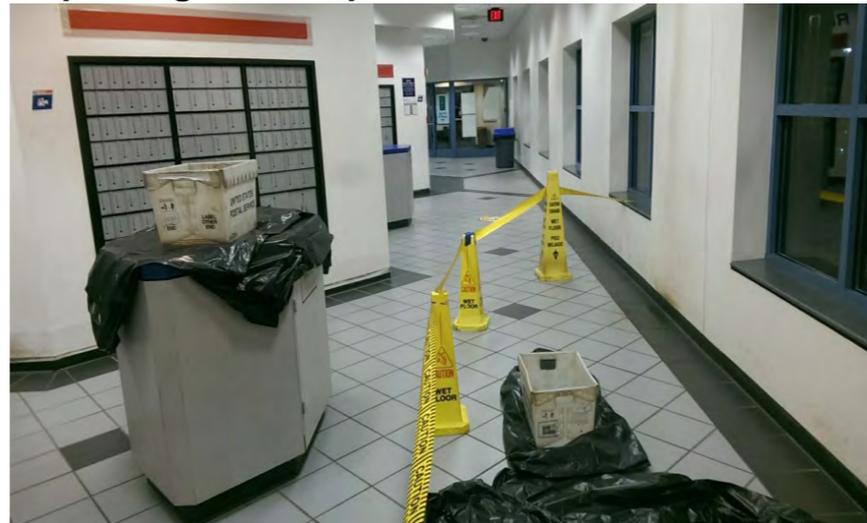
- In one instance, metal trash receptacles, postal tubs and trays, and plastic trash can liners were used on retail counters and floors to prevent water from pooling in the lobby and retail area; and caution tape was used to restrict access to these areas. The facility manager stated that the roof had been leaking for some time (see Figures 1 and 2). Facility management had requested repairs in the same area dating back to 2014 and five additional roof leaks were reported in the month following our observations.

**Figure 1: Roof and Maintenance Deficiencies Impacting Retail Operations**

Source: OIG photograph taken December 1, 2015, by an unidentified Postal Service employee, Bethabara Station, Winston-Salem, NC.

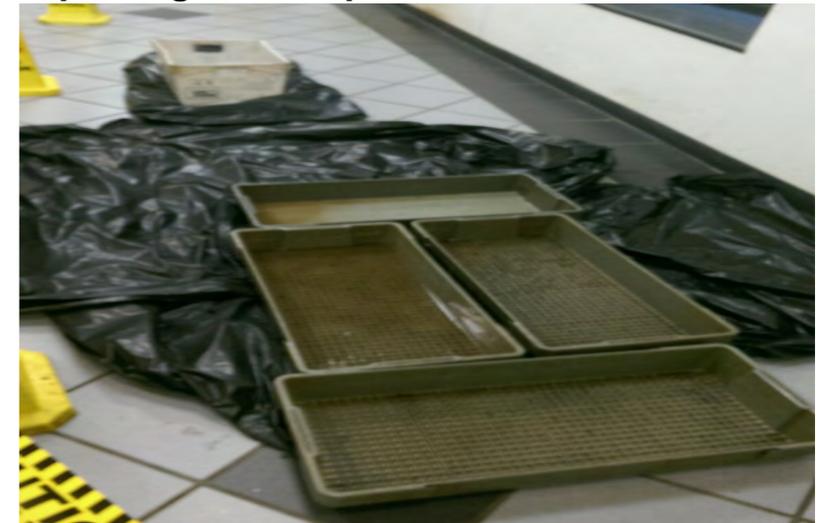
**Figure 2: Roof and Maintenance Deficiencies Impacting Retail Operations**

Source: OIG photograph taken December 1, 2015, by an unidentified Postal Service employee, Bethabara Station, Winston-Salem, NC.

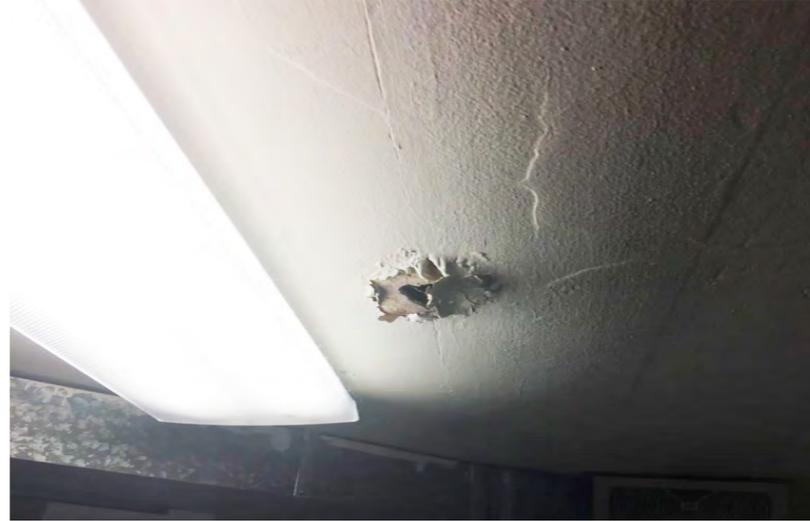
- At other facilities, we found damaged, stained, or missing ceiling tiles and water-stained walls. For example:
  - Two facilities had issues with birds and squirrels accessing facility work areas through damaged roofs (see [Figure 3](#)).

**Figure 3: Hole in Ceiling Where Birds Entered Work Area**

Source: OIG photograph taken February 2, 2016, Main Post Office, Cavetown, MD.

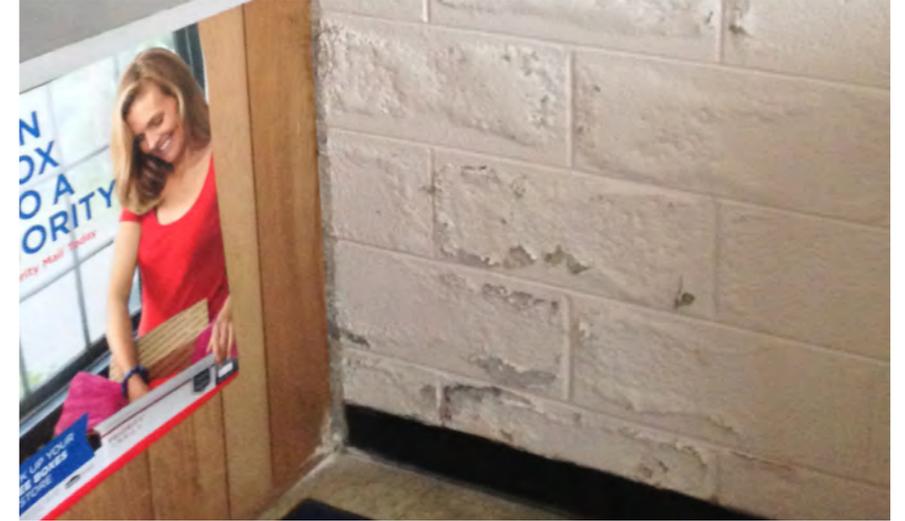
- Four facilities had chipped and cracked floor tiles, some marked with asbestos.
  - Some facilities needed fresh paint due to dirt and wear or had mold on walls and ceilings, leaking windows patched with tape, dirty vent covers and ceiling fans, or missing or damaged light covers (see [Figures 4 and 5](#)).

**Figure 4: Bubbling and Peeling Paint in Lobby**

Source: OIG photograph taken January 27, 2016, Main Post Office, Potecasi, NC.

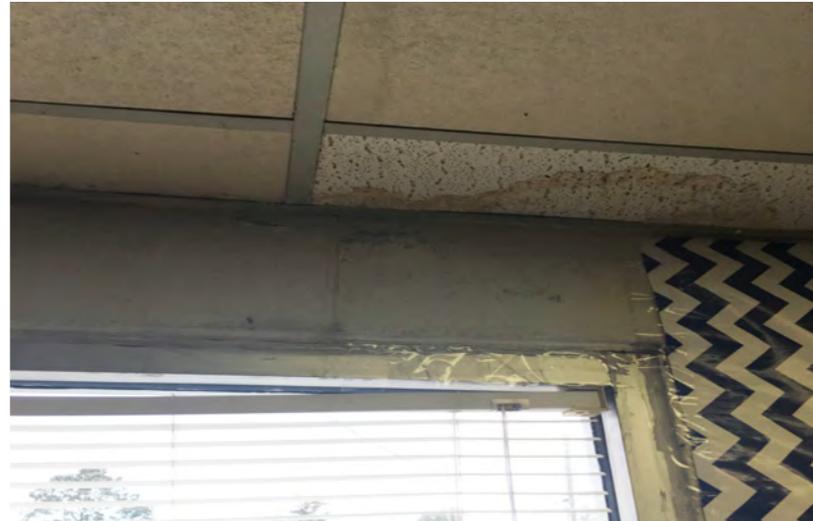
**Figure 5: Lobby Maintenance and Window Issues**

Source: OIG photograph taken January 27, 2016, Main Post Office, Potecasi, NC.

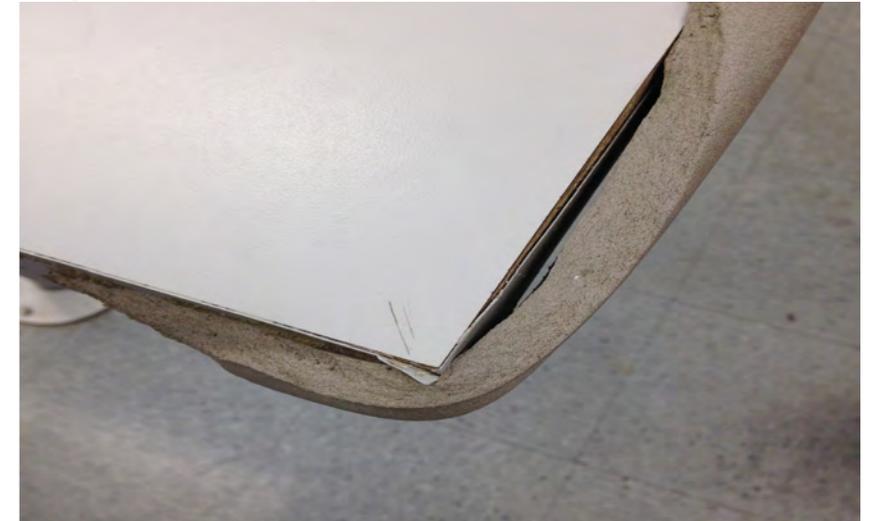
**Figure 6: Damaged Countertop**

Source: OIG photograph taken January 13, 2016, Main Post Office, Burlington, NC.

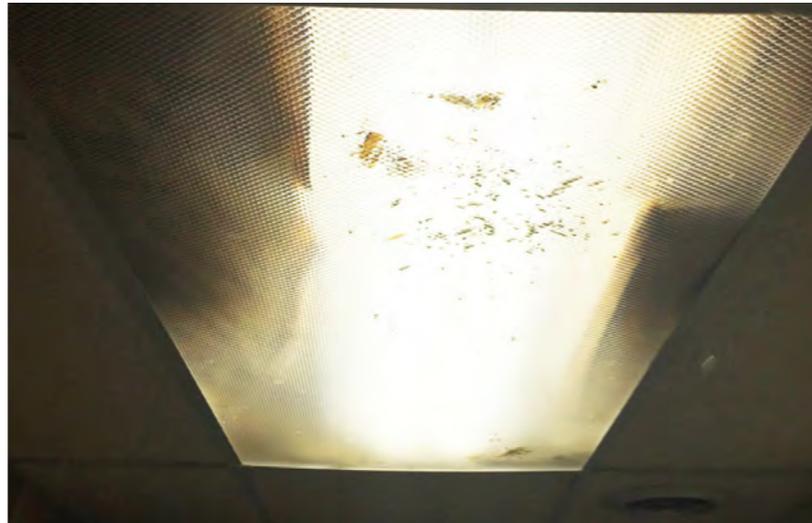
**Figure 7: Insects in Light Fixtures**

Source: OIG photograph taken January 27, 2016, Main Post Office, Potecasi, NC.

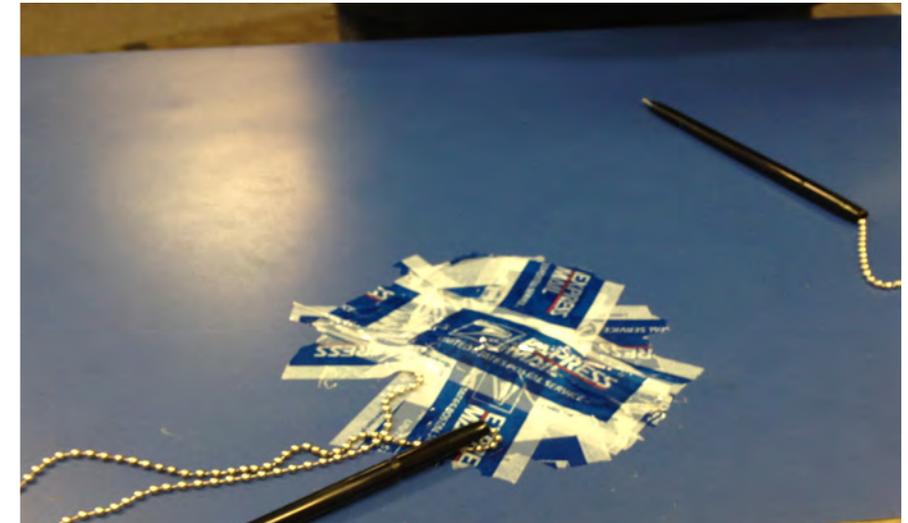
- Nine facilities (45 percent) had cleanliness issues, ranging from minor items, such as cobwebs, dead insects in light fixtures, damaged countertops, and dust and dirt to more prominent issues such as unswept floors, full trash receptacles, and broken signage (see Figures 6 and 7).
- At one facility, Priority Mail® tape was used to repair light fixtures, windows, and countertops; and at another facility, tape was used to secure broken chains on pens customers use and to secure baseboards to walls (see Figure 8).

**Figure 8: Lobby Maintenance Issues**

Source: OIG, photograph taken January 12, 2016, Bethabara Station, Winston-Salem, NC.

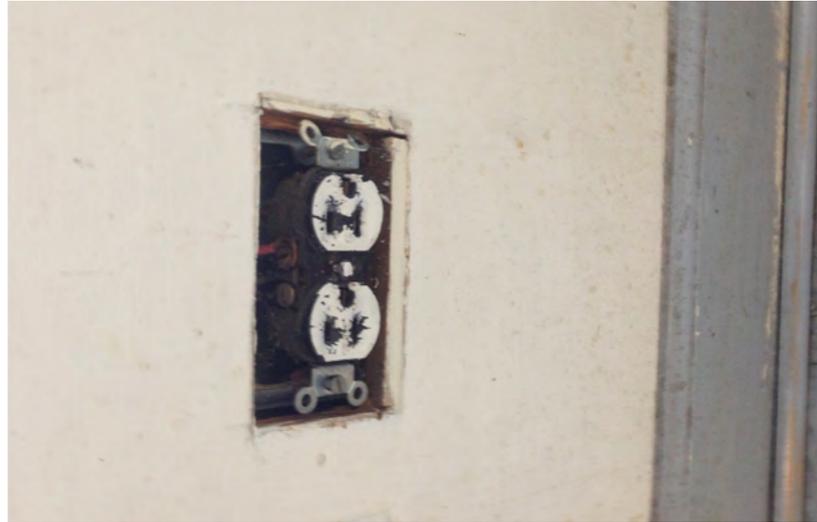
These conditions occurred due to a general absence of focus on and concern for health and safety issues at facilities (see [Figures 9 and 10](#)).

**Figure 9: Exposed Electrical Outlet**

Source: OIG photograph taken January 19, 2016, Eutaw Station, Fayetteville, NC.

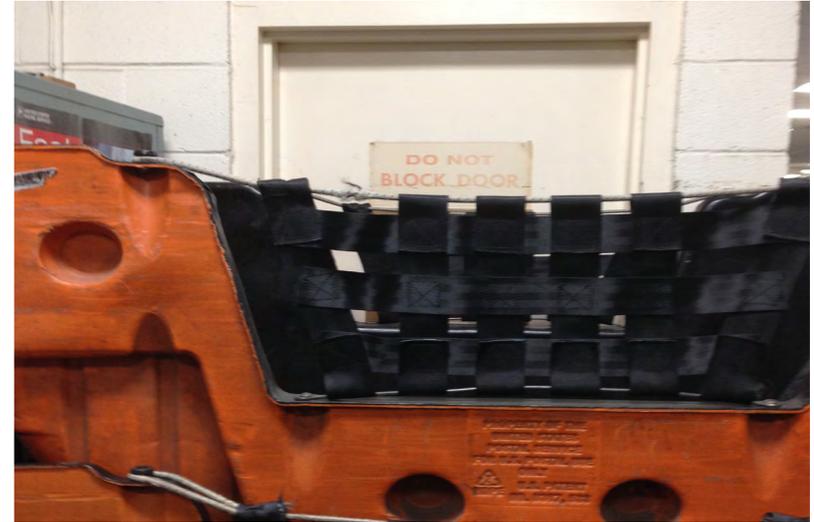
**Figure 10: Blocked Exit**

Source: OIG photograph taken January 19, 2016, Eutaw Station, Fayetteville, NC.
