Facility Condition Reviews – Northeast Area

Audit Report

Report Number
SM-AR-17-001

November 9, 2016

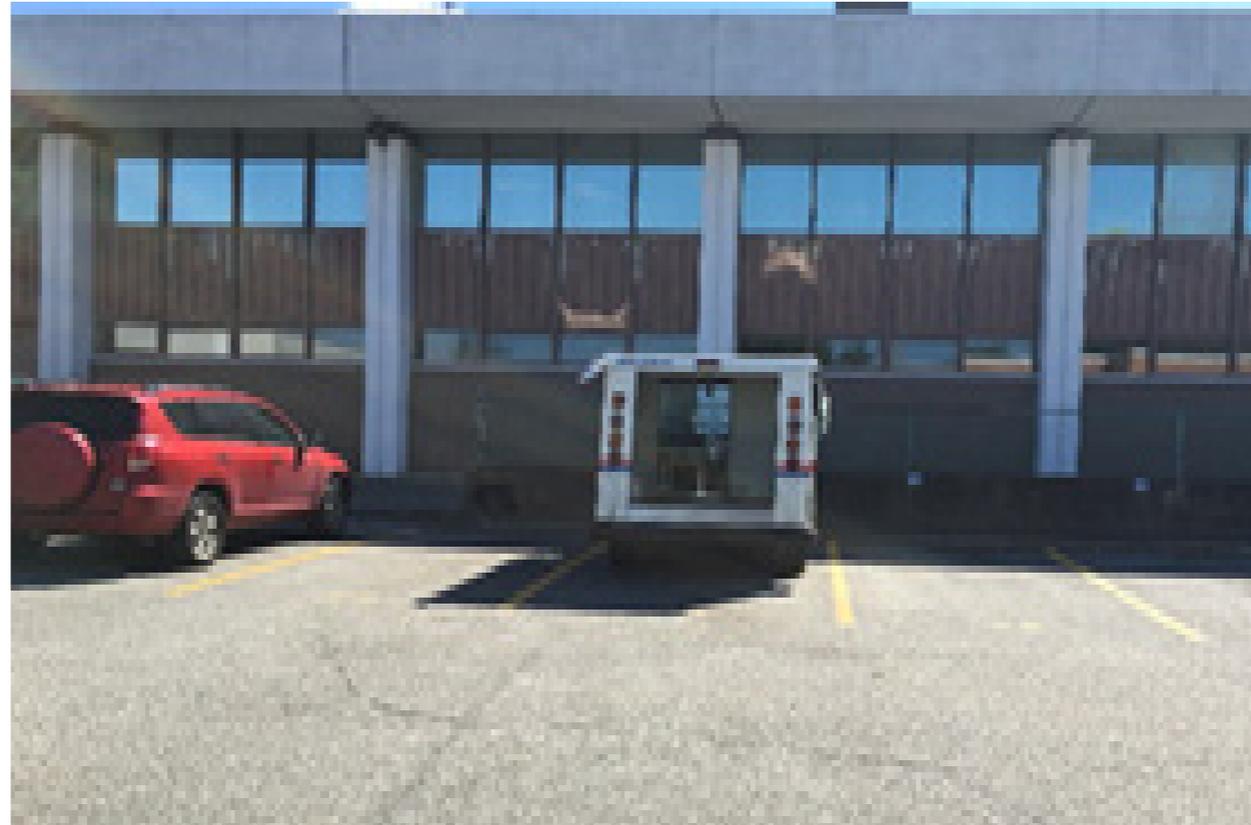
Figure 1. Unlocked Mail Truck

Source: OIG photograph taken May 16, 2016, at the Main Office – Totowa, NJ.

Management is responsible for providing maximum protection for Postal Service employees, funds, and property. Postal Service policy states that employees must firmly adhere to the door locking policy.⁶

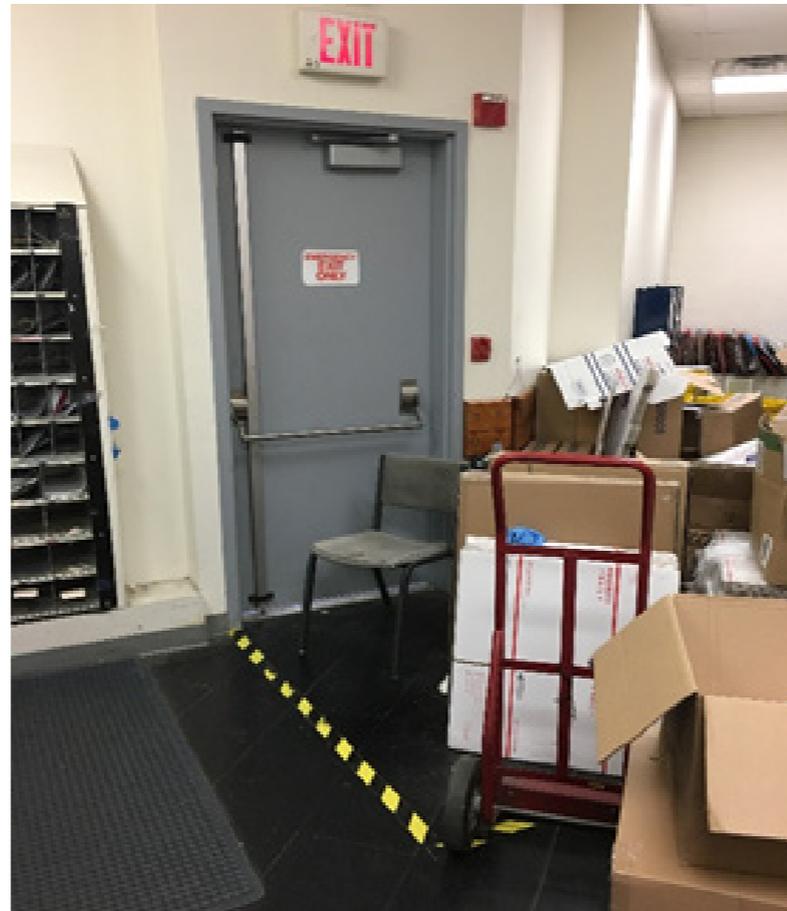
Figure 2: Blocked Exit Door

- Seven facilities (23 percent) had safety hazards such as blocked doors and trip hazards.
- Seven facilities (23 percent) had blocked exits, although signage on the door and floor indicated the area should be kept clear (see [Figure 2](#)).
- Four facilities (13 percent) had fire extinguishers that were not serviced monthly, as required.⁸ Eight fire extinguishers had not undergone monthly inspection and were missing monthly inspection tags and two of the eight had been significantly discharged and were not functional (see [Figure 3](#)).

Source: OIG photograph taken May 17, 2016, at Main Office – Jersey City, NJ.

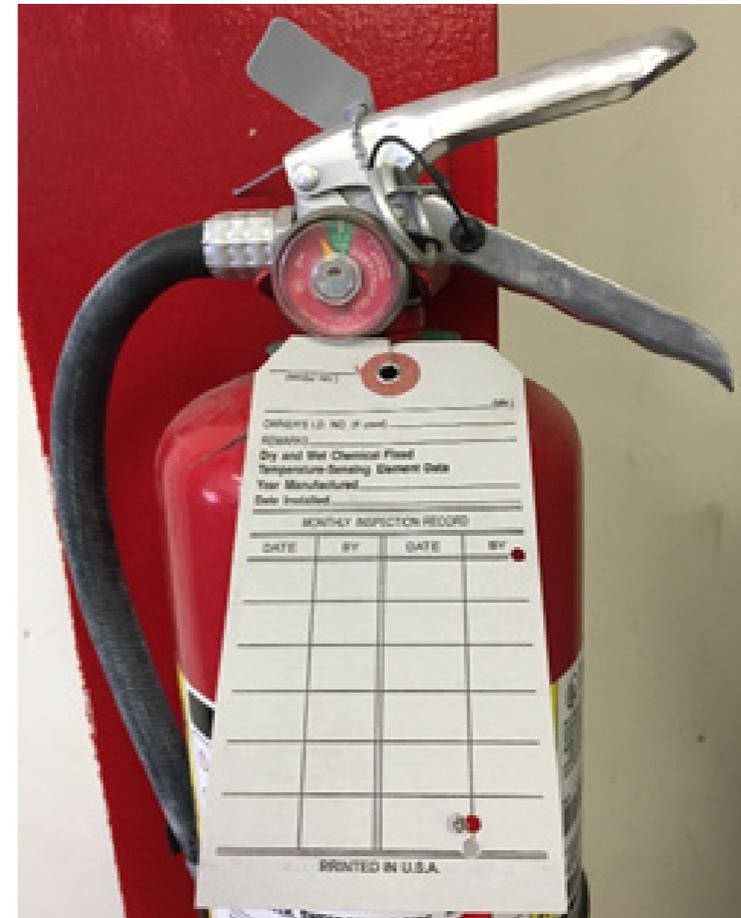
Figure 3: Discharged and Unserviced Fire Extinguisher

Source: OIG photograph taken May 17, 2016, at Main Office – Jersey City, NJ.

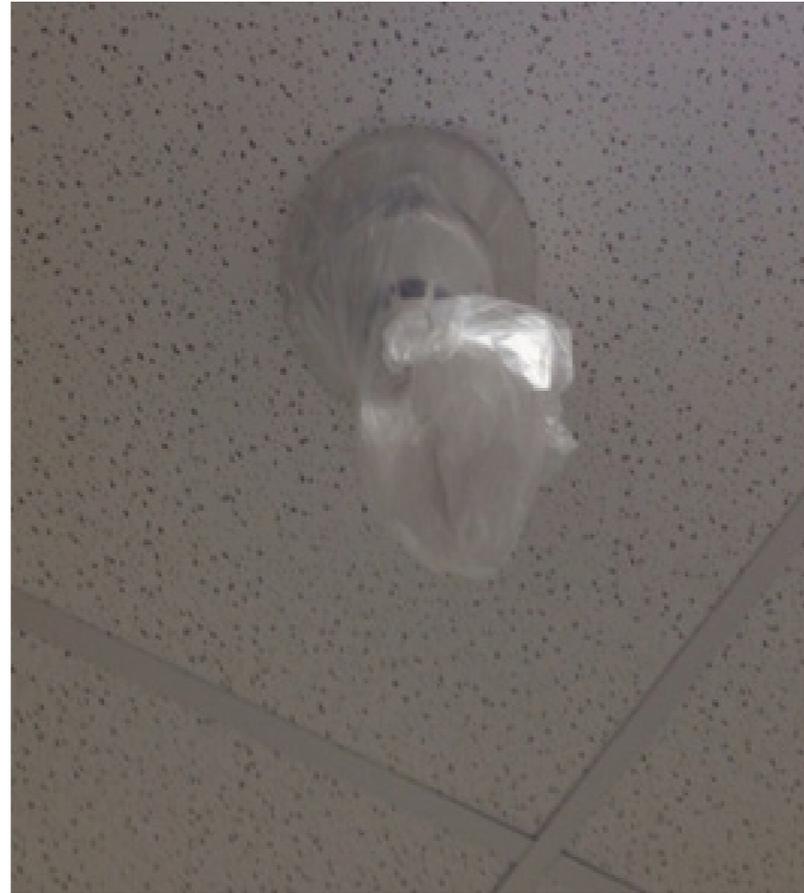
Figure 4: Covered Smoke Detector

- One facility (3 percent) had a smoke detector that was covered by plastic, impacting its ability to detect smoke. The supervisor on duty stated he did not know why the smoke detector was covered (see [Figure 4](#)).
- Four facilities (13 percent) had potential asbestos issues, each facility had several cracked and broken tiles labeled for asbestos, and one facility had broken tiles that were covered by a rug instead of replaced.
- One facility (3 percent) had equipment that was powered on and missing the cover, exposing the electrical components inside.
- Two facilities (6 percent) had missing wall plates for outlets⁹ (see [Figure 5](#)).

Source: OIG photograph taken April 27, 2016, at Greely Square – Brooklyn, NY.

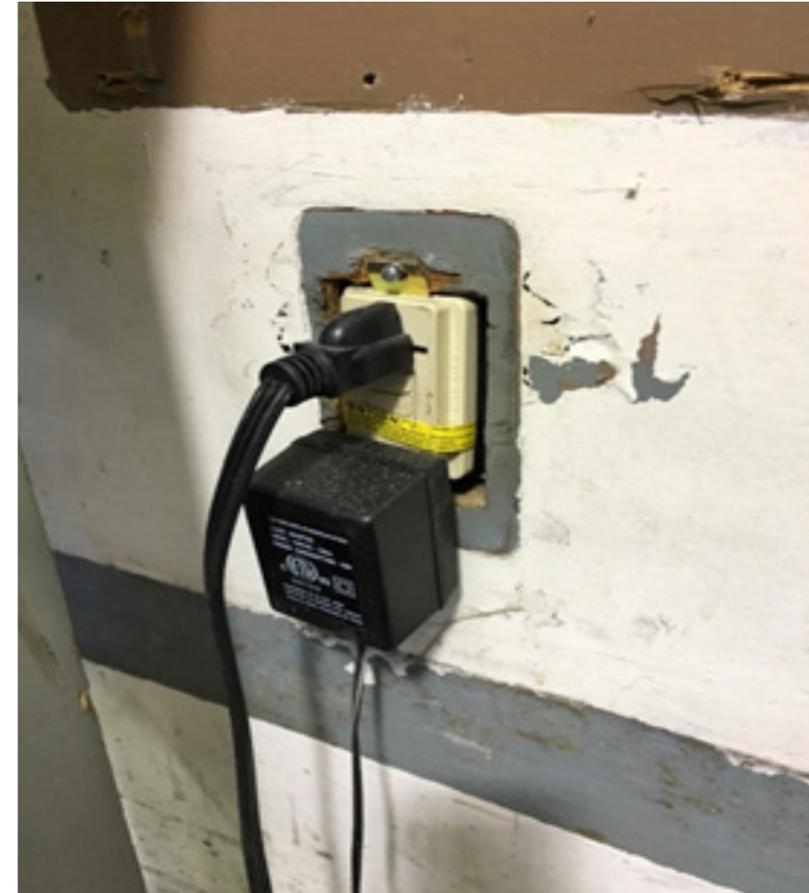
Figure 5: Exposed Electrical Outlet

Source: OIG photograph taken May 16, 2016, at the Main Office – Totowa, NJ.

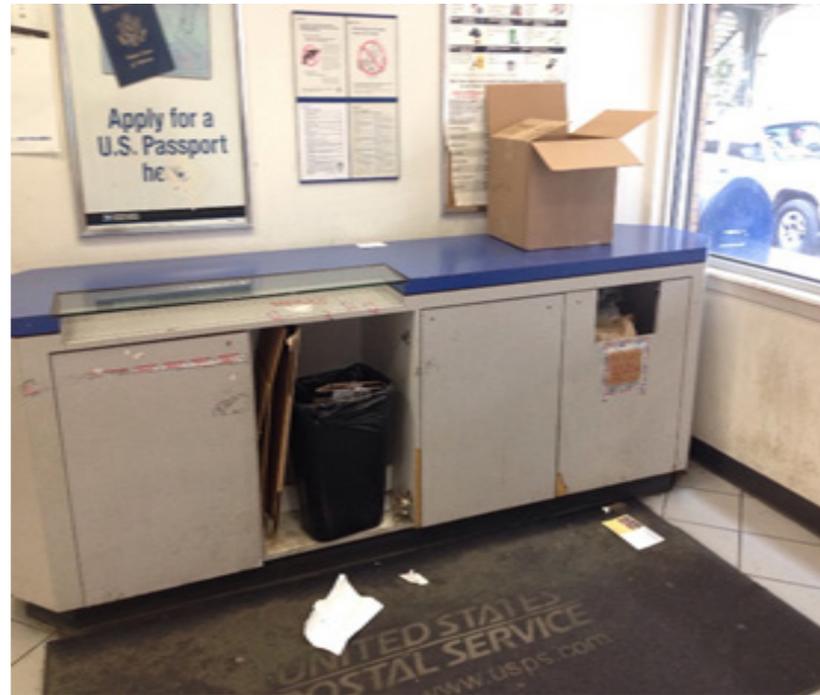
Figure 6: Lobby Trash

- Nine facilities (29 percent) had missing or burned out bulbs or exposed wires.
- Six facilities (19 percent) did not have appealing lobbies. The lobby areas of these facilities had overflowing trash cans, debris on the floor, holes in the walls or dirty walls, inoperable lights, missing cabinet doors, and stained or missing ceiling tiles (see [Figure 6](#)).

Source: OIG photograph taken April 28, 2016, at the Bushwick Retail Facility – Brooklyn, NY.

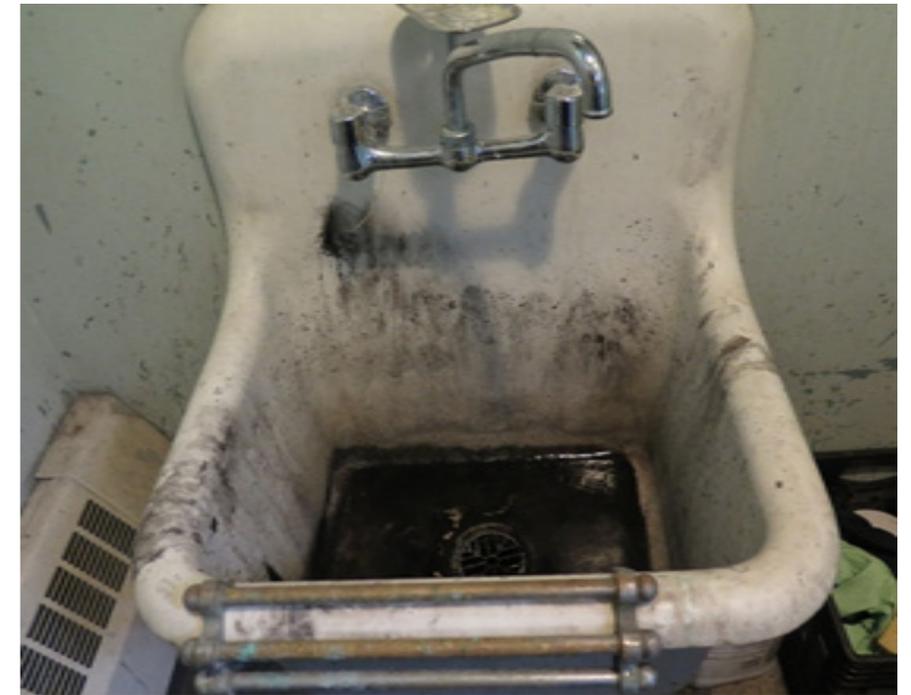
Figure 7: Stained Sink

- Ten facilities (32 percent) did not have a clean or well-maintained building. Issues included unsanitary conditions; the appearance of mold; poor landscaping; dust on fixtures (such as ceiling fans and lights); uneven sidewalks; and inoperable or stained toilets and sinks (see [Figure 7](#)).

Source: OIG photograph taken May 26, 2016, at the Main Office – Norwich, CT.

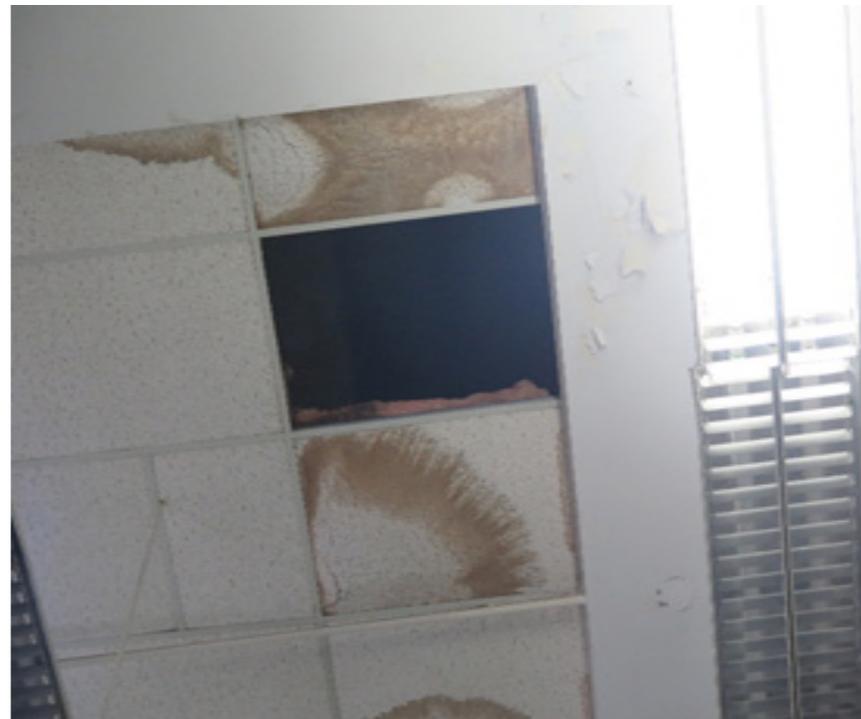
Figure 8: Damaged and Stained Ceiling Tiles

- Fifteen facilities (48 percent) needed repair and maintenance of paint, plaster, walls, floors, and ceilings. Other issues included roof leaks; walls that were either partially painted, stained from a roof leak, or had chipped paint, plaster, or holes; ceiling tiles that were stained, missing, or damaged; and floors that needed to be repaired, cleaned, or polished (see [Figure 8](#)).

Source: OIG photograph taken May 26, 2016, at the Main Office – Norwich, CT.

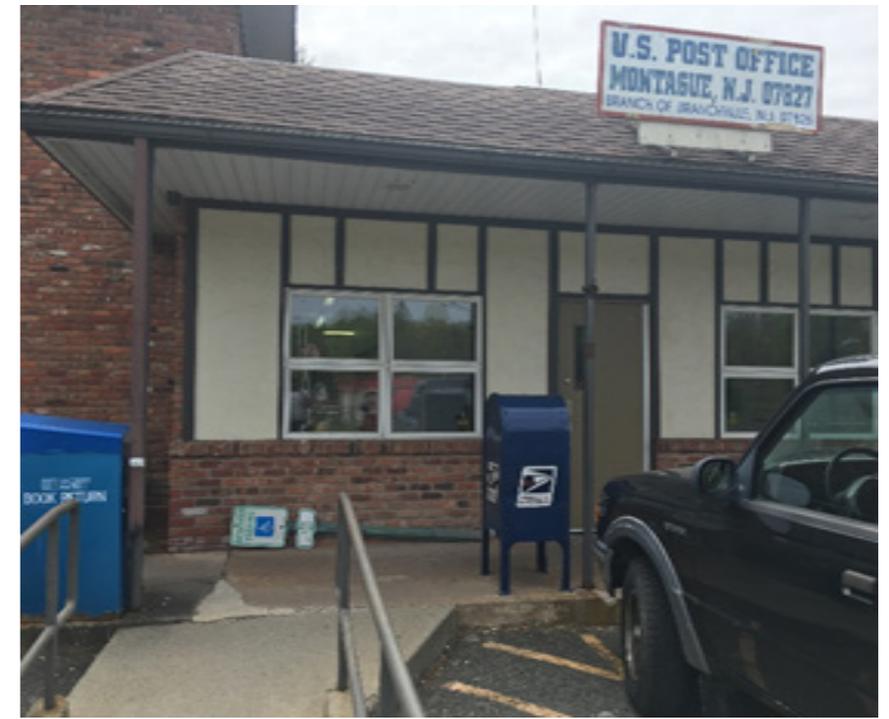
Figure 9: Handicap Parking Sign

Source: OIG photograph taken May 18, 2016, at the Main Office – Montague, NJ.

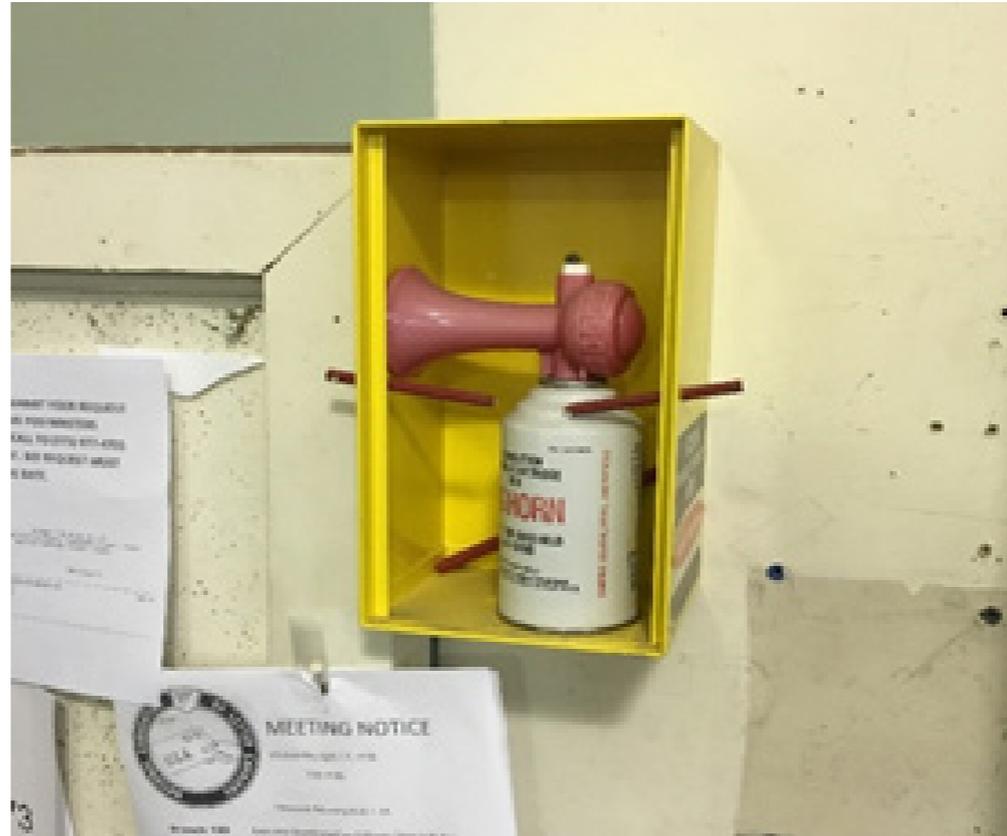
Figure 10: Air Horn Used As A Fire Alarm

- Four facilities (13 percent) did not display Poster 7, *Rules and Regulations Governing Conduct on Postal Property*.²⁹
- Fifteen facilities (48 percent) did not display the OIG poster,³⁰ though it is not required.
- Twenty-three facilities (74 percent) did not have emergency contact numbers by each phone. One facility had an air horn that functioned as a local fire alarm. (see Figure 10).

Source: OIG photograph taken May 16, 2016, at the Main Office – Totowa, NJ.
