Facility Condition Reviews – Southern Area

Audit Report

Report Number
SM-AR-17-003

April 28, 2017

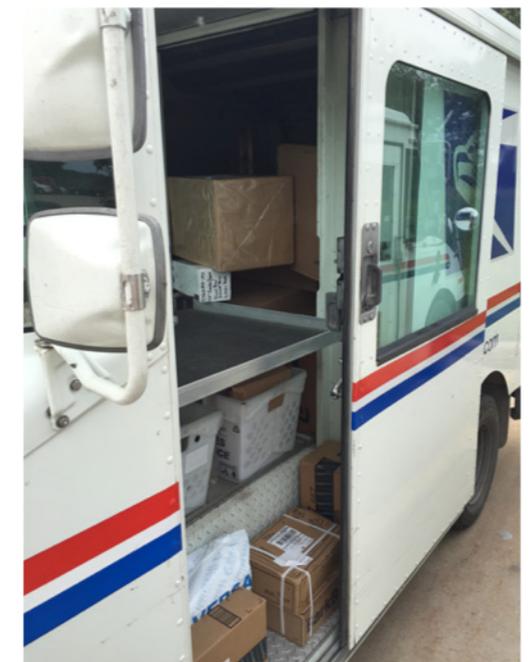
Figure 1: Unlocked Vehicle

- Five facilities (7 percent) had unlocked postal vehicles. As a result, OIG auditors were able to access 29 vehicles, 9 of which contained mail. Management took corrective action by securing all vehicles during our visit (see Figure 1).
- Four facilities (6 percent) had untrimmed trees or bushes that could allow unauthorized access to the building or fenced area. One facility had an overgrown tree in the back that could conceal a trespasser or allow access to the roof.
- One facility had inadequate exterior lighting with more than half of the lights in the customer parking lot not working.
- One facility had a damaged barbed wire fence, which could allow unauthorized access to the building.
- One facility had a dock area security camera that was broken. Specifically, the images from the camera did not display on the monitor.

Source: OIG photograph – Lake Travis Branch, Lakeway, TX, dated September 27, 2016.

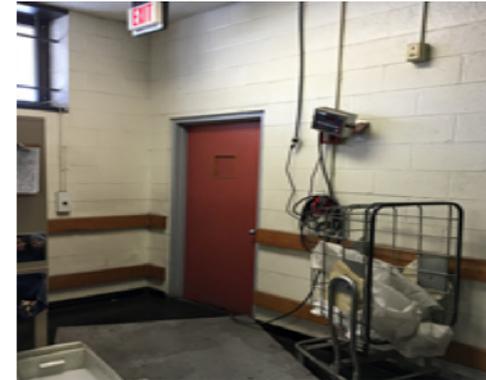
Figure 2: Blocked Exit Door

- One facility had a large floor scale blocking an exit door (see Figure 2).
- One facility had unsecured wires and cords between the workroom floor and front counter (see Figure 3).
- Three facilities (4 percent) had suspected mold and possible asbestos⁷ exposure and one had an asbestos warning sign on a damaged wall (see Figure 4).
- Twenty-four facilities (34 percent) had fire extinguishers that were not serviced monthly or annually as required,⁸ including one facility with fire extinguishers that had not been serviced annually since 2003 (see Figure 5). Two facilities (3 percent) had blocked electrical panels (see Figure 6).

Source: OIG photograph, Magnolia Post Office – Magnolia, TX, dated October 21, 2016.

attention during our site visits, such as displaying missing posters, unblocking exits, and securing unlocked vehicles.

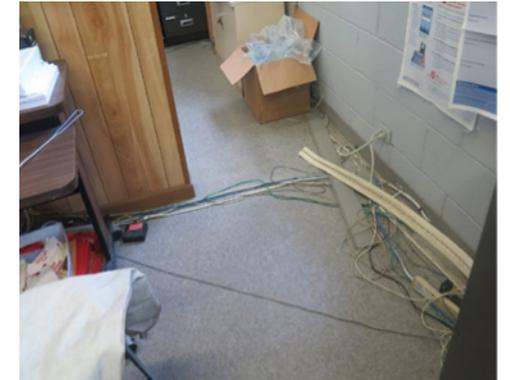
Figure 3: Unsecured Wires

Source: OIG photograph, Parkin Post Office – Parkin, AR, dated October 13, 2016.

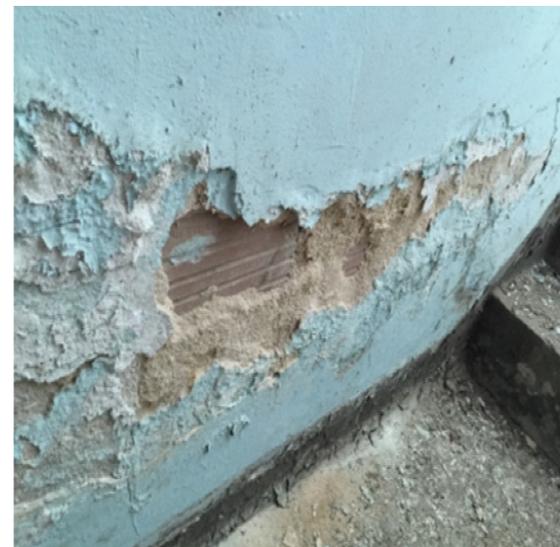
Figure 4: Potential Asbestos Wall

Source: OIG photograph, Bogalusa Post Office – Bogalusa, LA, dated October 17, 2016.

⁷ Possible asbestos exposure refers to asbestos-labeled floor tiles or walls that are cracked or damaged.

Regarding the other impact, while the missing OSHA posters may not have resulted in actual fines in the past, we noted the violations are "potentially" finable based on OSHA criteria. In addition, regarding the asbestos-associated risk, we noted "possible" asbestos exposure only at facilities with asbestos-labeled floor tiles and walls that were cracked or damaged in the area of the asbestos label.

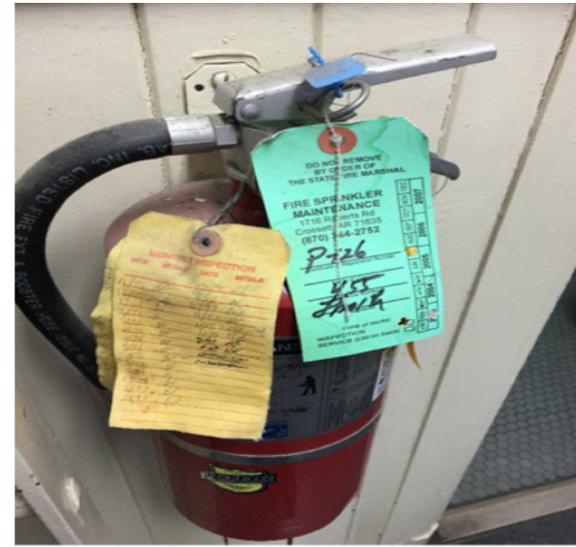
Figure 5: Uninspected Fire Extinguisher

Source: OIG photograph, Hamburg Post Office – Hamburg, AR, dated October 19, 2016.

Regarding recommendation 5, management will reissue the housekeeping requirements per Handbook MS-47 to include standards for improving the customer retail experience and requirements for maintaining and inspecting fire extinguishers. Management will also require districts to review and update all offices on the Vulnerability and Risk Assessment Tool, which evaluates vulnerabilities of the site, facility, security system, registry/remittance, policy and procedure, information technology, and personnel. Finally, all offices will be provided a diagram of required postings and certify that they have posted all required material. The target implementation date is May 20, 2017.

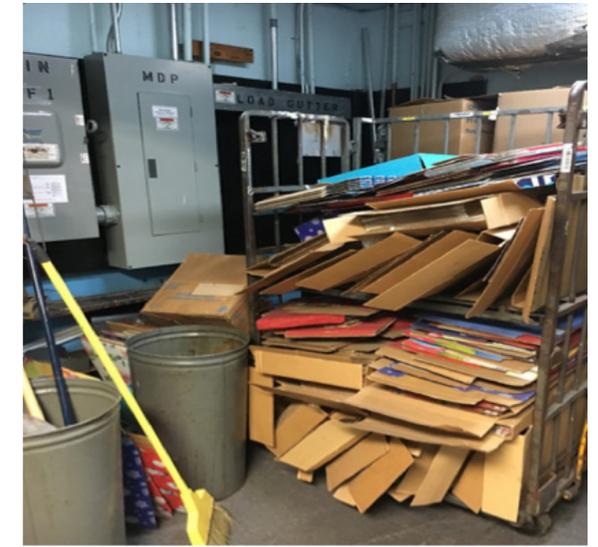
Figure 6: Blocked Electrical Panels

Source: OIG photograph, Miami Springs Branch – Miami, FL, dated September 28, 2016.

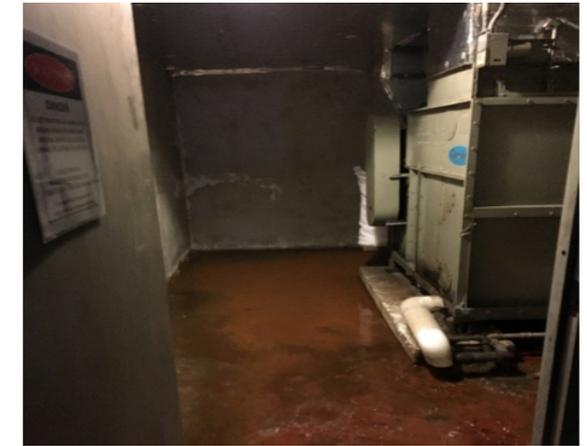
Figure 7: Rusty Standing Water

- One facility had rusty standing water in a basement room that housed the air conditioning unit (see Figure 7). The water seeped outside of the room and damaged boxes and other materials. The postmaster was unaware that the basement had standing water and said the facility had an ongoing sump pump issue.

Source: OIG photograph, Bogalusa Post Office – Bogalusa, LA, dated October 17, 2016.

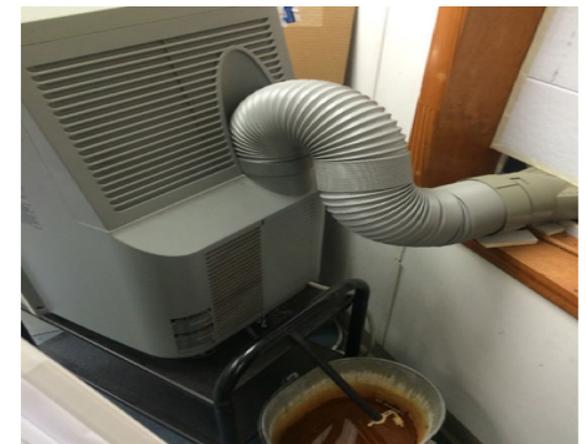
Figure 8: Temporary AC Unit

- Two facilities (3 percent) had air conditioning (AC) units that did not work properly. At one facility, a temporary AC unit was used to cool the workroom floor (see Figure 8). Local management reported this issue for repair in the electronic Facilities Management System (eFMS)⁹ in March 2013, July 2014, and April 2016. Although repairs were made, the unit did not work properly at the time of our visit in September 2016. At another facility, personal fans were on each workstation throughout the workroom floor to keep the area cool. Local management reported the AC problems in eFMS in May 2015 and again in August 2015; however, maintenance did not address the deficiencies.

Source: OIG photograph, Venus Post Office – Venus, FL, dated September 27, 2016.

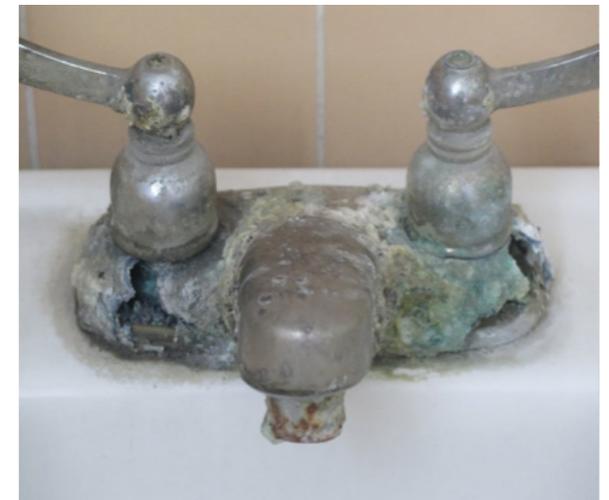
Figure 9: Corroded Faucet

Source: OIG photograph, George West Post Office – George West, TX, dated September 26, 2016.

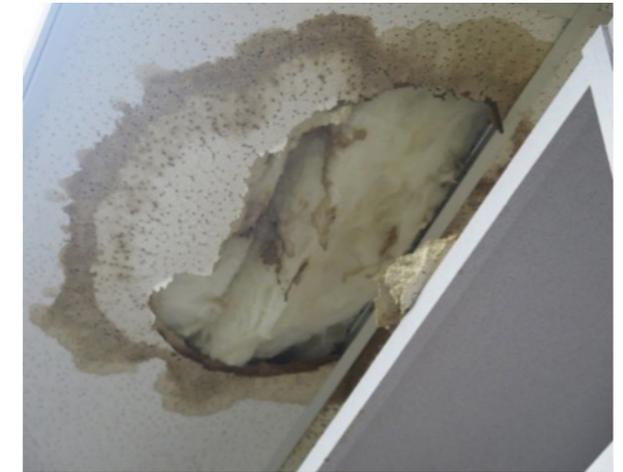
Figure 10: Damaged Ceiling Tile

- Thirty-one facilities (44 percent) needed repair and maintenance of paint, plaster, walls, floors, and ceilings in the employee areas. These facilities had walls with holes, cracks, chipped paint or plaster; floors with holes, that were dirty, or needed repair; and stained, missing, or damaged ceiling tiles (see Figure 10).
- Twelve facilities (17 percent) did not take the American flag down at night or have it illuminated, as required.¹⁴
- Nine facilities (13 percent) required landscaping maintenance and removal of excess equipment, such as cluster boxes and utility carts. One facility had broken or unused equipment located on the side of the building, another had overgrown grass, and three had overgrown trees and bushes close to the front and rear of the building.
- Sixty-two facilities (87 percent) did not complete a quarterly housekeeping inspection as required¹⁵ (see Table 1).

Source: OIG photograph, Jacksonville Post Office – Jacksonville, AR, dated October 13, 2016.
