Facility Condition Reviews – Eastern Area

Audit Report

Report Number
SM-AR-17-004

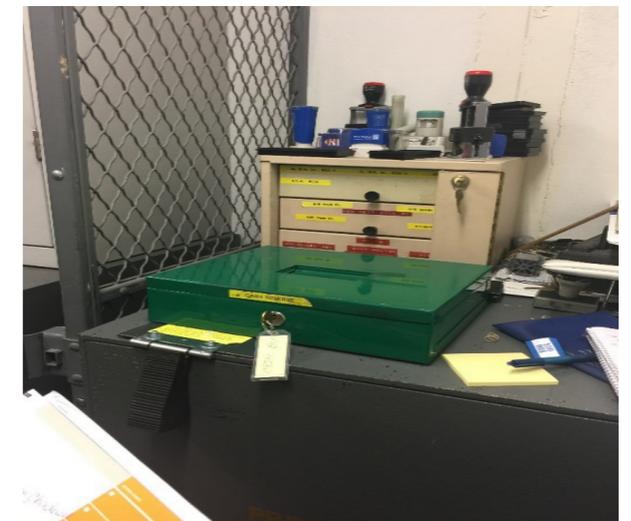
Figure 1. Unsecured Cash Drawer in Unsecured Vault Room

- One facility (2 percent) had an unsecured vault room with loose cash and an unlocked cash drawer on top of an unsecured safe, which contained locked cash drawers (see Figure 1).

Source: OIG photograph taken November 29, 2016, Williamsburg Post Office, Williamsburg, KY.

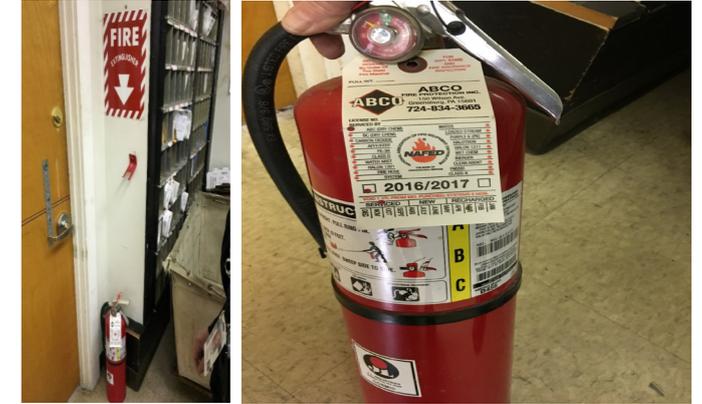
Figure 2. Inoperable Fire Extinguisher and Broken Mounting Bracket

- Twenty-two facilities (43 percent) had fire extinguishers that were not inspected monthly and annually, as required, or were missing.⁷ One facility had fire extinguishers that had not been inspected since 1999, while another had an inoperable fire extinguisher and a broken mounting bracket (see Figure 2).

Source: OIG Photographs taken November 8, 2016, Larimer Post Office, Larimer, PA.

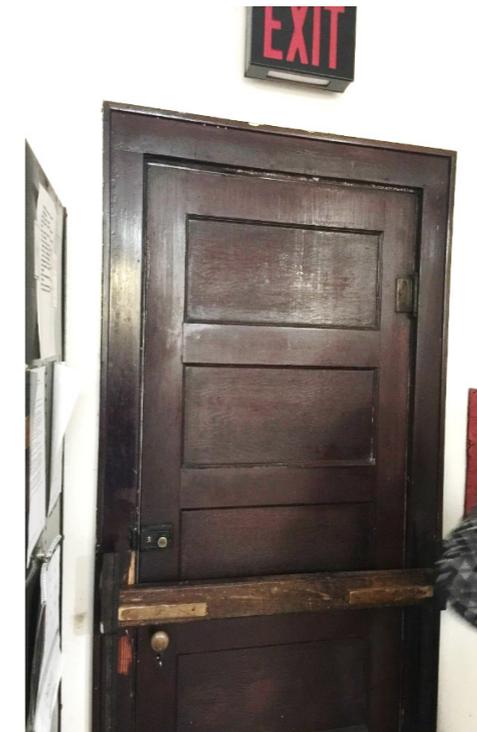
Figure 3. Exit Braced With Wood and Locked With Skeleton Key

Source: OIG photograph taken December 1, 2016, War Post Office, War, WV.

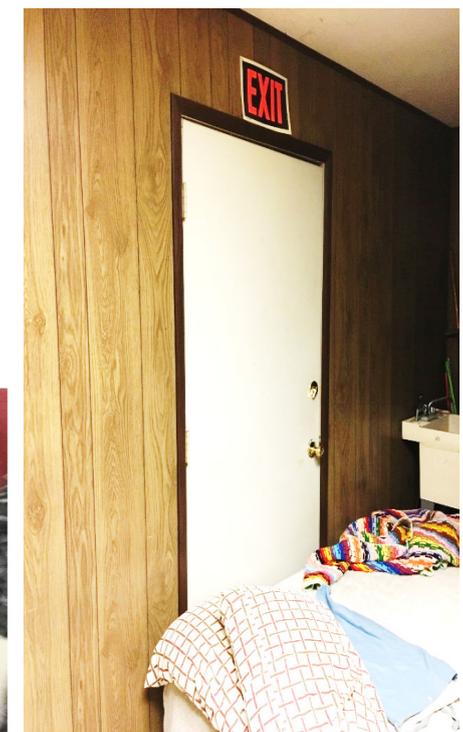
Figure 4. Exit Blocked With Mattress

Source: OIG photograph taken November 8, 2016, Littleton Post Office, Littleton, WV.

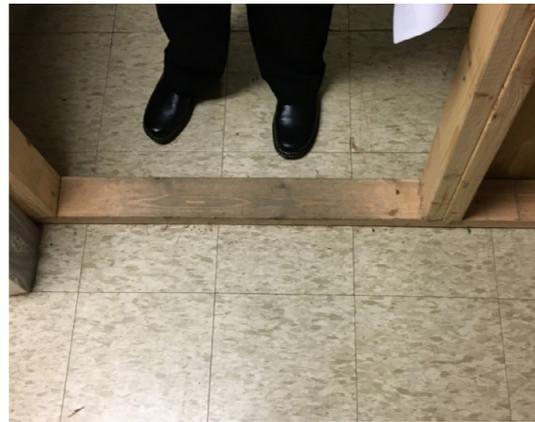
Figure 5. Trip Hazard

- Eight facilities (16 percent) had potential mold and asbestos exposure.⁸
- Eight facilities (16 percent) had trip hazards in the customer and employee areas (see Figure 5).

Source: OIG photographs taken November 8, 2016, Littleton Post Office, Littleton, WV.

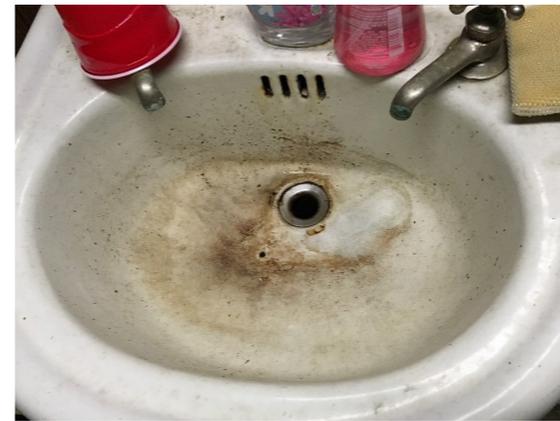
**Figure 6. Poorly
Maintained Restroom**

- Three facilities (6 percent) had lighting issues such as bulbs needing replacement or missing light covers.
- Two facilities (4 percent) had sanitary issues such as clogged sinks with no hot water, poorly maintained bathrooms, and peeling floors (see Figures 6 and 7).

Source: OIG photograph taken November 8, 2016, Mather Post Office, Mather, PA.

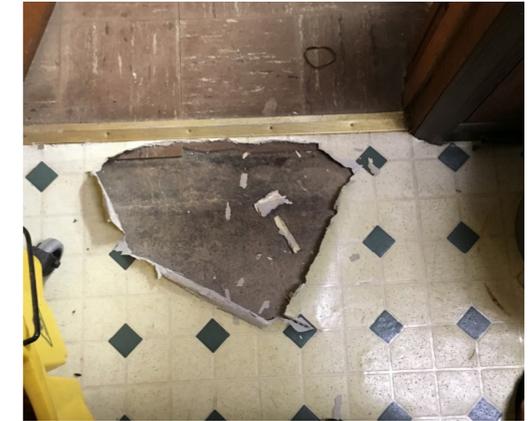
Figure 7. Peeling Floors

Source: OIG photograph taken November 8, 2016, Mather Post Office, Mather, PA.

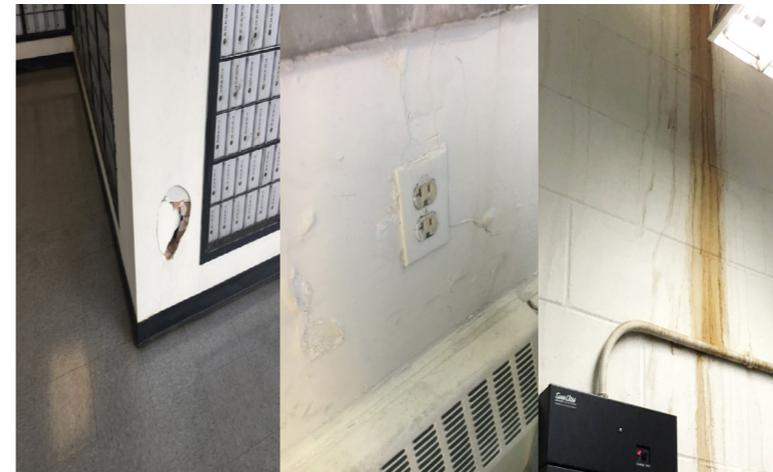
Figure 8. Damaged Walls

- Nineteen facilities (37 percent) needed repair and maintenance of ceilings, walls, and floors. Some facilities had stained or damaged ceiling tiles; while others needed fresh paint, new carpets, and repairs to chipped and worn asbestos-containing floor tiles. We also observed dirty floors and walls needing repair (see Figures 8 and 9).

Source: OIG Photographs taken November 8, 2016, Nashville Northeast Station, Nashville, TN (left) and November 8, 2016, North Dayton Station, Dayton, OH (middle and right).

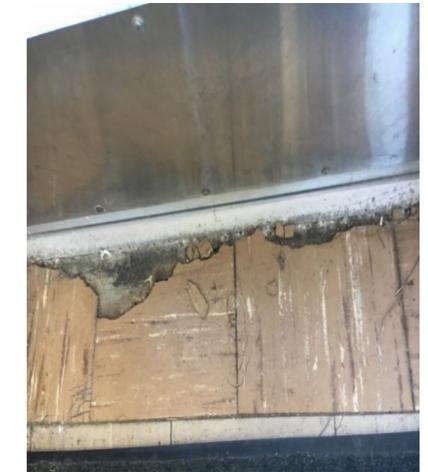
Figure 9: Damaged Asbestos Floors

Source: OIG photograph taken November 7, 2016, Orient Post Office, Orient, OH.

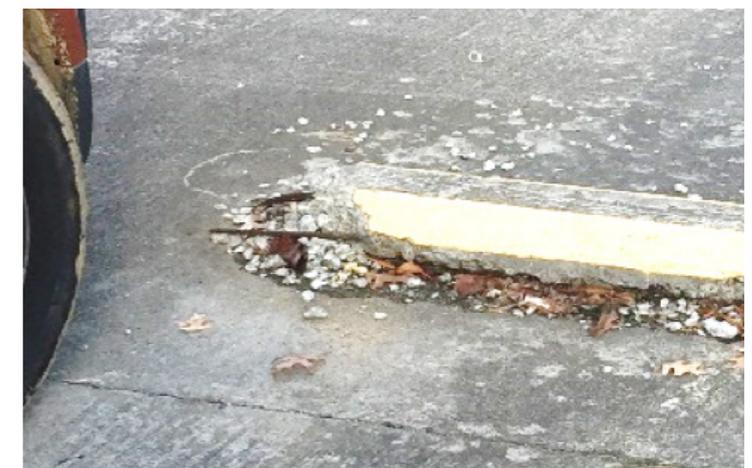
Figure 10. Broken Cement Parking Block With Protruding Metal

- Eight facilities (16 percent) had parking lot issues such as potholes and faded or missing painted parking spaces, including one parking lot that had broken cement-parking blocks with protruding metal that could cause physical harm or damage to a vehicle (see Figure 10).

Source: OIG photograph taken December 1, 2016, Elizabethton Post Office, Elizabethton, TN.

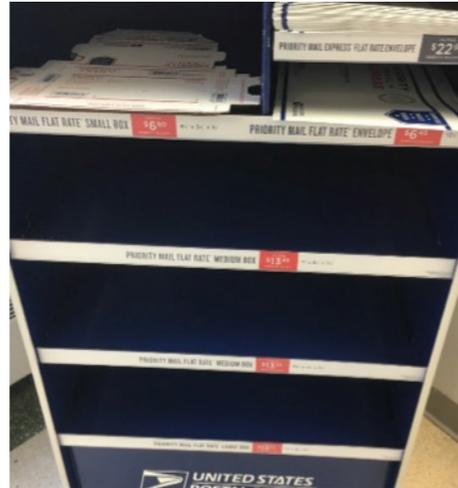
Figure 11. Empty Merchandise Racks

- Six facilities (12 percent) had interior and exterior lighting issues, such as bulbs needing replacement and missing light covers.
- Five facilities (10 percent) had unappealing lobbies such as overflowing trash containers, empty or dirty merchandise racks, worn or damaged signage, and Priority Mail® tape used to secure shipping instructions to a counter in the lobby and repair a broken door handle (see Figures 11 and 12).

Source: OIG Photographs taken November 8, 2016, North Dayton Station, Dayton, OH.

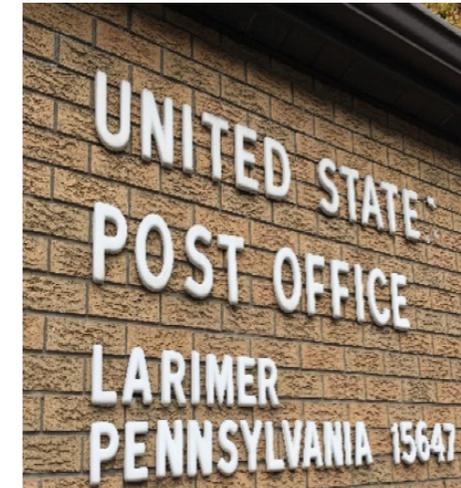
Figure 12. Damaged Signage

Source: OIG Photograph taken November 8, 2016, Larimer Post Office, Larimer, PA.
