Facility Condition Reviews — Western Area

Audit Report

Report Number
SM-AR-17-009

September 8, 2017

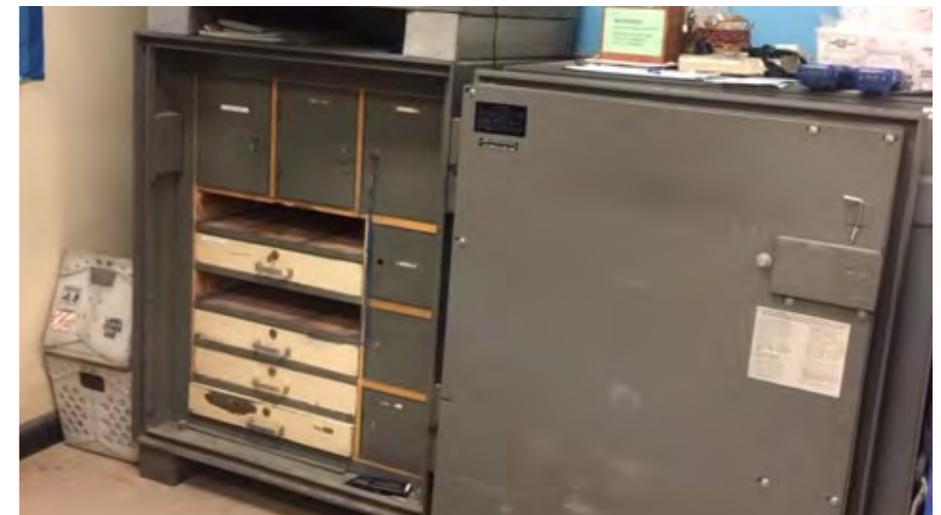
Figure 1. Unlocked Safe in Workroom Area

- Four facilities (10 percent) had 40 USPS vehicles that were unlocked and unattended.
- Two facilities (5 percent) did not prevent public access to employee work areas that should have been secured. The doors leading from the customer lobby to the employee work area of the facilities were unlocked and not monitored, allowing unrestricted access.
- One facility (3 percent) had an unsecured safe containing documents (see Figure 1).

Source: OIG photo taken June 6, 2017, Bonner Springs Post Office, Bonne Springs, KS.

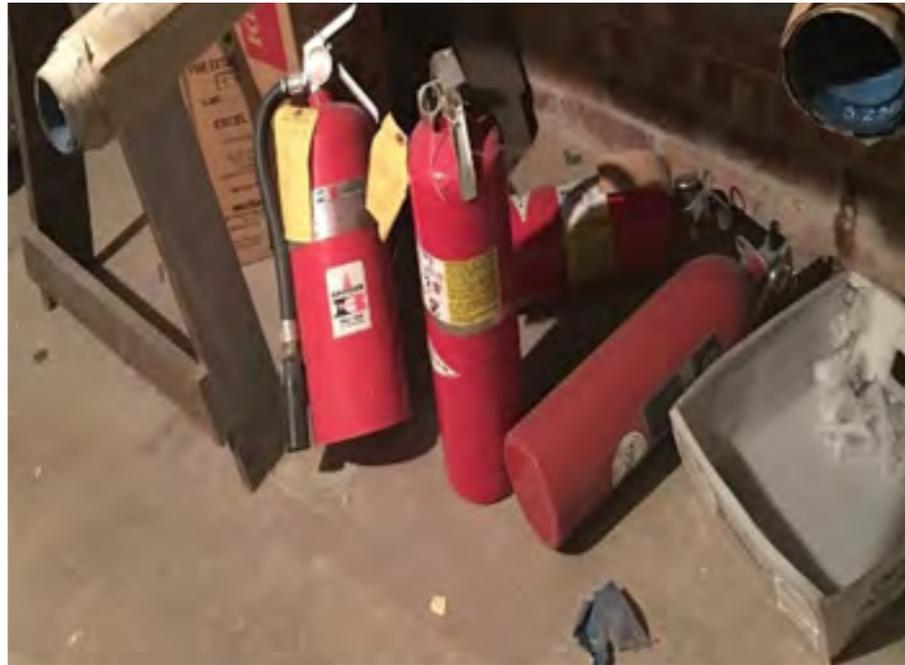
Figure 2. Inoperable Fire Extinguishers

Source: OIG photo taken June 7, 2017, Globe Post Office, Globe, AZ.

Regarding recommendation 5, management stated that the area will communicate to district managers the need for installation heads to conduct monthly inspections of fire extinguishers and that the oversight mechanism for compliance will be the Fire Inspection Completion report that will be populated during required periodic fire inspections. Management further stated that current unit closeout procedures include a certification process to ensure vehicles are locked and secured. The target implementation date is September 1, 2017.

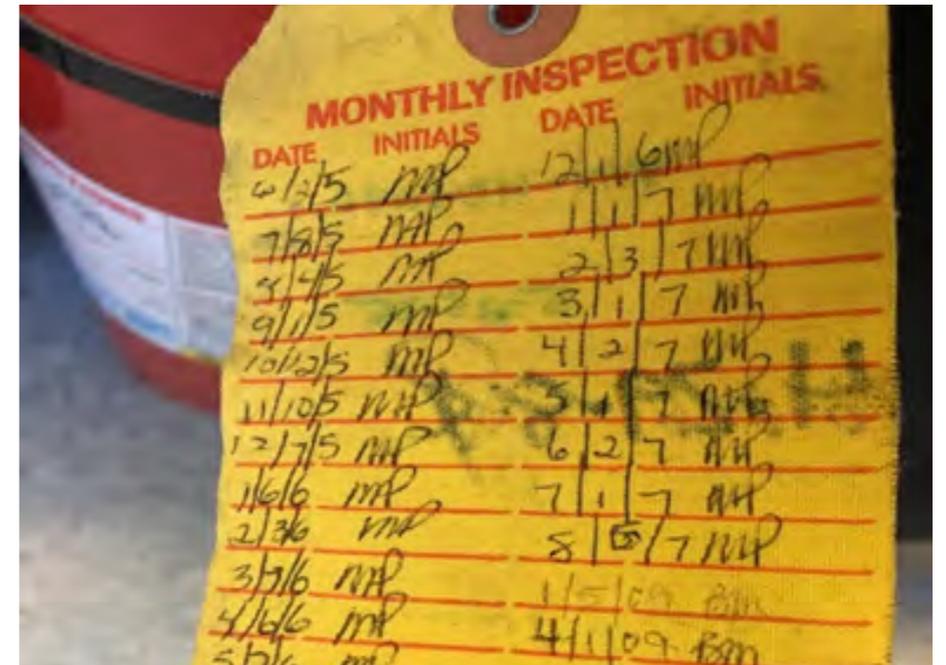
Figure 3. Fire Extinguisher Not Inspected Since 2009

Source: OIG photo taken June 8, 2017, Drake Post Office, Drake, CO.

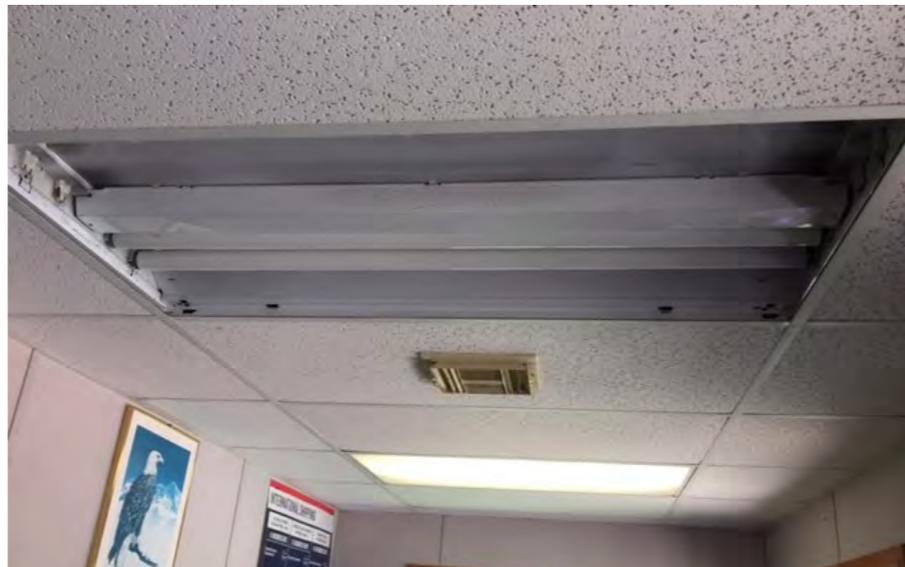
Figure 4. Bulbs Need Replacement and Cover is Missing

- Five facilities (13 percent) had potential mold or asbestos exposure.⁸
- Seven facilities (18 percent) had lighting issues⁹ such as bulbs needing replacement or missing covers (see [Figure 4](#)).

Source: OIG photo taken June 5, 2017, Waldron Post Office, Waldron, MO.

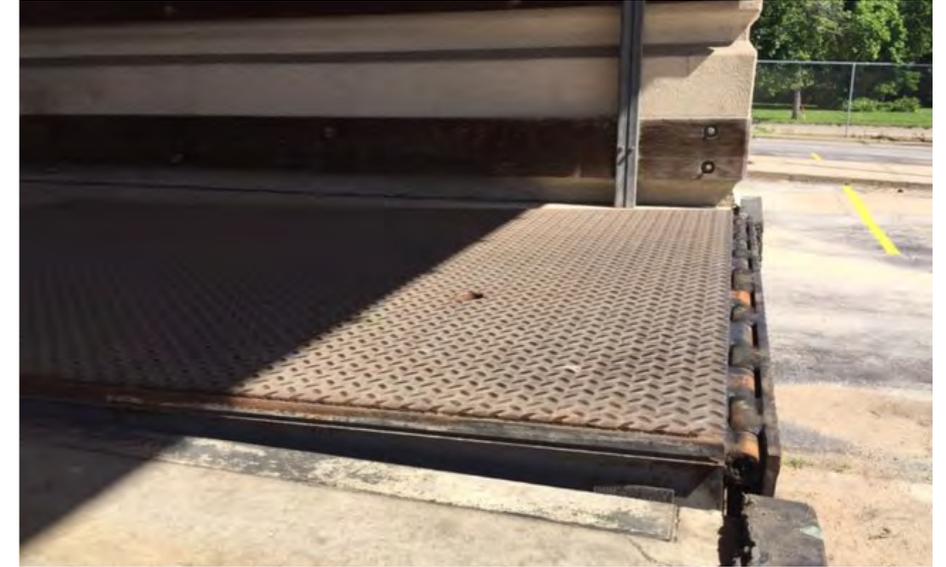
Figure 5. Tripping Hazard – Uneven Loading Dock Plate

- Four facilities (10 percent) had parking lot issues such as faded lines and missing directional arrows for the safe flow of traffic.
- Four facilities (10 percent) had potential tripping hazards, including two with uneven loading dock plates and another with a poorly maintained walkway for employee access (see [Figure 5](#)).

Source: OIG photo taken June 8, 2017, Kansas City Post Office, Kansas City, KS.

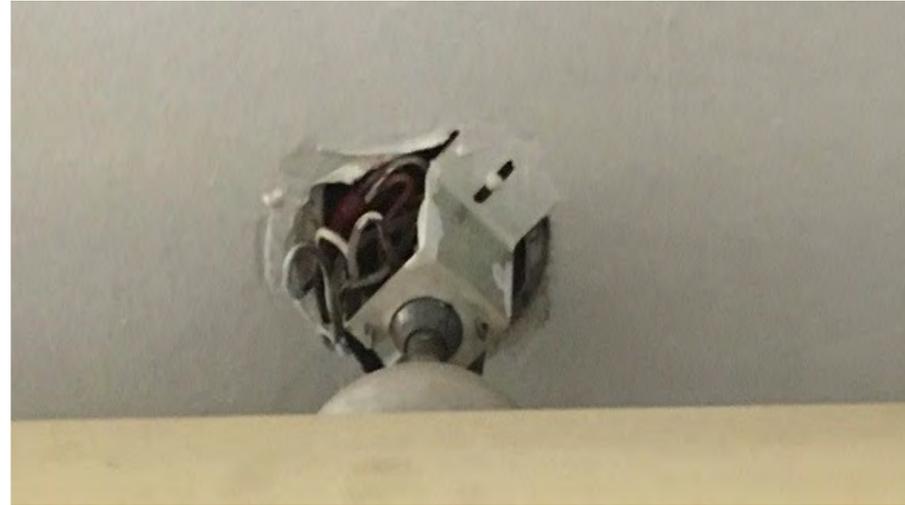
Figure 6. Exposed Wiring

Source: OIG photo taken June 7, 2017, Globe Post Office, Globe, AZ.

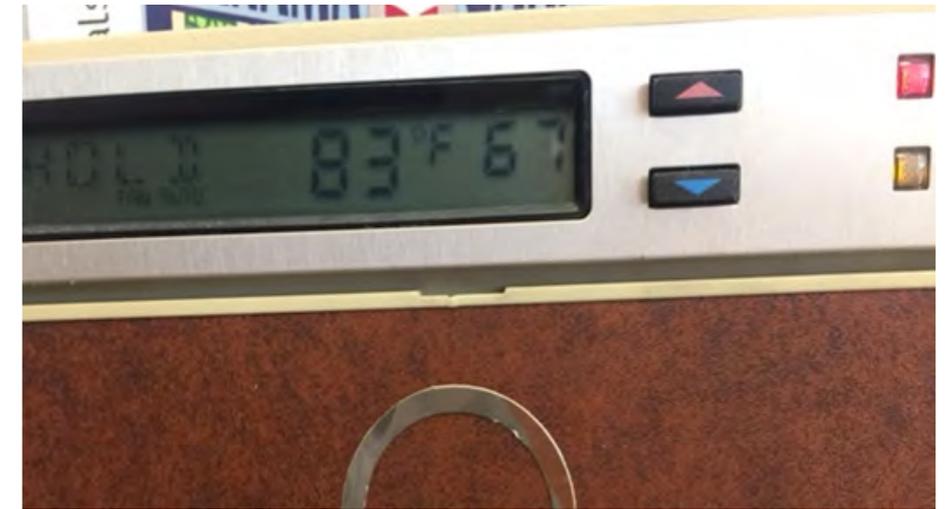
Figure 7. Room Temperature of 83 Degrees Fahrenheit

- Two facilities (5 percent) had air conditioning issues. One facility had a recorded room temperature of 83 degrees Fahrenheit in June. Another facility with an inoperable air conditioner received numerous complaints from customers. The lobby was hot and uncomfortable and the facility had to replace three labeling equipment machines due to overheating (see [Figure 7](#)).

Source: OIG photo taken June 6, 2017, Bonner Springs Post Office, Bonner Springs, KS.

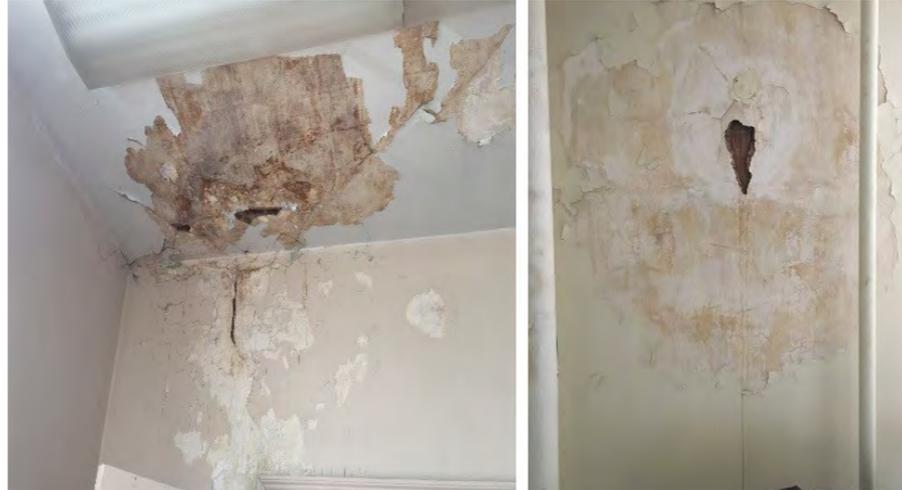
Figure 8. Damaged Walls

- Sixteen facilities (41 percent) had ceilings, walls, and floors that needed repair and maintenance. Some facilities had stained or damaged ceiling tiles, while others needed fresh paint and repairs to missing and broken asbestos-containing floor tiles. We also observed dirty floors and walls needing repair (see Figures 8 and 9).

Source: OIG photos taken June 7, 2017, Globe, AZ.

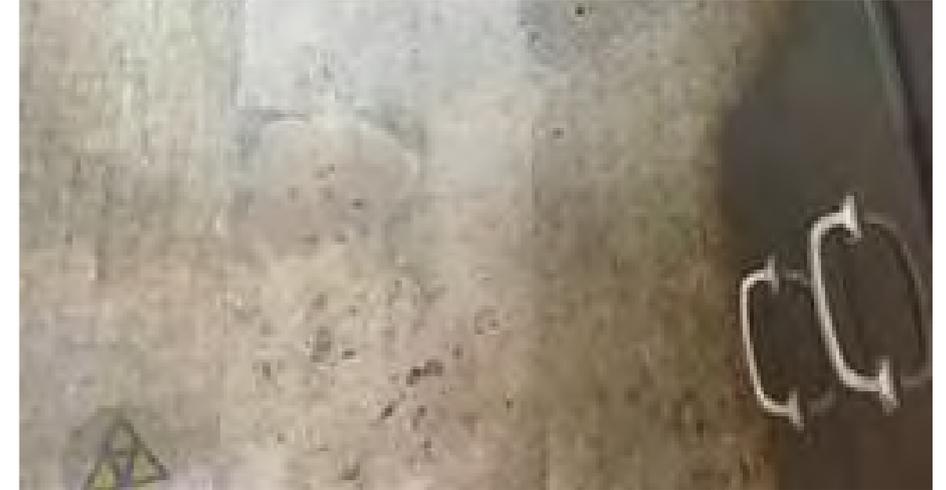
Figure 9: Damaged Asbestos Floors

Source: OIG photo taken June 6, 2017, Wikieup Post Office, Wikieup, AZ.

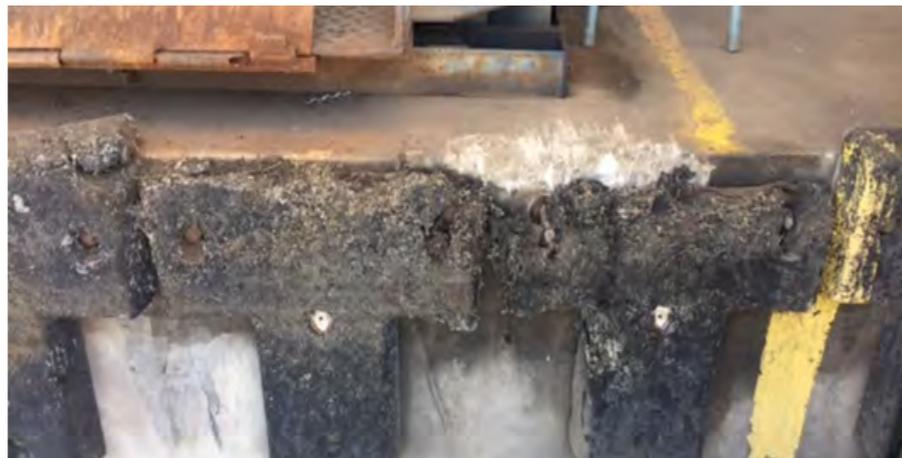
Figure 10. Damaged Loading Dock Bumper

- Eleven facilities (28 percent) had exterior maintenance issues, such as damaged loading dock bumpers, cracked decorative columns, cracked and broken windows, rotting wood on roof support beams, bubbling paint on windows, and missing letters in signage (see Figures 10 and 11).

Source: OIG photo taken June 7, 2017, Robert L. Roberts Post Office, Kansas City, KS.

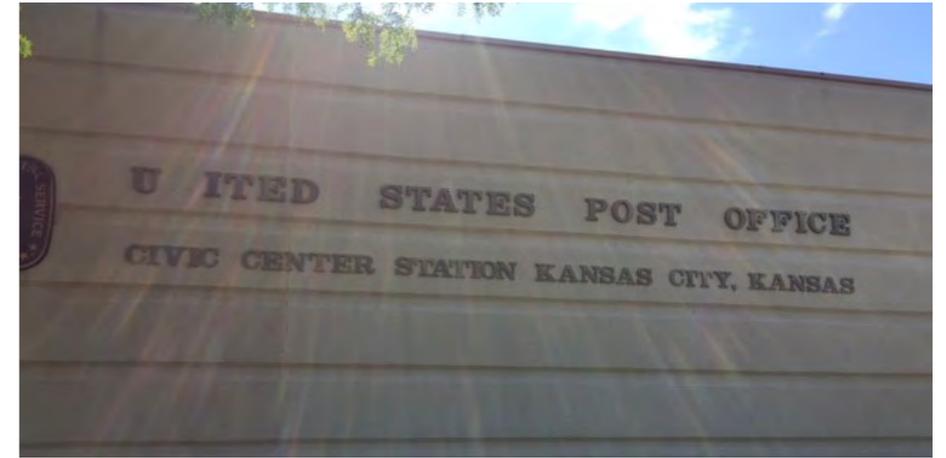
Figure 11. Missing Letter in Signage

Source: OIG photo taken June 8, 2017, Kansas City Post Office, Kansas City, KS.

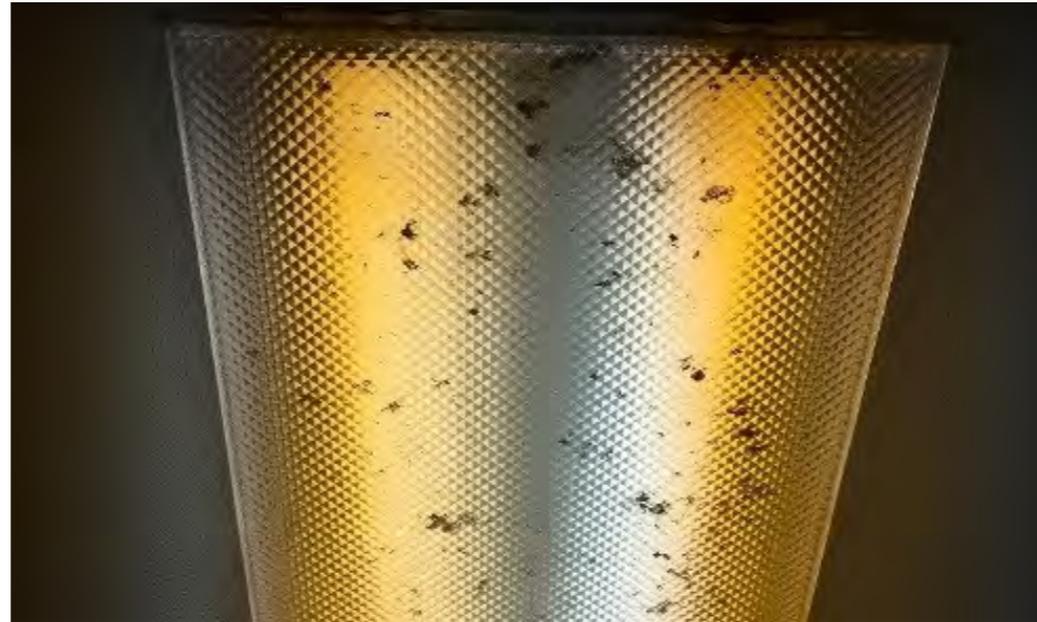
Figure 12. Dead Bugs in Ceiling Light Fixture

- Eleven facilities (28 percent) had interior and exterior lighting issues,¹³ such as bulbs needing replacement, missing light covers, and U.S. flags not illuminated after dusk.¹⁴
- Five facilities (13 percent) had unappealing lobbies with cobwebs and dead bugs on floors and ceilings (see Figure 12).

Source: OIG photo taken June 7, 2017. Tonto Basin Post Office, Tonto Basin, AZ.
