SUBJECT: Management Advisory – Trailer Damage
(Report Number-TD-MA-02-002)

This management advisory presents the results of our self-initiated review of the Postal Service trailer fleet (Project Number 00PA032TR003) and is part of a series of reports on this subject. The objective of the review was to determine whether Postal Service initiatives, policies, and procedures were effective in controlling the cost of damage to trailers the Postal Service owns.

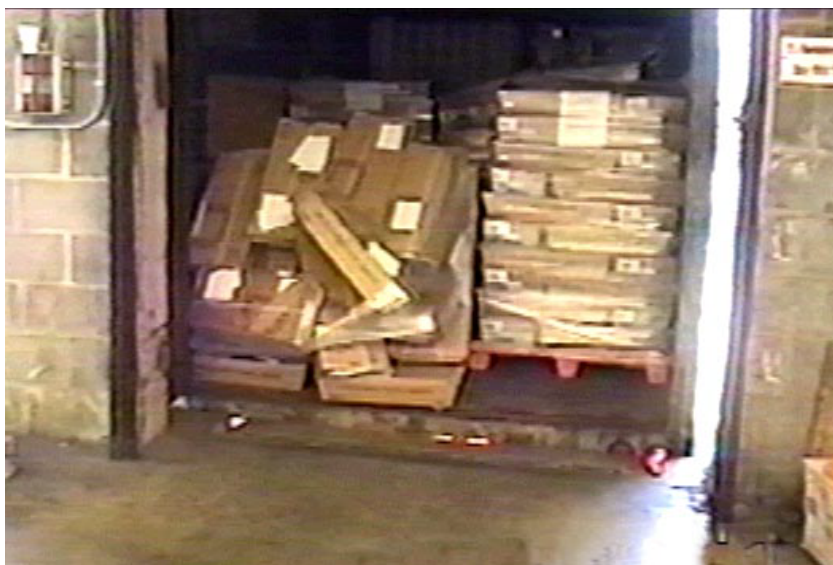
Unnecessary Damage Unnecessary damage to trailer doors was caused, in large part, by cargo that was not properly loaded or secured. Consequently, the cargo shifted in transit and resulted in damage. For example, Figure 4 below illustrates how cargo can shift when it is not properly secured. In this case, the load shifted in transit and jammed against the door. As a result, personnel were required to use a forklift to pry the door open.

Figure 4. Example of unsecured load that shifted.

1. Issue the Northeast Area video, "Shoring for Safety," to all Postal Service areas, to reinforce proper load securing procedures for Postal Service personnel who load and secure trailers.
2. Emphasize effective management controls, like safety posters, checklists, inspection sheets, and the PS Form 5500.

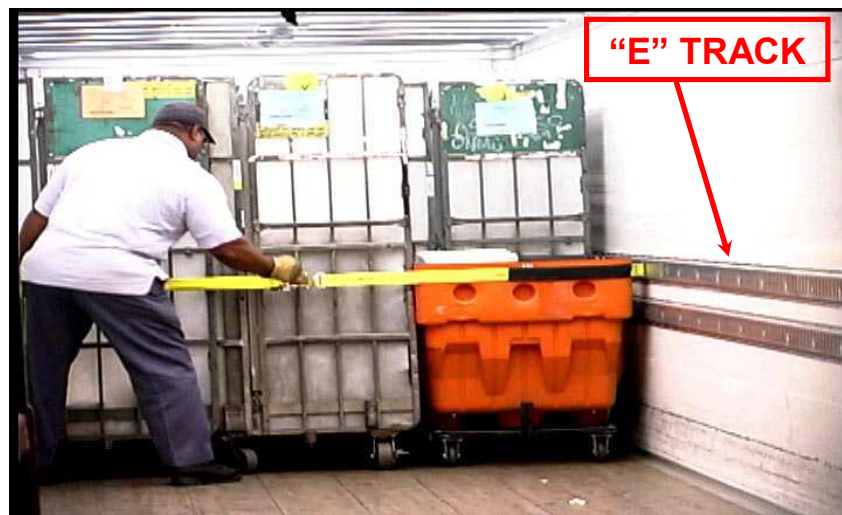
Figure 6 provides a good view of an “E” track to which straps or shoring bars are normally secured. The employee pictured is in the process of securing mail containers with a safety strap attached to an “E” track.

Figure 6. Employee in process of securing load using strap attached to an “E” track. Proper load security requires two straps.
