**Management of Equipment in
Capitol Heights, MD**

Management Advisory Report

Report Number HR-MA-14-001

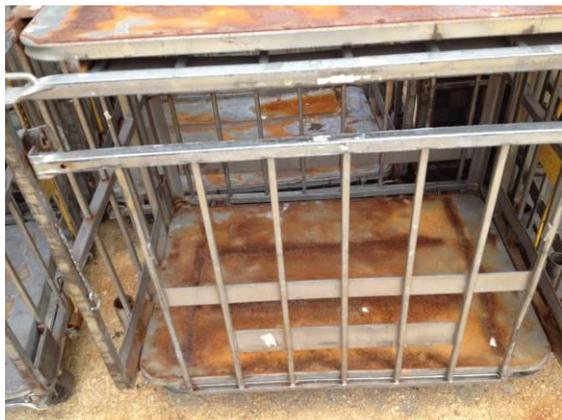
Figure 1. Rusted APC

items, such as flat tubs, general mail containers, and wire containers showed rust (see Figure 1) and appeared to have been subjected to extended weather exposure. Additionally, the mail tubs in Figure 2 crumbled at physical touch. A U.S. Postal Service mechanical engineer indicated it would take years of exposure to deteriorate the tubs to this degree.

1. Establish procedures to comply with the revised mail transportation equipment policy when implemented.
2. Reinforce proper mail transportation equipment handling guidelines with maintenance and operations managers at the Southern Maryland Processing and Distribution Center and Washington Network Distribution Center and ensure mail transportation equipment is used only to transport mail.
3. Ensure maintenance and operations managers at the Southern Maryland Processing and Distribution Center and Washington Network Distribution Center comply with policies and procedures for disposing of damaged or excess mail transportation equipment.
4. Replace coverings on existing container loaders stored outside and establish procedures to monitor the condition of current and future mail processing equipment stored outside.

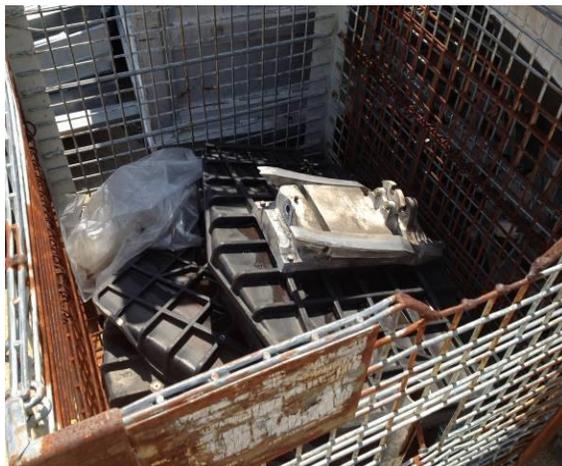
Figure 3. Storing Parts

Regarding improper use, we observed numerous pieces of MTE containing fire extinguishers, machine parts, rubber floor mats, debris, and other MTE (see Figures 3 and 4).

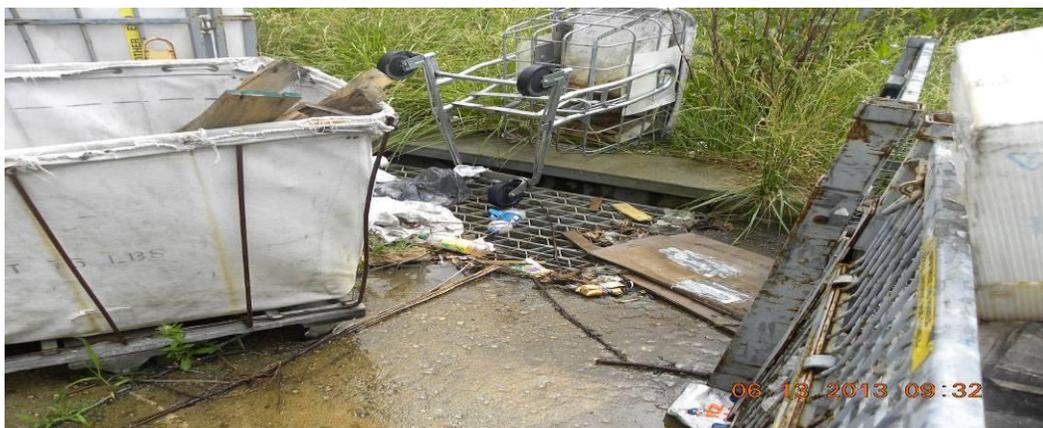
Figure 5. Rusting MTE Near Storm Drain

Additionally, outdoor MTE storage poses an environmental risk of discharging rust and other materials into storm water. MTE, such as the APCs, poses a risk of discharging rust runoff into storm water when the APCs are staged near storm drains (see Figure 5). According to the U.S. Environmental Protection Agency, heavy metals are toxic to aquatic life and can contaminate ground water. Also, other hazardous materials stored inside the MTE could discharge into storm water.

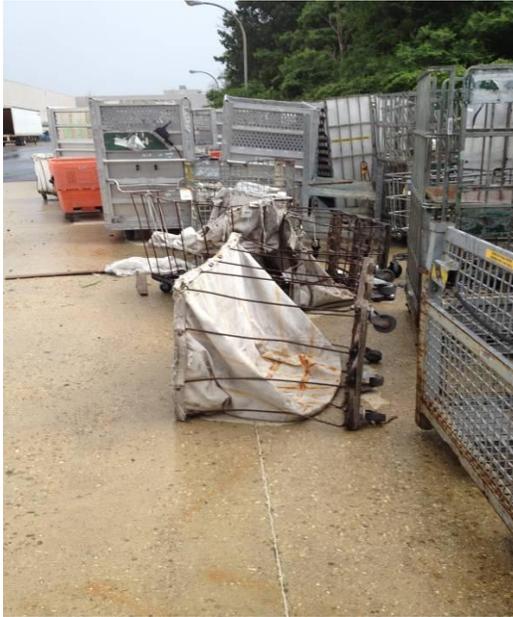
Figure 6. Broken MTE

Personnel at the Southern Maryland P&DC and Washington NDC did not always promptly identify and send damaged or excess MTE to the MTE SC for repair. We identified several damaged pieces of equipment that were not identified as such, as depicted in Figures 6 and 7.

MTE inventory shortages could result if damaged or excess MTE is not immediately dispatched to the MTE SC for repair and redistribution. More importantly, there are safety concerns because untagged, unserviceable equipment could contribute to employees being injured.

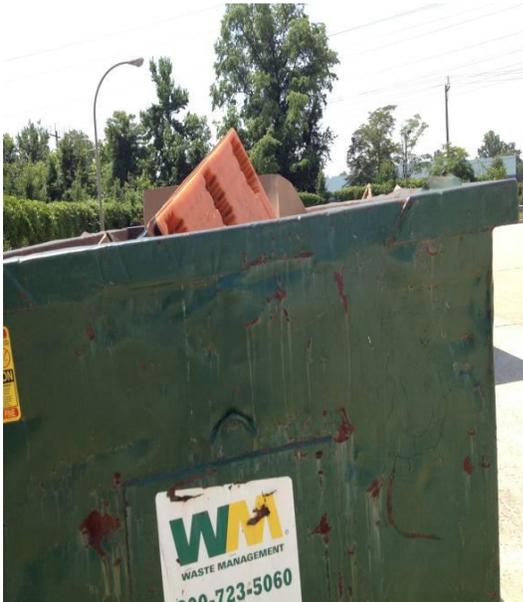
Figure 8. Pallet in Dumpster

We also found pallets that had been discarded in the dumpster, as depicted in Figures 8 and 9.

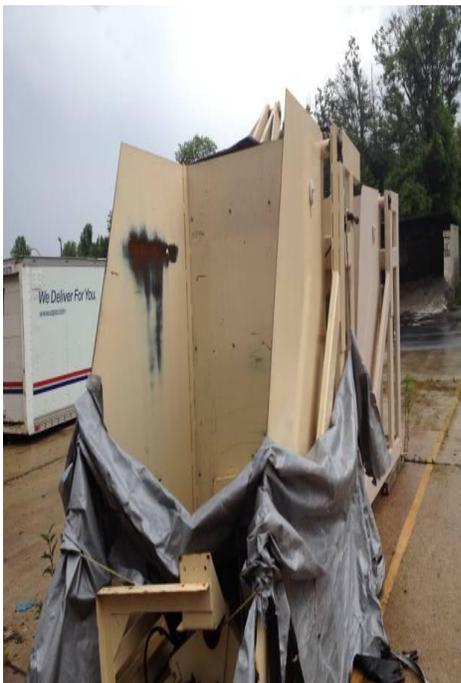
Figure 11. Uncovered Loader

The Washington NDC also stored unsheltered MPE outdoors. During the physical inventory we conducted on June 27, 2013, we identified 12 container loaders that were not adequately protected. The Washington NDC received the container loaders from another facility and stored them outdoors due to space constraints resulting from remodeling and reconfiguration efforts ongoing at the facility. Maintenance management indicated the loaders were covered with tarps at one time; however, as depicted in Figures 11 and 12, we found the tarps had deteriorated and management had not monitored or replaced them.

Extended outdoor storage exposes the container loaders to weather, which could cause damage, particularly to electrical components. Based on the median cost of all container loaders purchased between January 1, 1995, and September 30, 2008, we valued these assets at \$284,544. See [Appendix B](#) for our calculation of assets at risk.

Management Response: Management agrees with this recommendation and has purchased new covers for the container loaders and they were deployed in September (attachment 2). As discussed in our entrance meeting, the long term plan for MPE storage is to clear out the existing maintenance storage building of obsolete equipment to make space for the loaders in the yard.

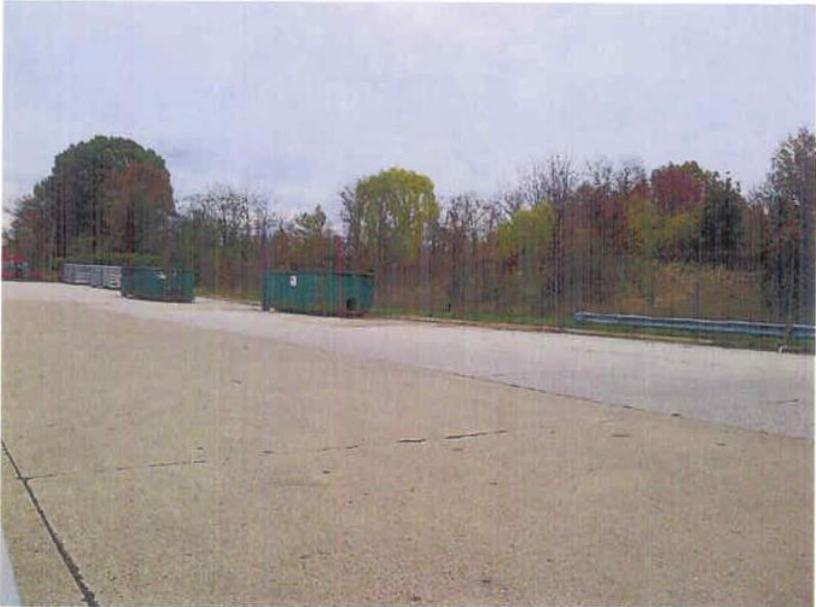
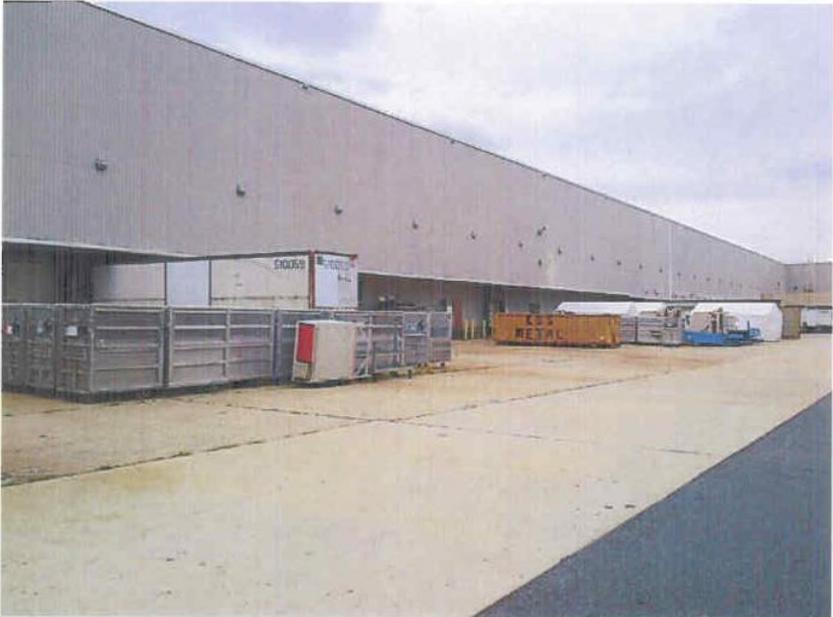
ATTACHMENT 1

Management Response: Management agrees with this recommendation. The NDC Plant Manager, Maintenance Manager, and Sr. OIE, are presently conducting weekly yard inspections to monitor improper staging and/or disposal of mail transportation equipment in the yard. Pictures from today's inspection attached (attachment 1).
