Toa Baja Post Office, Toa Baja, PR: Delivery Operations

AUDIT REPORT

Report Number 24-079-2-R24 | May 22, 2024

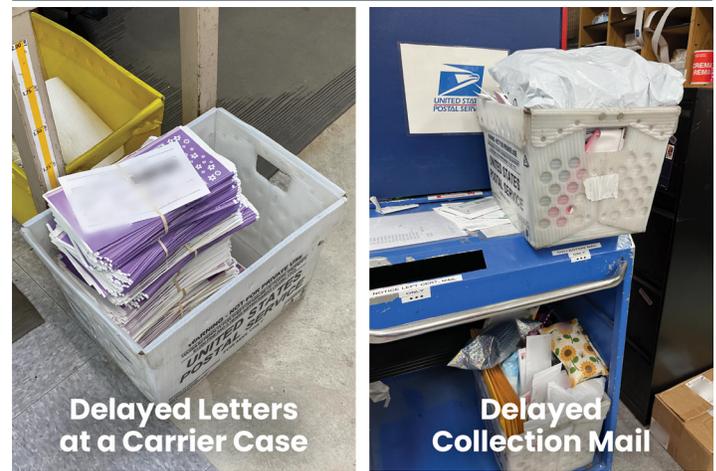
Figure 2. Examples of Delayed Mail

On the morning of March 19, 2024, we identified 887 delayed mailpieces at four carrier cases and carrier collection mail received the previous day that was not dispatched to the MPA. Specifically, we identified 832 letters, 25 flats, and 30 packages.¹⁴ In addition, management did not report this mail as delayed in the Delivery Condition Visualization (DCV)¹⁵ system. See Table 3 for the number of pieces for each mail type and Figure 2 for examples of the delayed mail found at the unit.

Management did not verify that all mail was delivered and that the delayed mail was reported in the DCV system. Unit management stated they thought they had three days to deliver the delayed letters we identified, and that they normally do not apply color codes to curtailed mail.¹⁶ Management also stated they curtailed the letters we identified so they could focus on delivering packages the previous two delivery days.

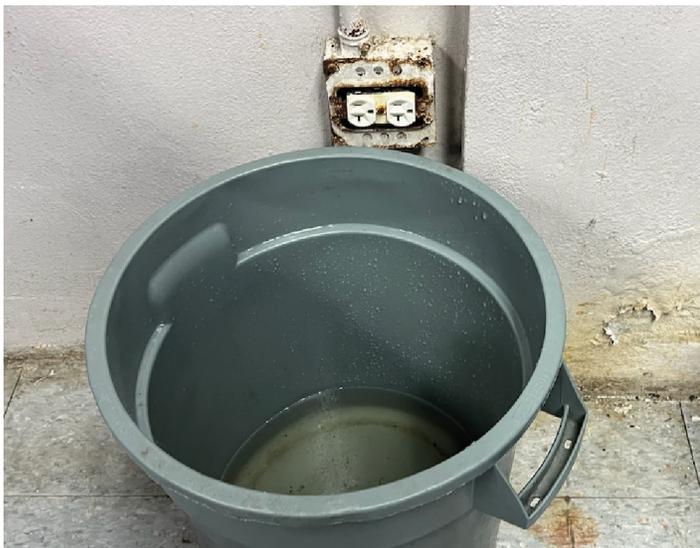
Figure 3. Exposed Electrical Outlet

- An electrical outlet on the workroom floor was missing the cover and was exposed to water leaks from the ceiling (see Figure 3).
- An internal Postal Inspection Service door was blocked.
- One fire extinguisher in the employee breakroom had an expired monthly inspection.
- The handicap automatic door button for entry into the retail lobby was inoperable, and there was no handicap automatic door button for the Post Office Box section.

Management did not provide sufficient oversight and take the necessary actions to verify that property condition issues were corrected. The OIC, who began his assignment the week before our visit, stated that he was aware of some of the issues and had submitted work orders for the damaged and missing ceiling tiles in the workroom and the inoperable sink prior to our visit. He also said that the landlord was scheduled to repair the floor tiles in May 2024. However, other duties, such as delivery operations and staffing issues, took priority over addressing the remaining maintenance issues.

Property Conditions: Local management is working to abate all reported property conditions with their control and will submit work orders for those requiring repair by other resources.

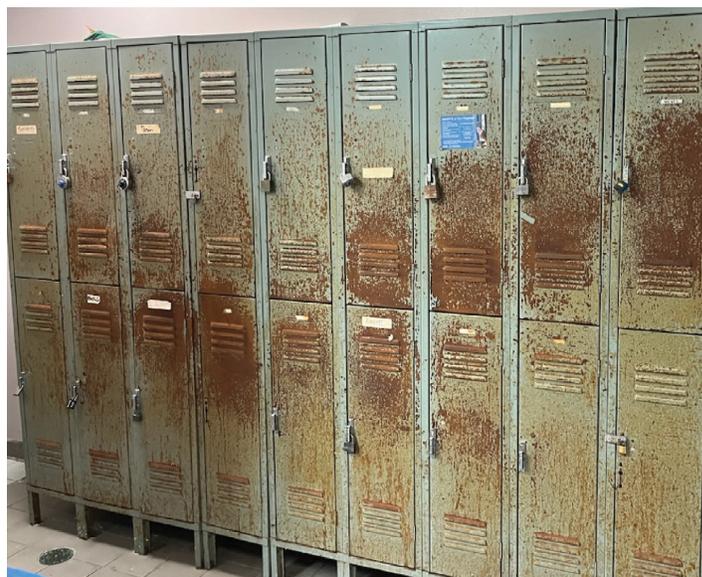
Figure 4. Rusted Metal Lockers

- The floors in the workroom and customer lobby had damaged and missing tiles.
- Metal lockers in the employee locker rooms were rusted (see Figure 4).
- There were damaged walls on the workroom floor, vestibule, and PO Box area.

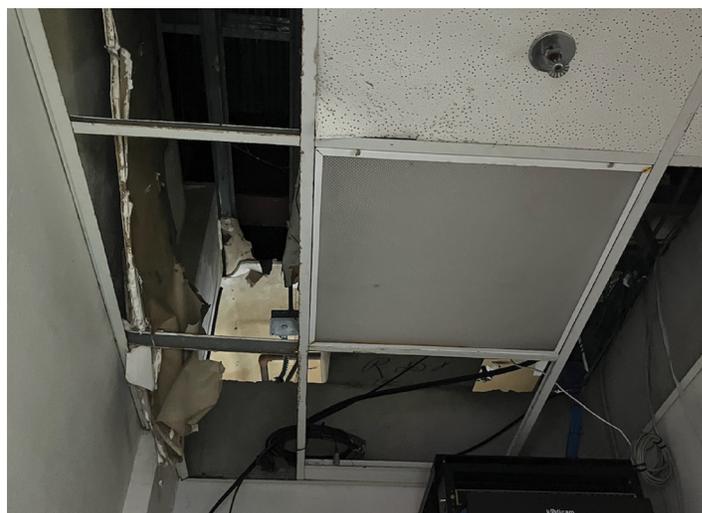
Figure 5. Damaged/Missing Ceiling Tiles

- There were missing and damaged ceiling tiles in the workroom and other areas throughout the unit (see Figure 5).
- The men's restroom had two inoperable sinks, and a women's restroom had an inoperable sink and toilet.
- The dock area was littered with trash and overgrown weeds.
