# Leon Station, Tallahassee, FL: Delivery Operations

**SUBJECT:** Audit Report – Leon Station, Tallahassee, FL: Delivery Operations

(Report Number 24-085-2-R24)

This report presents the results of our audit of mail delivery operations and property conditions at the Leon Station in Tallahassee, FL.

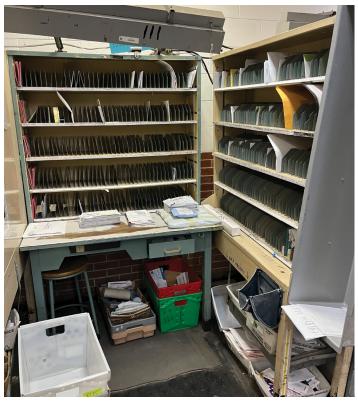
Figure 2. Example of Delayed Mail in the Carrier Cases

On the morning of April 2, 2024, we identified 256 delayed mailpieces at three carrier cases. Specifically, we identified 182 letters and 74 flats. In addition, management did not report this mail as undelivered in the Delivery Condition Visualization (DCV)<sup>13</sup> system. See Figure 2 for examples of delayed mail found at carrier cases.

Management did not provide adequate oversight to verify all mail was cleared from the unit and any delayed mail was reported in the DCV system. The station manager stated that the closing supervisor may not have properly checked the carrier cases for mail left in the cases at the end of the day. He also indicated that the PM Supervisor was on leave that week, so he has been rotating with other employees to close the unit. In addition, the station manager stated that delayed mail was not reported in the DCV system because the responsible PM supervisor was new and had not been properly trained on the process.

Management should have conducted an adequate walkthrough of the workroom to verify that all mail was delivered. Postal Service policy<sup>14</sup> states that all types of First-Class Mail, Priority Mail, and Priority Mail Express are always committed for delivery on the day of receipt. In addition, managers are required<sup>15</sup> to report all mail in the delivery unit after the carriers have left for their street duties as either delayed or curtailed in the DCV system. Further, management must update the DCV system if volumes have changed prior to the end of the business day.

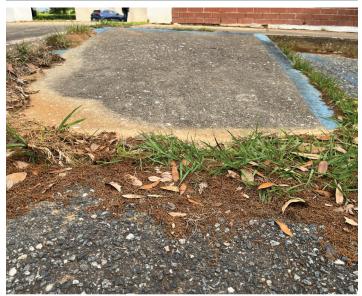
Figure 4. Handicap Accessible Parking Ramp with Tripping Hazard

- All six fire extinguishers at the unit missing updated monthly and annual inspections.
- Loose dock ramp railings with broken concrete bases.
- A set of wooden steps not properly secured to the loading dock.
- A handicap accessible parking ramp with tripping hazard (see Figure 4).
- Two fading handicap accessible parking signs.
- Several parking concrete blocks in the customer parking lot not secured.
- Electrical panels locked in a security cage and inaccessible (see Figure 5).

Property Conditions: Management has begun abating the property condition issues and will submit work orders for repairs required by other resources.

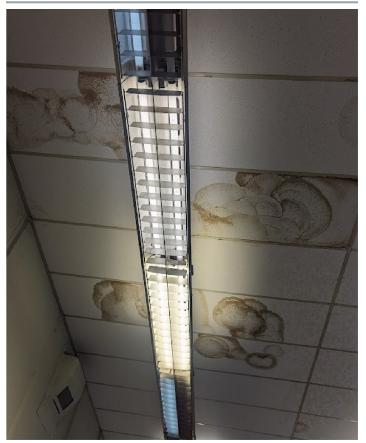
Figure 7. Water Stained and Damaged Ceiling Tiles over Workroom Areas

- Both women's bathroom toilets not fully secured to the floor.
- Numerous stained and damaged ceiling tiles over the employee workroom areas (see Figure 7).

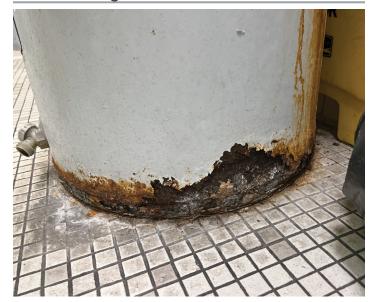
Figure 8. Non-Functioning Water Heater with Rusted Through Base

- A non-functioning water heater with rust through base (see Figure 8).
- A bent and damaged metal fence post at the mail vehicle parking lot (see Figure 9).

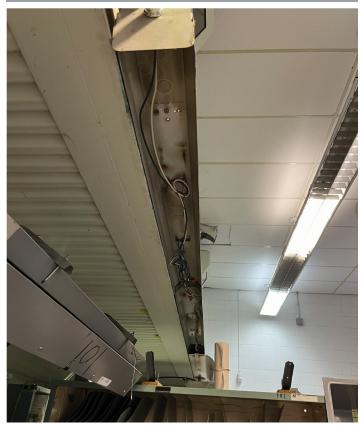
Figure 10. Several Broken Light Fixtures, with Exposed Wires, over Carrier Cases

- Several low tree branches at the customer parking area.
- Broken and missing asphalt at the loading dock ramp.
- Several broken light fixtures, some with exposed wires, over carrier cases (see Figure 10).
